EXPERIMENTAL BRIDGE DECK MEMBRANE USED ON

Milton BMA 6216

POLYASTIC'S CONCRETE POXY MEMBRANE SEALER

Report 72-8

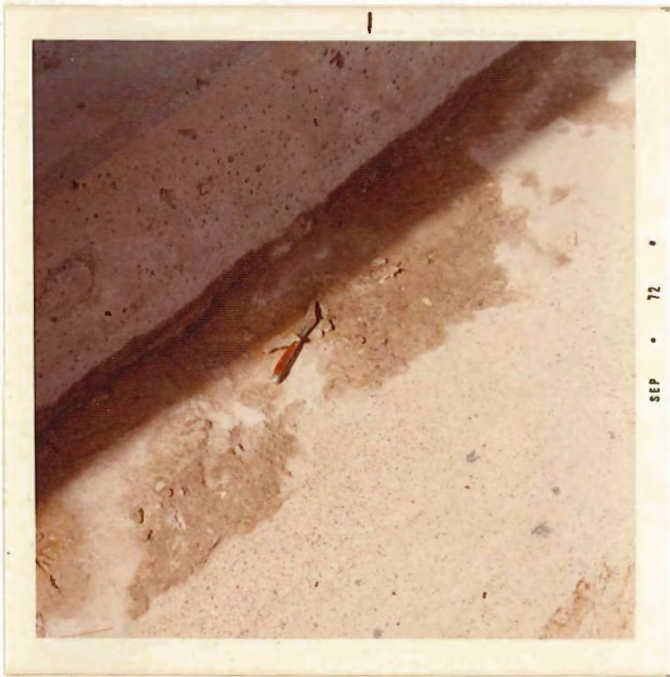
Laitance - At the base of the westerly curb and out approximately 12 inches - the laitance averaged 1/8" in thickness.

Laitance along westerly curb

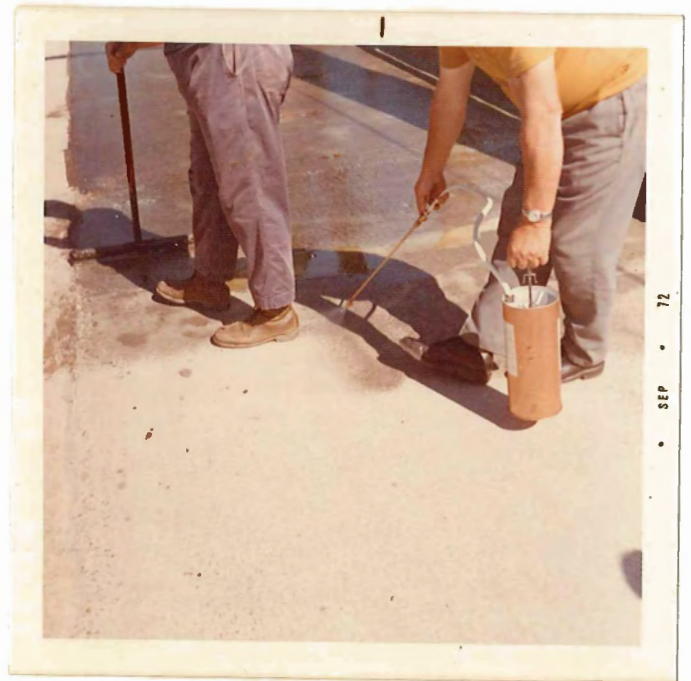
The company representative on the project requested that a light application of water be placed on the concrete prior to the epoxy application. The purpose of the water was to lower the surface temperature of the concrete which in turn slows the solvent flash off and supposedly reduces the number of air bubbles which would otherwise occur in the epoxy.

Applying first coat of the clear epoxy.
Note the spray application of water

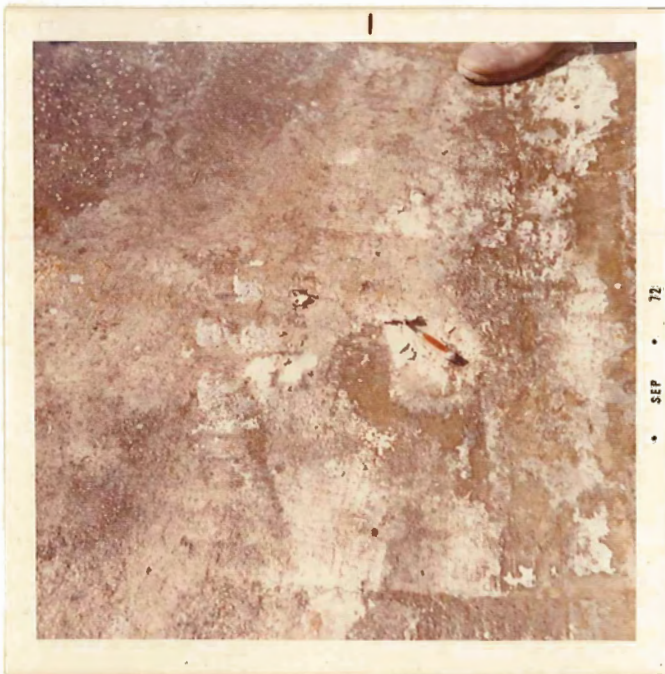
The Polyastic's representative on the project, Mr. Charles B. Gennaro, stated that 3 to 3½ mils of a 4 mil application (180 s.f./gal. produces a 4 mil thickness) should penetrate into the concrete. Inspection of the first coat revealed some dry looking areas which appeared to be due to penetration of the epoxy into the concrete. However, laboratory inspection of treated 6" by 6" by 1" thick concrete test slabs with a 30 power microscope did not reveal significant penetration of the material. The microscope did reveal many small air bubbles in the coating which could not be detected without magnification. Field inspection of areas with surface laitance (see deck condition on page 2) also disclosed that the epoxy was not able to penetrate through heavy laitance.

Inspection of first coat of epoxy revealed that the material had not penetrated into areas of heavy laitance

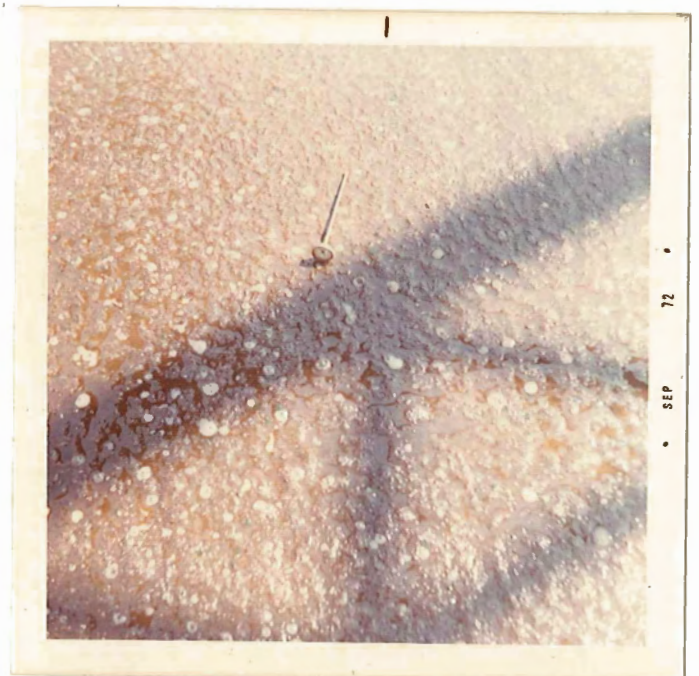
Northerly half of the northbound lane - many small depressions caused by rain-fall during the finishing operation.

Shortly after application of the first coat of liquid epoxy, individual air bubbles and air bubble clusters were noted. The bubble clusters generally consisted of one large bubble (1/8" to 1/4" in diameter) surrounded by 50 or more small bubbles. Most but not all of the bubbles were in areas where there was a build up of epoxy due to depressions in the deck or areas pock marked by rain during the concrete finishing operation. Visual inspection revealed that the individual air bubbles had at least a thin coating of epoxy on the concrete beneath the bubbles, although the original pinhole in the concrete which caused the air bubble might still not have been sealed. Most of the bubble clusters appeared to be floating on the epoxy. This gave the impression that they may have been caused by the presence of solvent or due to air entrapped in the material during mixing and or application.

Air bubbles and bubble clusters in first coat shortly after application. Concrete surface texture due to rain during finishing operation

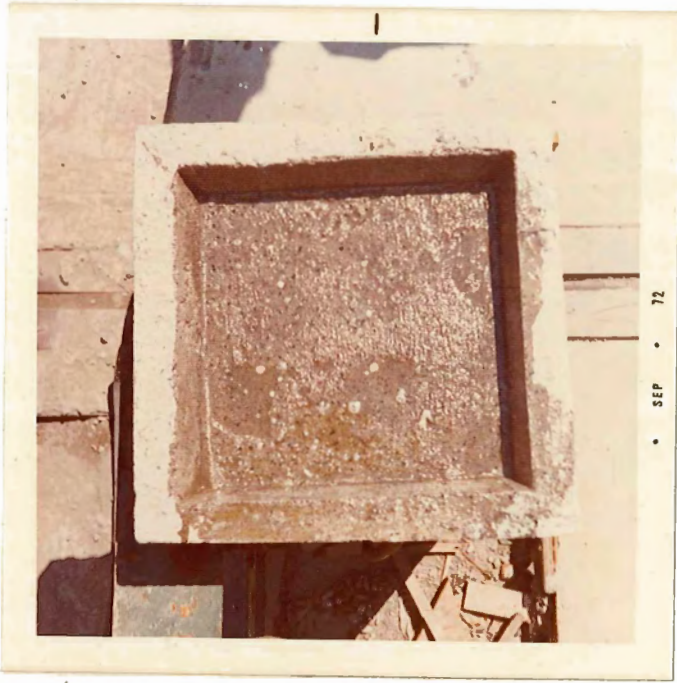
Air bubble clusters in first coat placed on concrete test slab

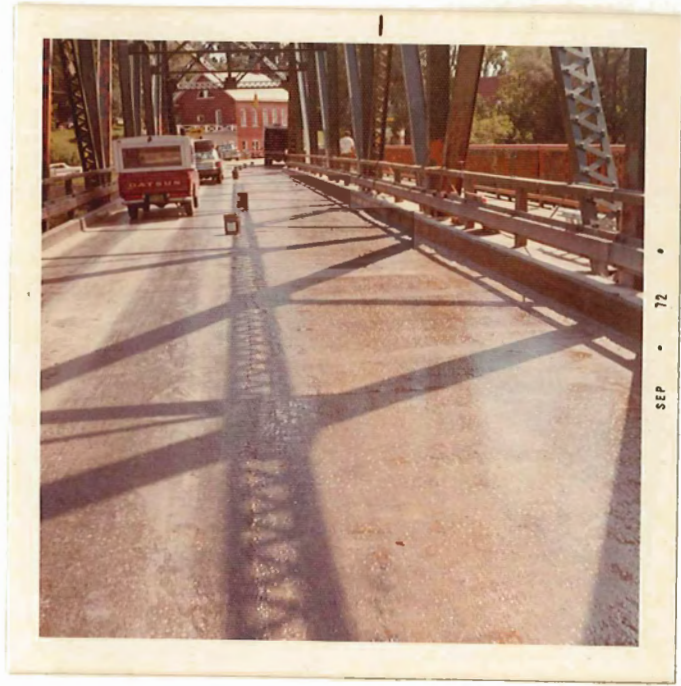
First coat complete on southbound lane

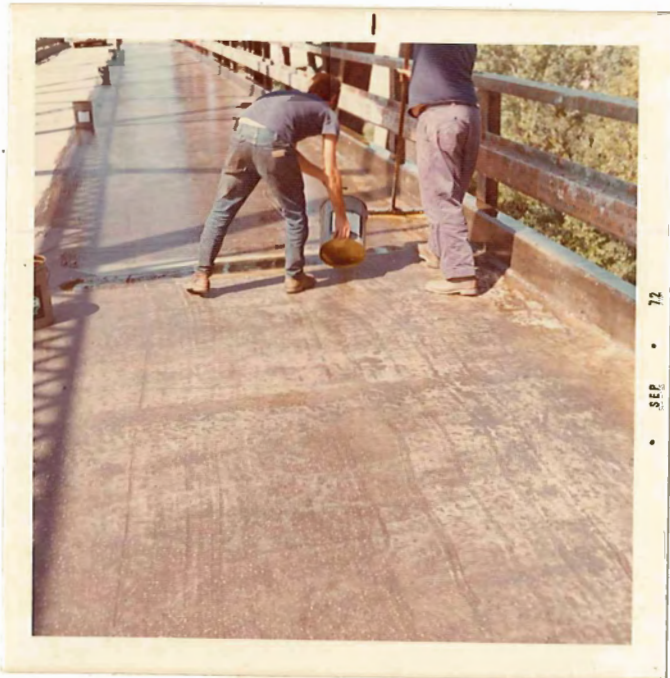
Applying second coat. Note dry looking areas where the first coat of epoxy appears to have penetrated into the concrete
