NATIONAL EXPERIMENTAL & EVALUATION PROGRAM

BRIDGE DECK PROTECTIVE SYSTEMS

WORK PLANS #1-#3 - INITIAL REPORT

REPORT 72-10

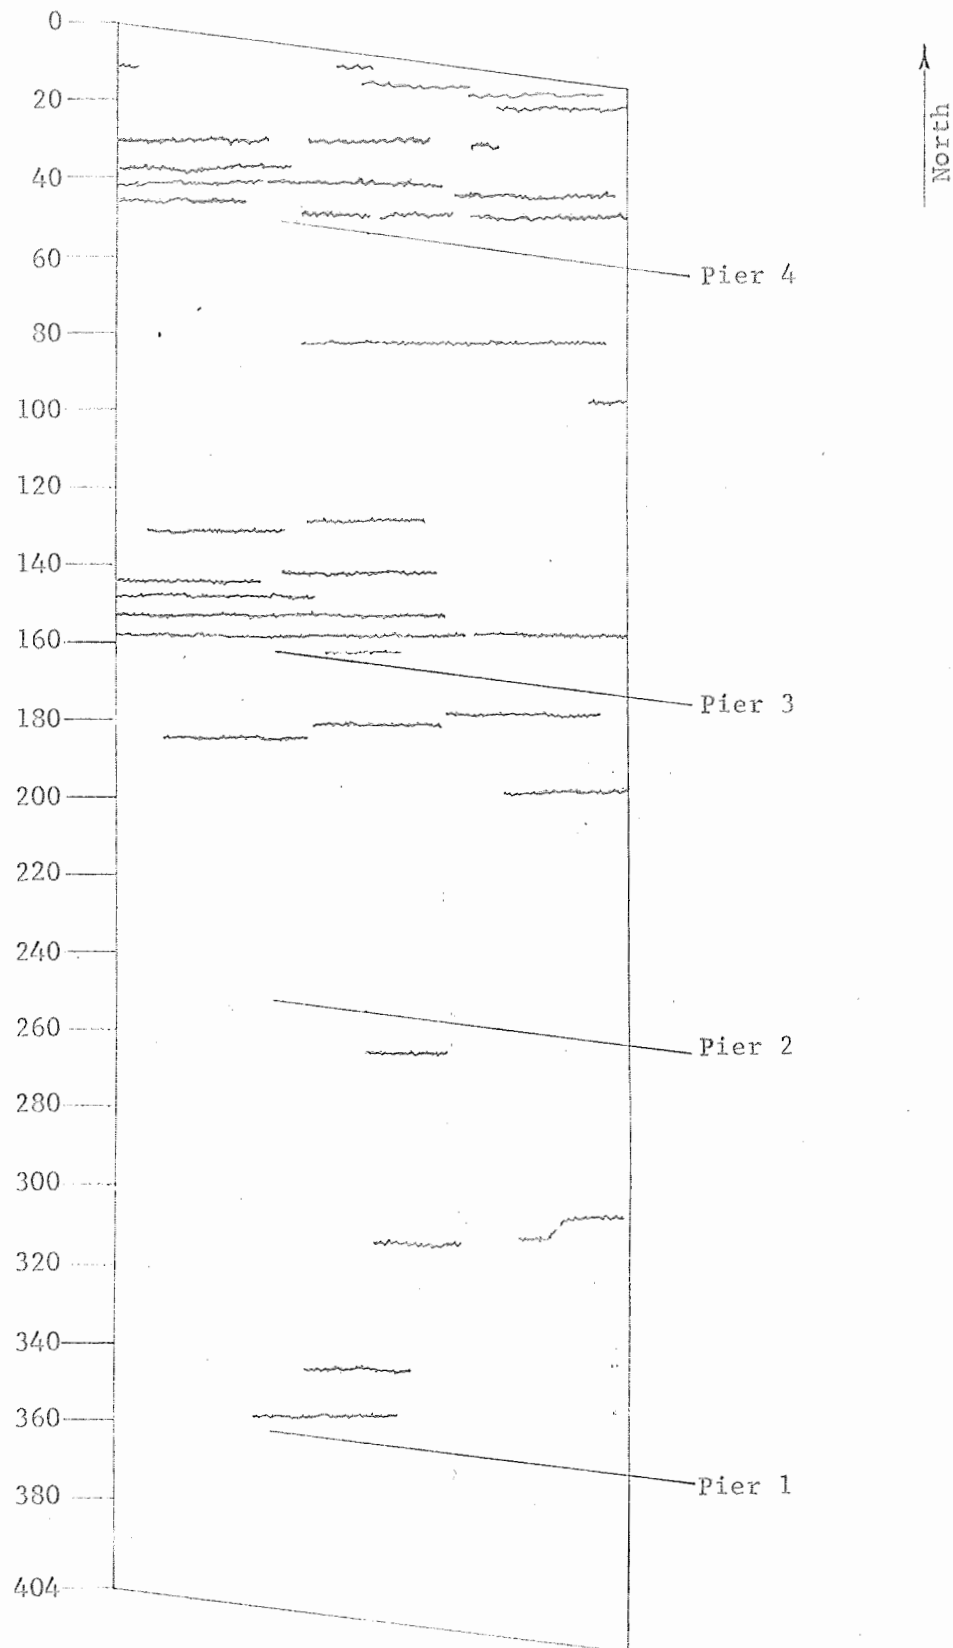
Figure I Cracks in Concrete Deck

A total of 33 transverse cracks were logged on the concrete deck. The cracks ranged in length from one foot to the full width of the deck. See Figure I, Page 21 for additional information.

All cracks were noted on both the surface and bottom of the deck. Length of cracks and their locations are to scale. **Vertical Scale 50'/in.** **Horizontal Scale 10'/in.**
