NATIONAL EXPERIMENTAL & EVALUATION PROGRAM

BRIDGE DECK PROTECTIVE SYSTEMS

WORK PLANS #4-#11 INITIAL REPORT

VERMONT DEPARTMENT OF HIGHWAYS

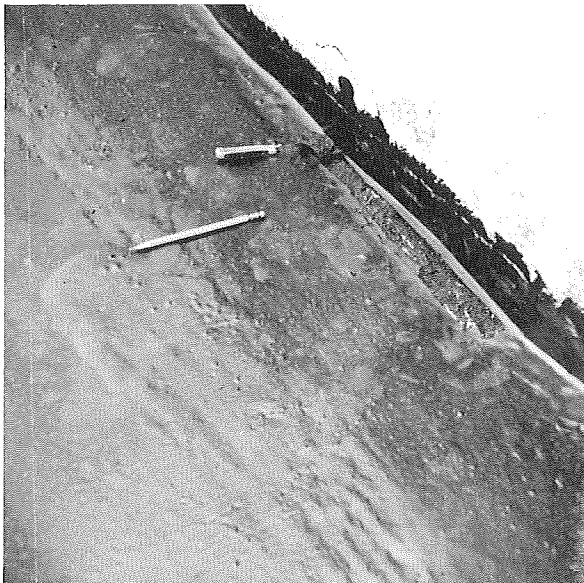
squeegee along the westerly curb. Ridges and areas with an excess of material were levelled by rolling the polyurethane with a long handled paint roller as recommended by the manufacturer. Close control over the membrane thickness was necessary because excessive thickness of the polyurethane causes the material to foam or expand. This results in a network of air cells forming in the membrane.

Excesses of material, particularly along the curb, caused foaming which resulted in air cells in the membrane.

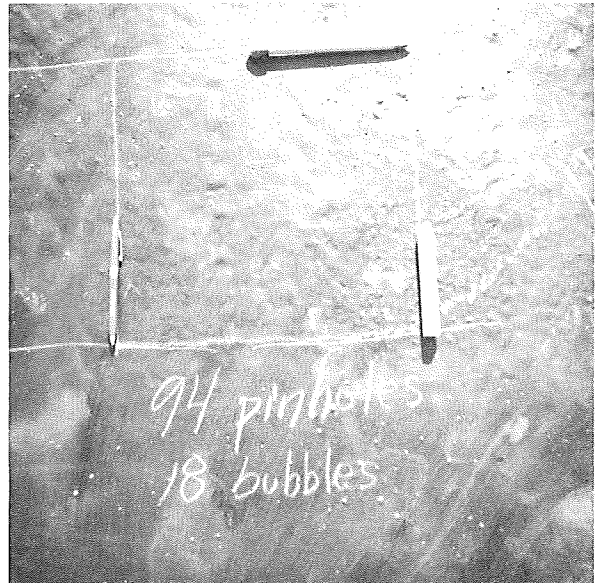
Spot checks of the membrane system revealed an average of 49 pinholes and 10 bubbles per square foot (see table I, page 5). Areas treated before noon had an average of 81 pinholes and bubbles per square foot while areas treated after 12:00 P.M. had an average of 35 pinholes and bubbles. A greater increase in air temperature just prior to and during the morning application with the resulting escape of air and or water vapor from the concrete was believed to be the cause of the difference in the number of pinholes and bubbles. Most of the pinholes were 1/16 inch in diameter or less. Concrete appeared to be visible at the bottom of a few of the pinholes but spot checking with hydrochloric acid did not disclose any effervescence of the concrete. When some of the larger bubbles were broken open, the primed concrete could be seen, but once again checking with acid did not reveal any unprotected concrete. Electrical resistance readings taken on the membrane averaged 480,000 ohms per square foot. This also indicates that the concrete was protected even in areas with numerous pinholes and bubbles.

Inspection of cured membrane revealed an average of 49 pinholes and 10 bubbles per square foot, none of which were completely open to the concrete.

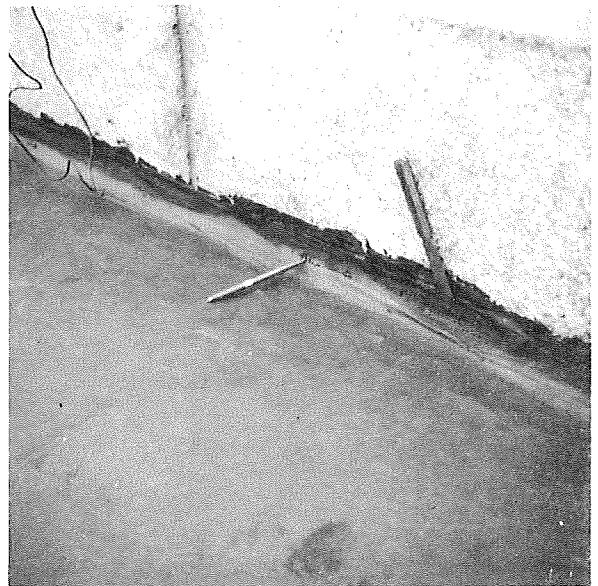
Curb area not properly sealed.

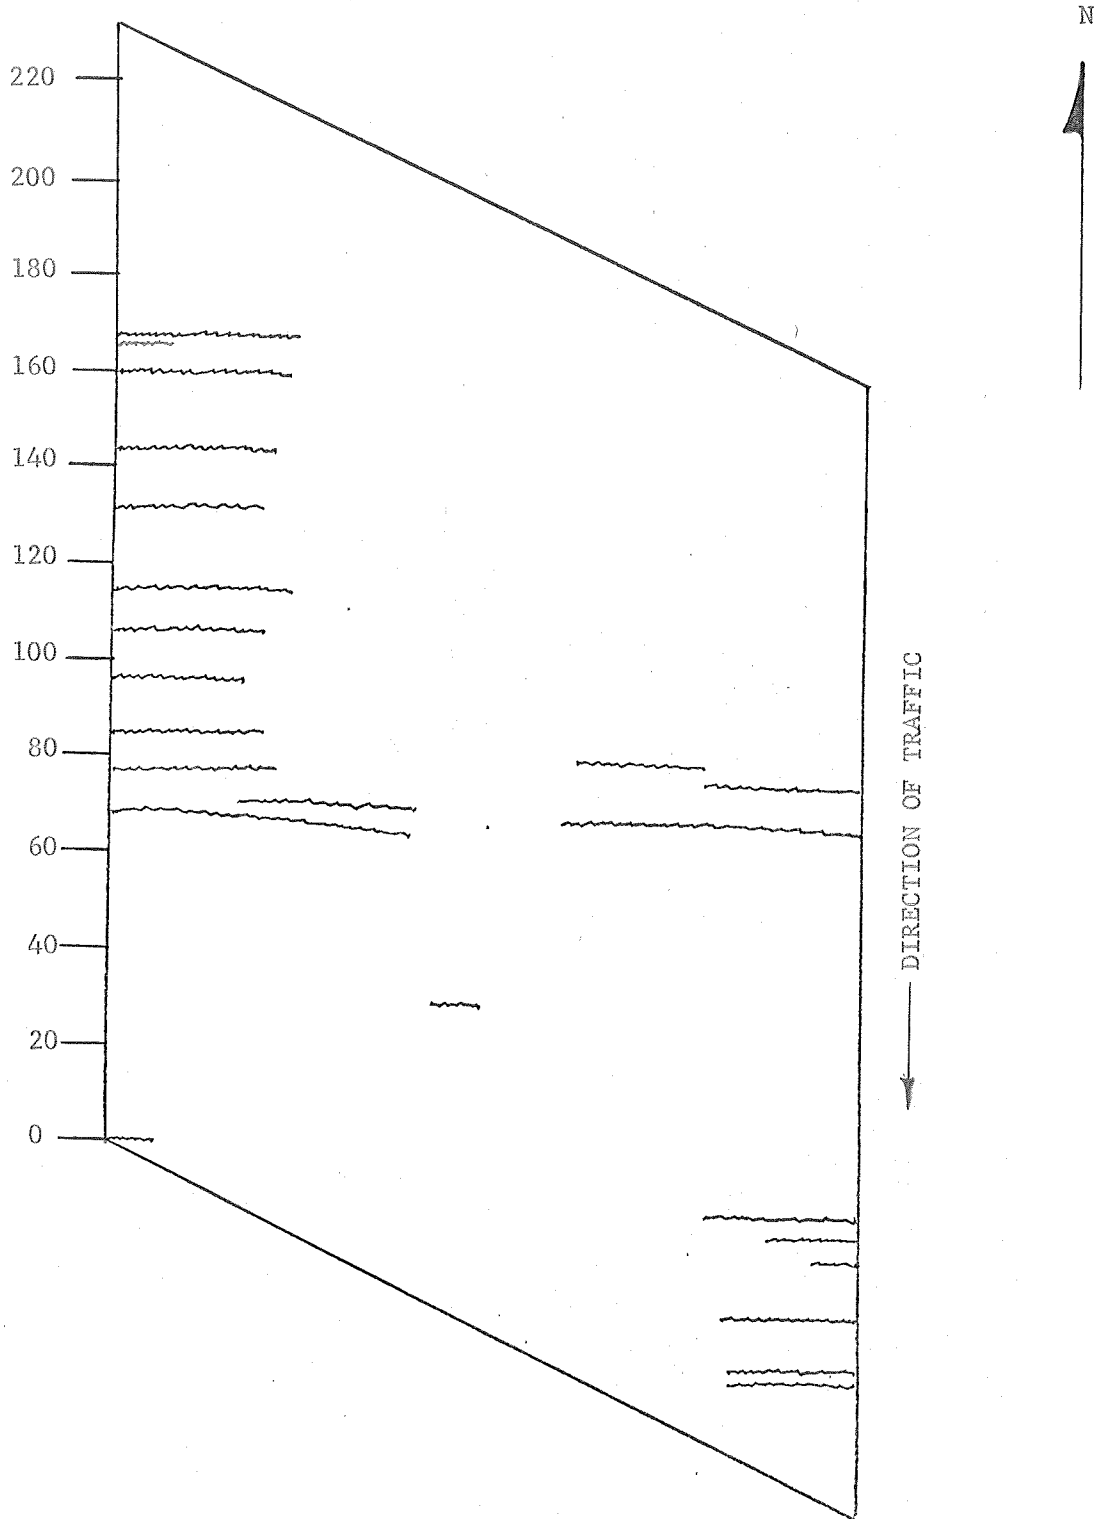
Cracks in Concrete Deck

Cracks - Twenty-three transverse cracks ranging from 2.6' to 14.5' in length were noted in the deck. All cracks observed on the surface could also be detected on the bottom of the deck. The severity of the transverse cracks decreased noticeably as they approached the curb section. See crack layout on Figure I, Page 20.

All cracks were noted on both the surface and bottom of the deck. Length of cracks and their locations are to scale. Vertical scale 40'/in Horizontal scale 10'/in

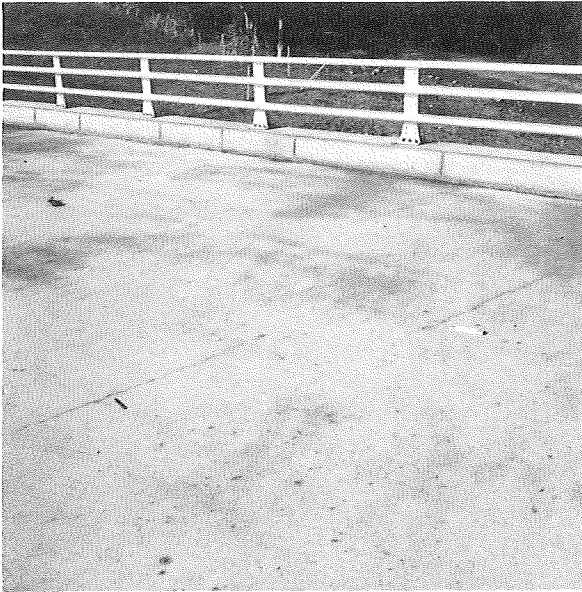
Twenty-two cracks were noted in the deck. The cracks ranged from 2.5 feet to 13 feet in length and extended through the full depth of the deck.

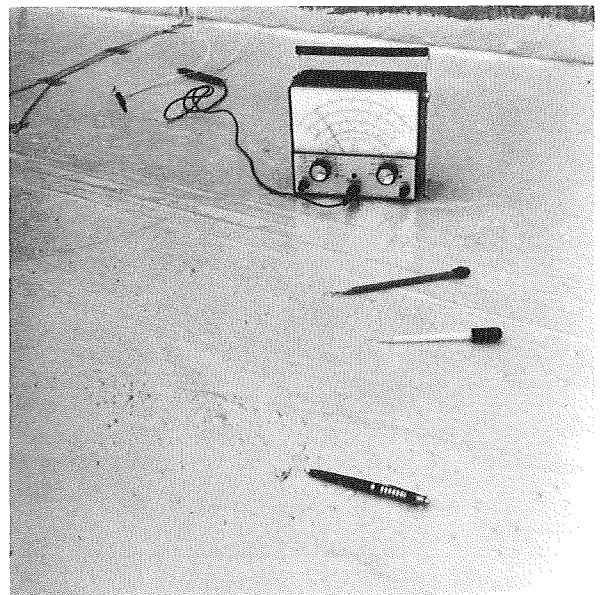
One of several areas which had air bubbles in the second coat. Very small pinholes numbering up to 70 per square inch were also detected in many areas.

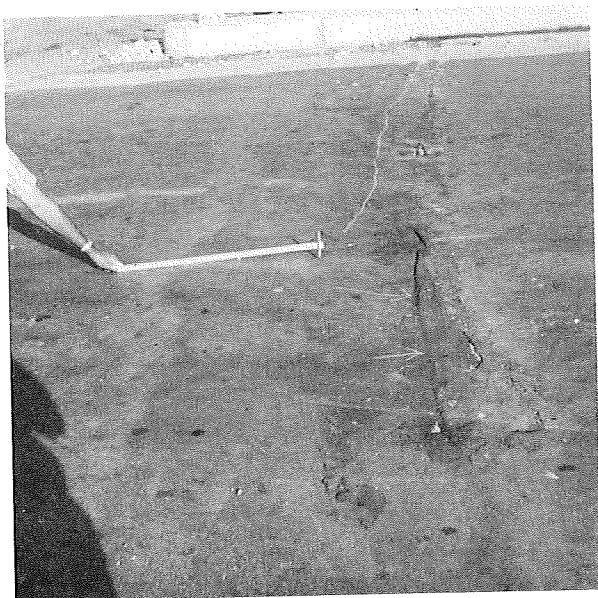
Distress adjacent to northerly approach slab includes movement of pavement and membrane which caused a bump and bleeding of the liquid membrane up through the pavement.

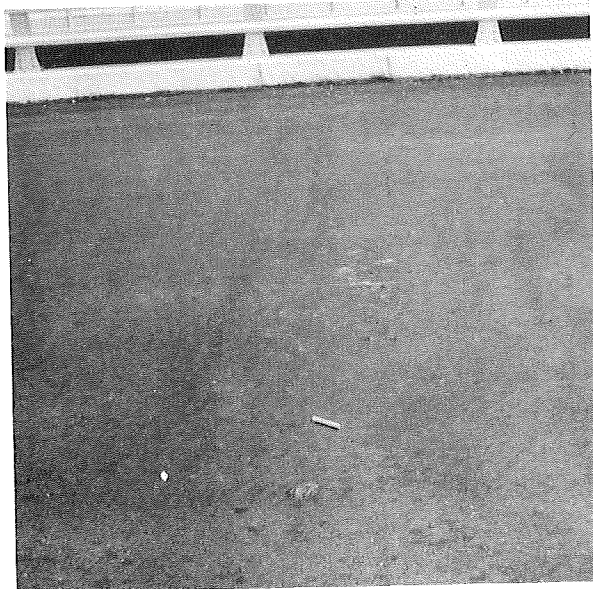
Distress over construction joint where Elastosheet had been placed.

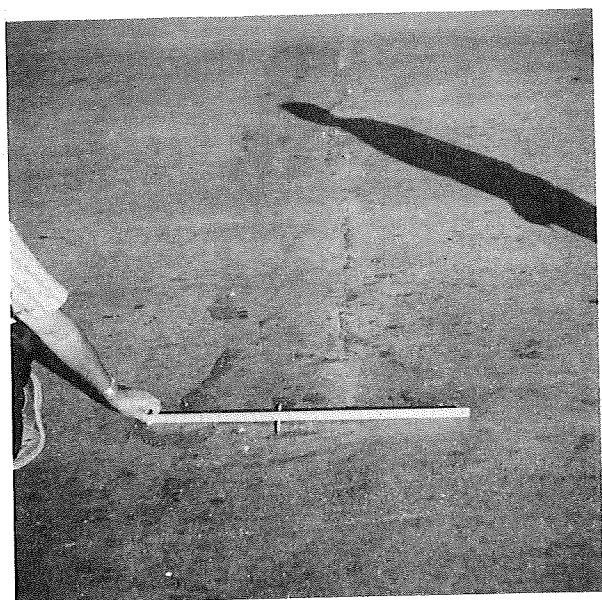
Movement of pavement over joint at southerly approach slab.

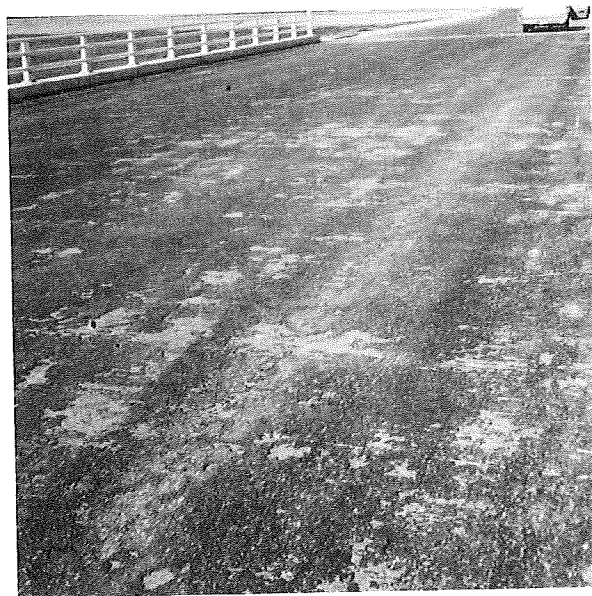
Removal of the distorted pavement with a grader resulted in exposed areas of concrete where the Uniroyal stuck to the bituminous mix rather than the concrete deck.

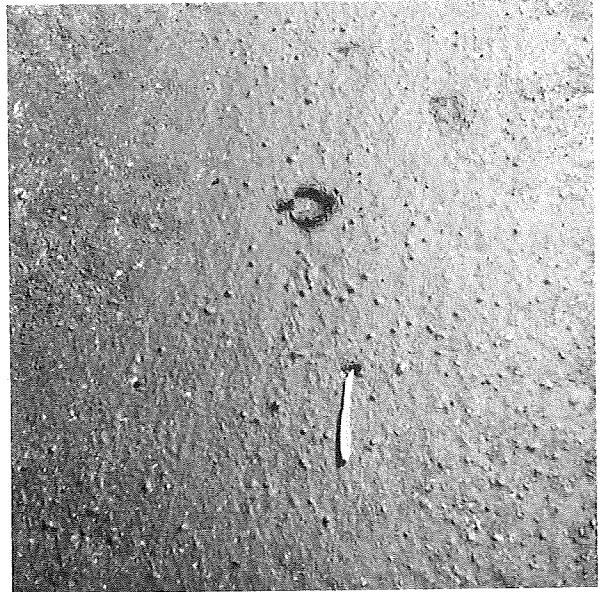
One of several areas where air bubbles could still be found in the membrane after the pavement had been removed.

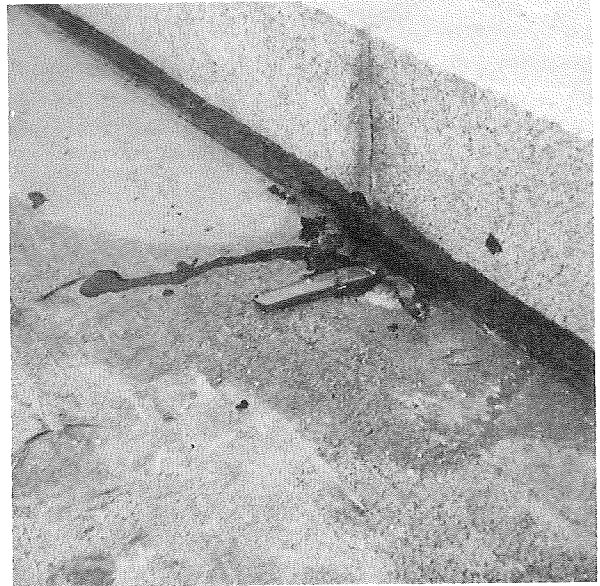
Largest of 3 areas along the westerly curb where water was able to get behind the Elastosheet before the pavement was placed.

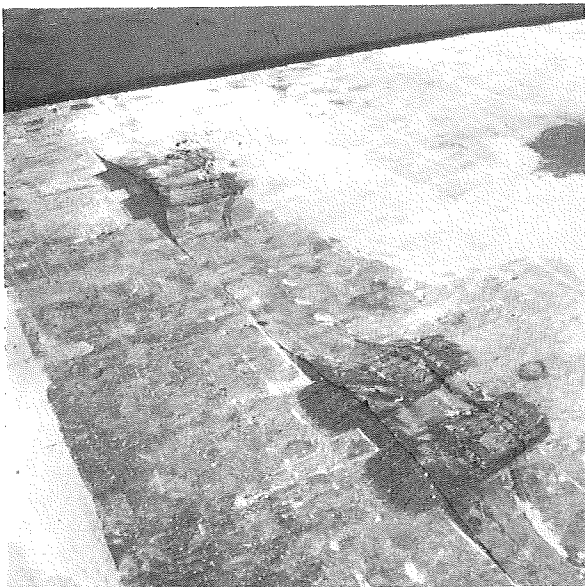
Movement of Elastosheet over southerly deflection joint caused by a truck transporting the bituminous mix.

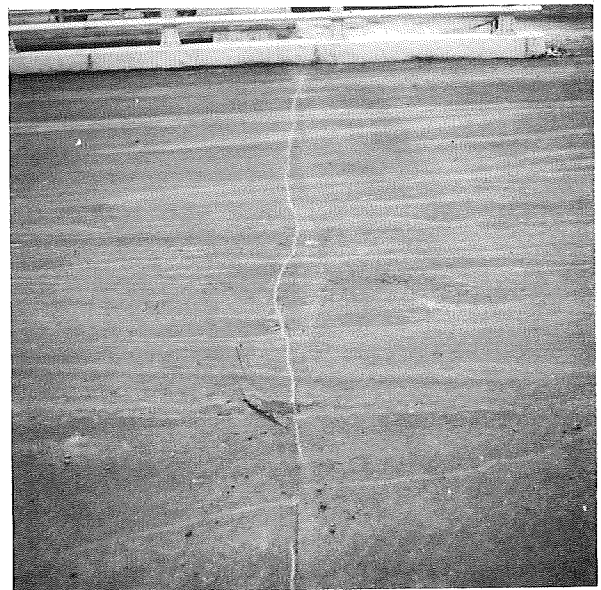
Movement of 1" thick pavement and membrane several weeks after application as indicated by keil mark on sawed pavement joint.

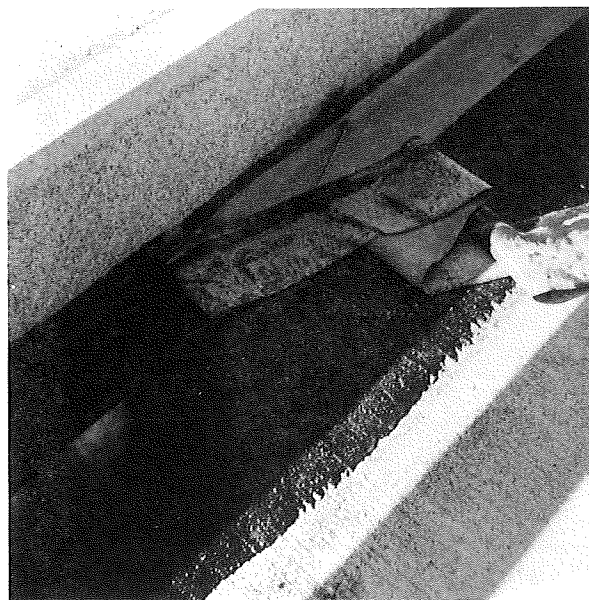
Very little bond detected between the talcum dusted Elastosheet and liquid membrane along westerly curb. Sheeting was removed.

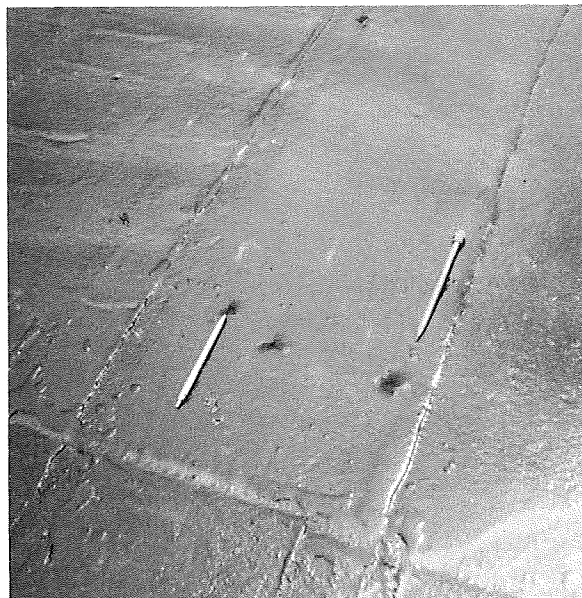
Bubbles noted in liquid membrane shortly after application. All revealed concrete when broken open.

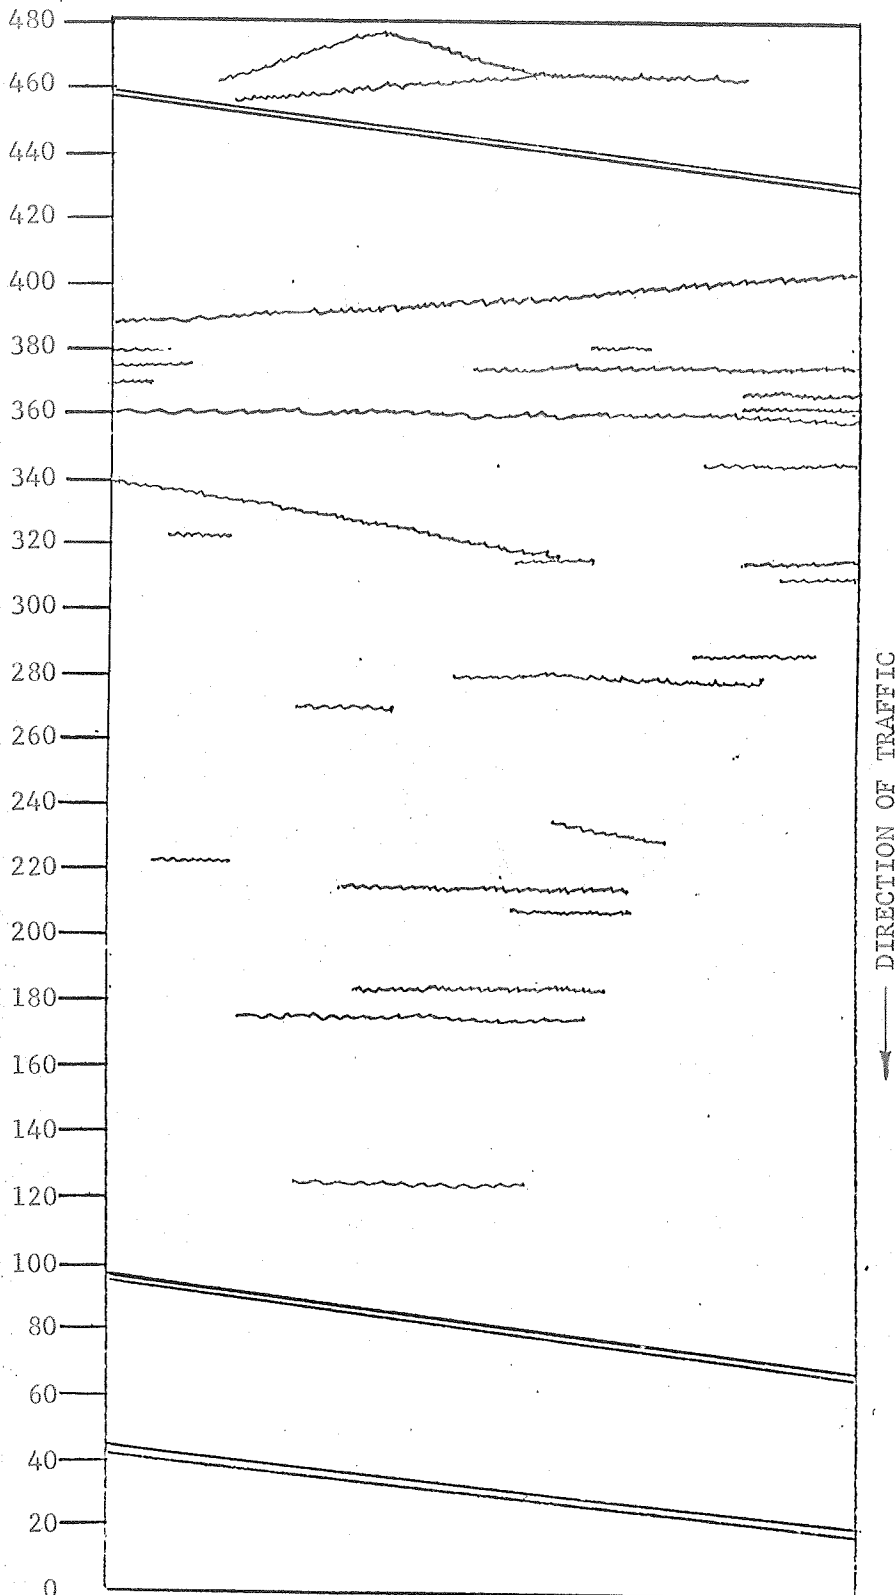
Cracks in Concrete Deck

Length of cracks and their locations are to scale. Vertical Scale 60'/in.
Horizontal Scale 10'/in.

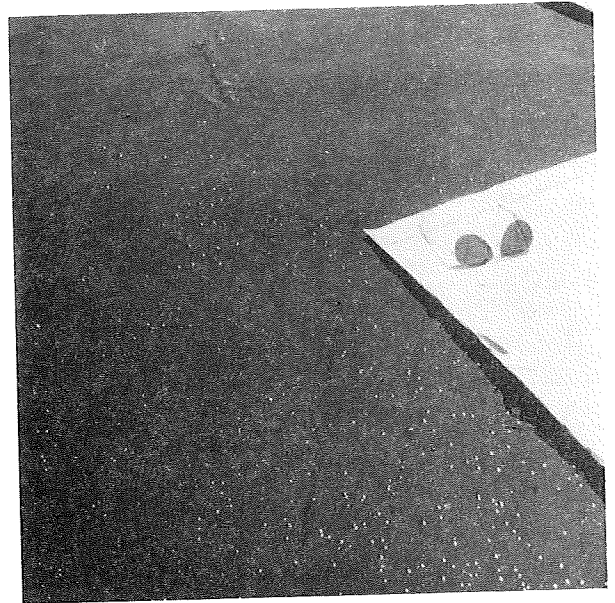
Bubbles and pinholes which appeared in the liquid membrane shortly after application.

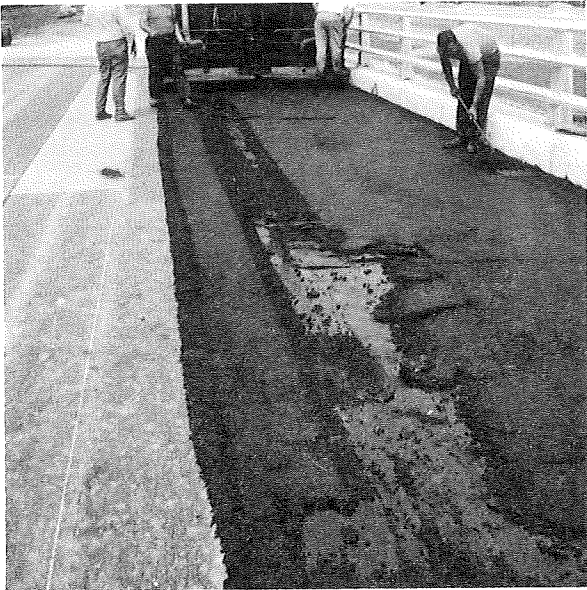
Movement of the unbonded roofing sheet caused blockage of the paver screed.

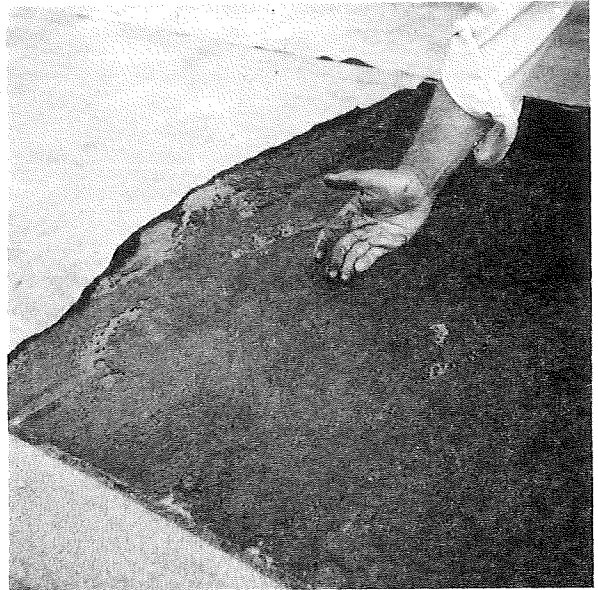
Removal of unbonded roofing sheet revealed partially cured polyurethane in some areas.

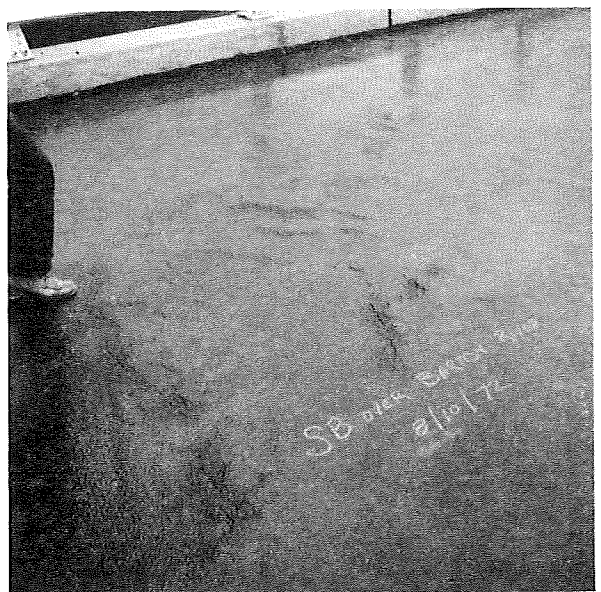
The reapplication of pavement on the polyurethane without roofing sheet resulted in numerous cracks and porous areas.

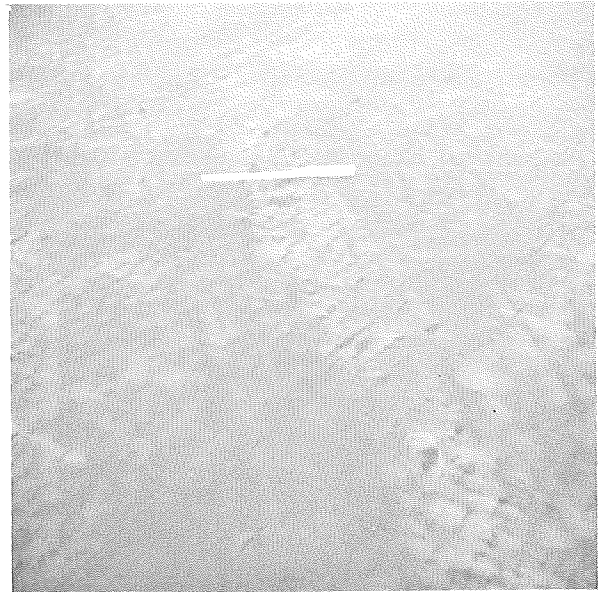
Areas with a rough or uneven concrete surface did not appear to have a sufficient buildup of tar emulsion when the final coat had dried.

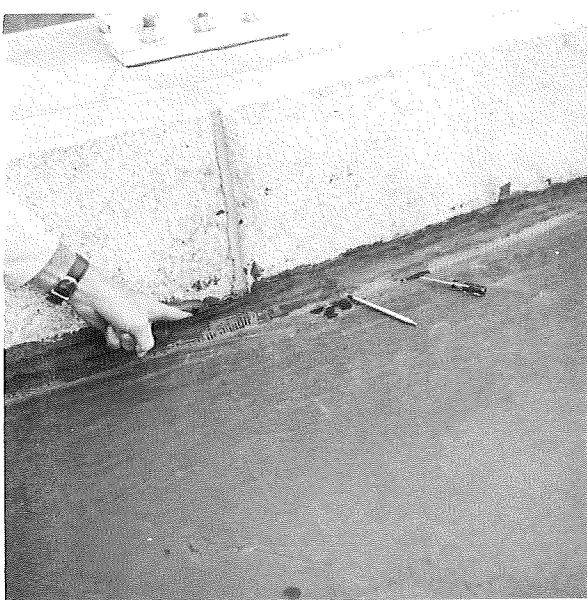
The system's sealing value did not appear satisfactory at many locations along the curbs.

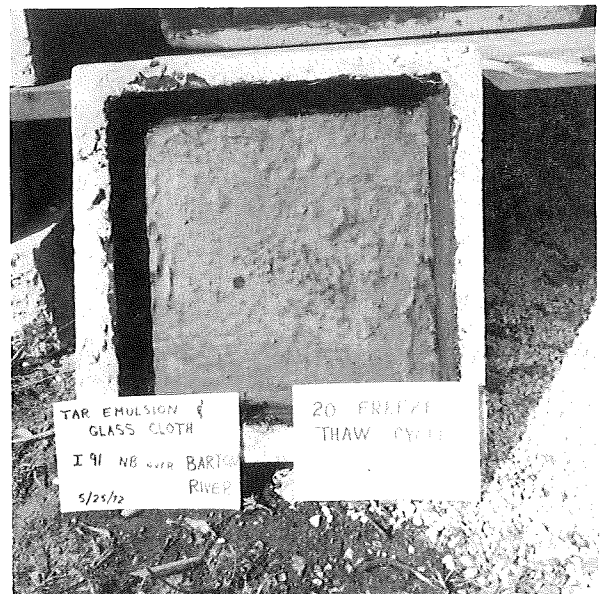
A concrete sample treated at the project site developed blisters when it was covered with water and exposed to five freeze-thaw cycles.

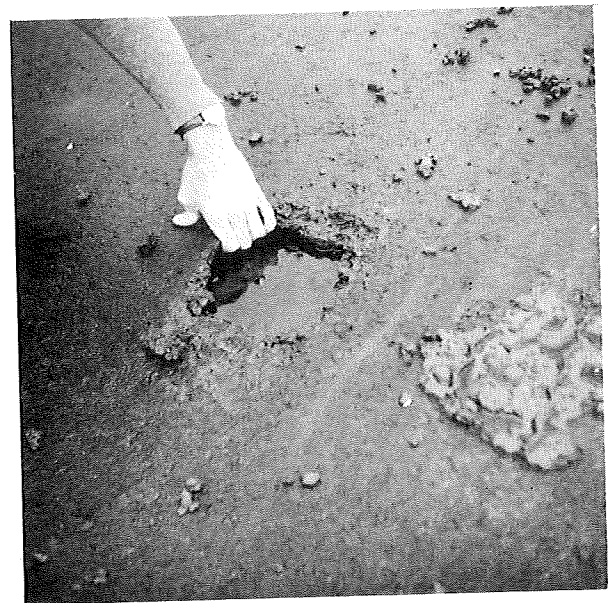
The lack of bond between pavement and epoxy is revealed by area where the hot mix stuck to the tire of a parked vehicle.

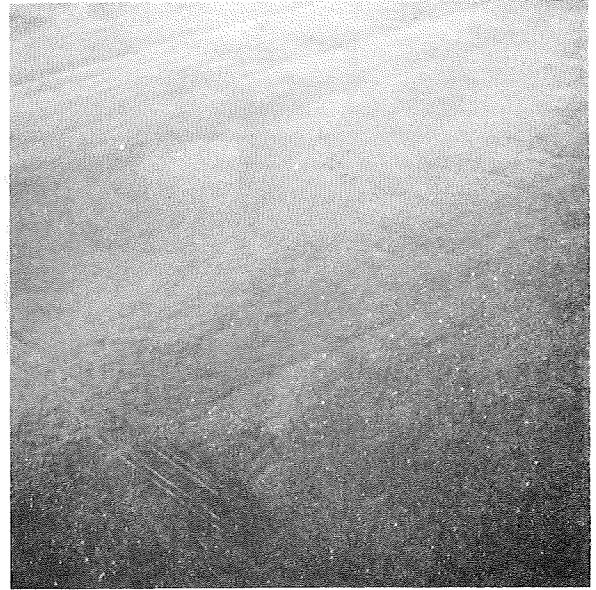
First coat thinned with solvent and applied at the rate of 125 sf/gal. resulted in bubble clusters numbering about 5 per sf.

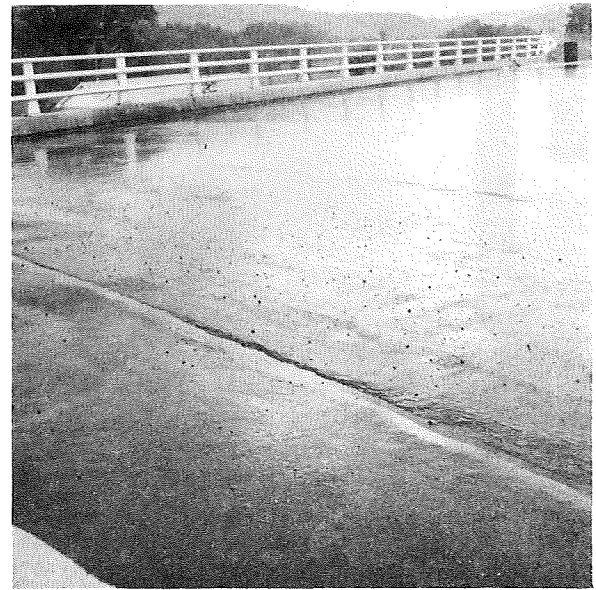
Air bubbles up to $\frac{5}{8}$ " diameter appeared in the second coat placed over the section of prime coat which had been rained on. Many areas on the southerly end of the deck had no pinholes.

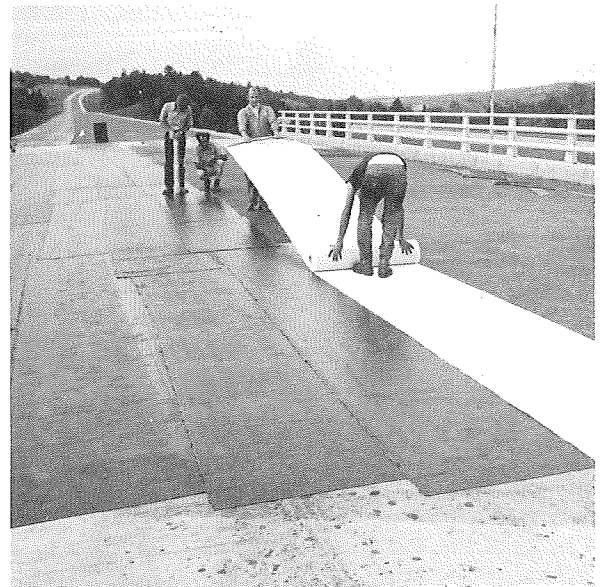
Note short strips due to difficulty in maintaining correct alignment and overlap.

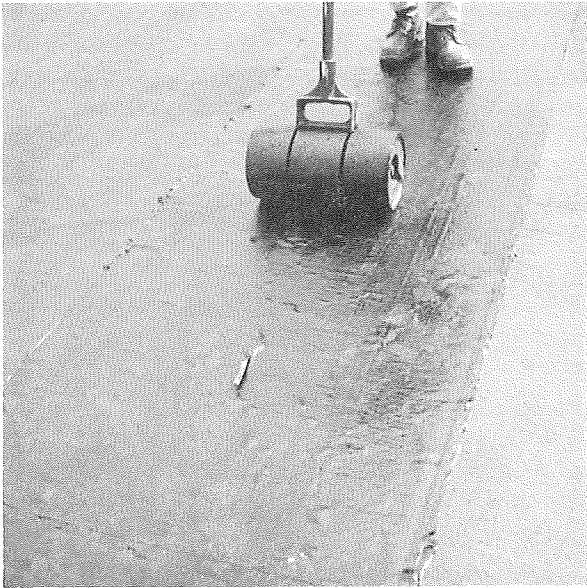
Rolling the membrane. Note entrapped air.

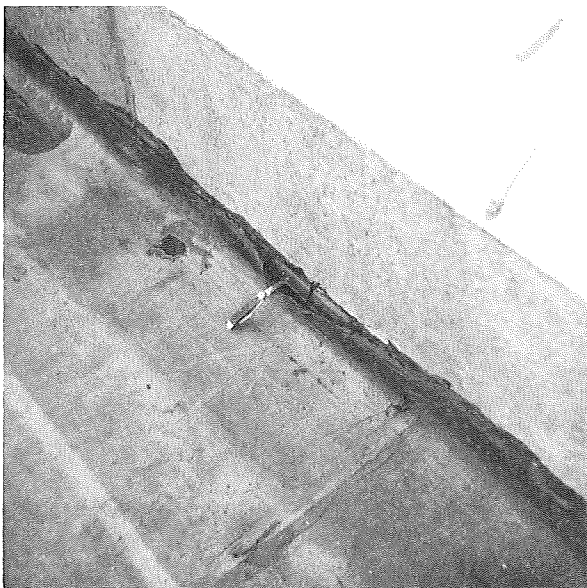
Water found behind the membrane system at the curb 11 days after installation.

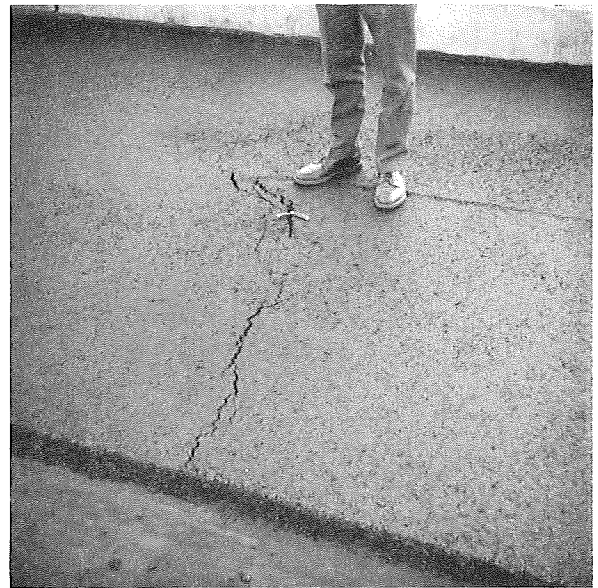
The worst of 21 cracks which occurred in the first course of pavement during the initial compaction.

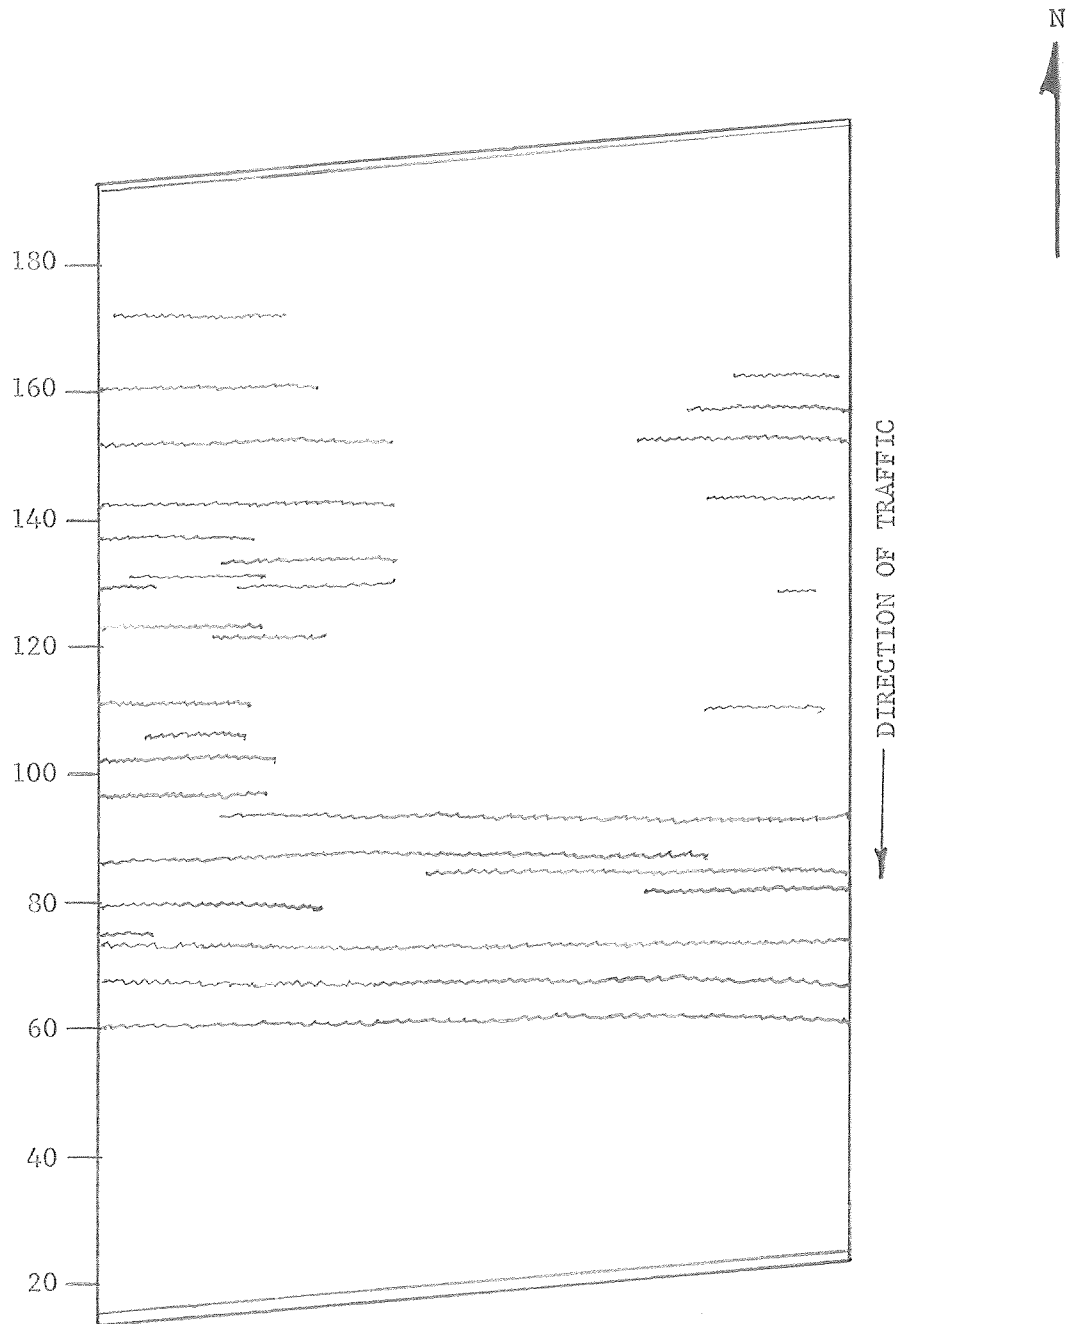
All cracks were noted on both the surface and bottom of the deck length of cracks and their locations are to scale. Vertical Scale 30'/in. Horizontal Scale 10'/in.

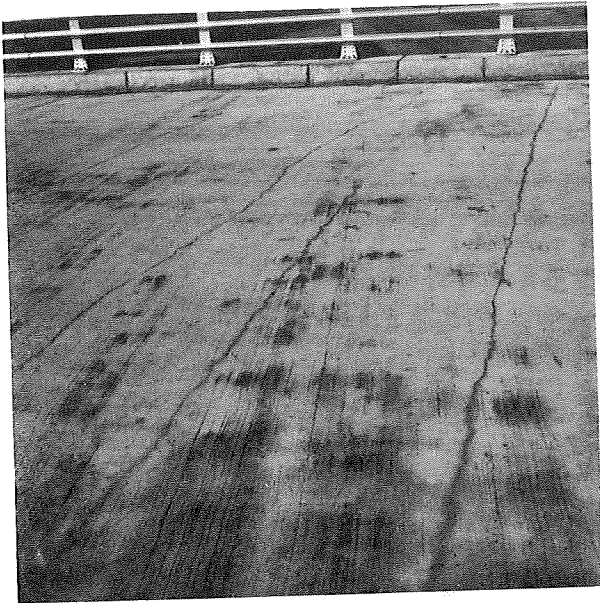
Thirty cracks ranging in length from 2' to the full width of the deck were noted. All cracks extended through the full depth of the deck.

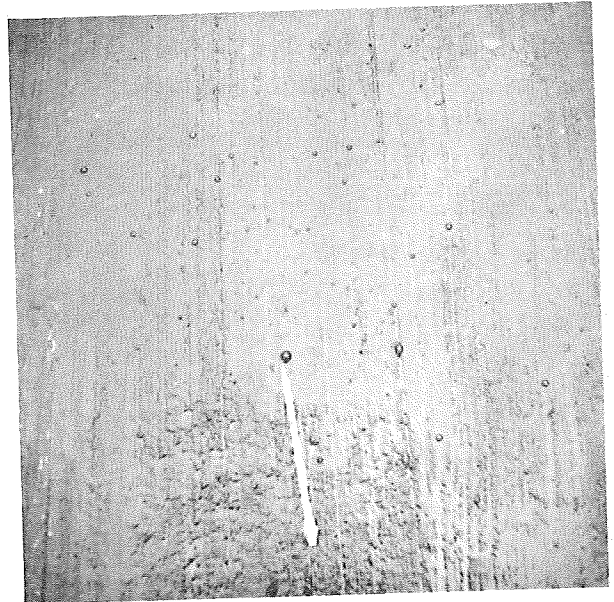
One of several areas where air bubbles were noted in the prime coat which consisted of 50% Polytok and 50% Xylol. Note concrete surface texture.

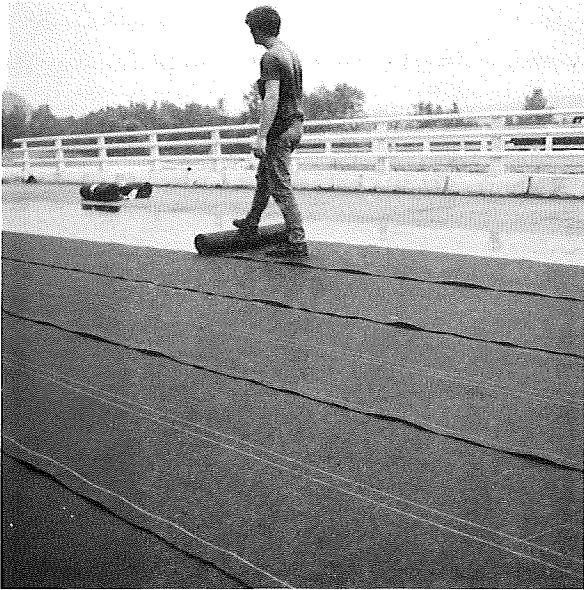
Rolling out sheets lapped in shingle fashion. Note fish mouths beginning to develop along edges.

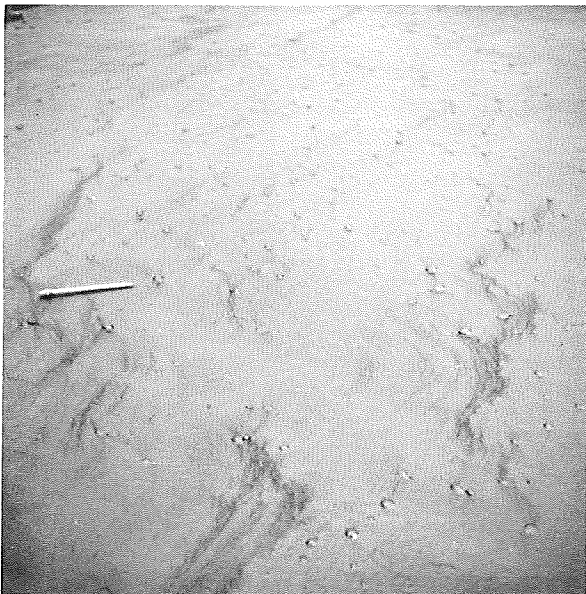
Air bubbles and ripples in the membrane left uncovered shortly after application.

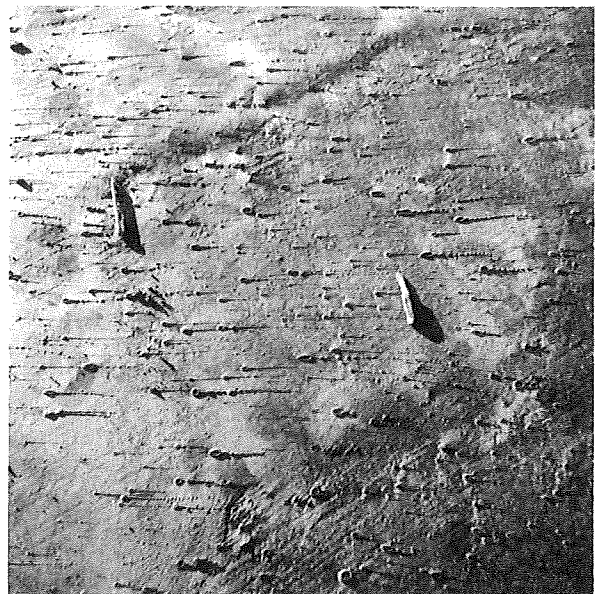
Air bubbles and craters in the cured membrane.

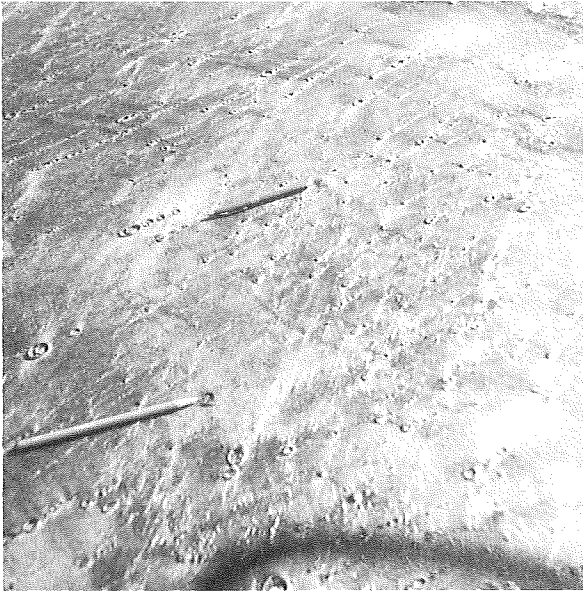
When air bubbles were broken open, little more than primer was detected on the concrete in many cases.

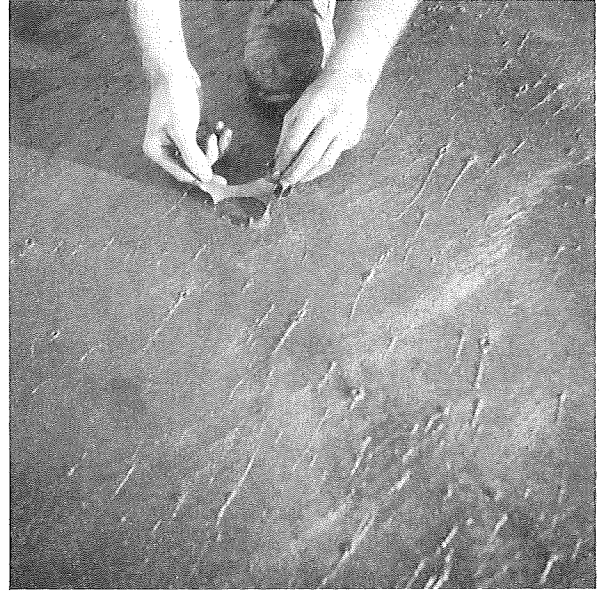
After a bubble or crater was broken open, the membrane could be peeled from the primed concrete.

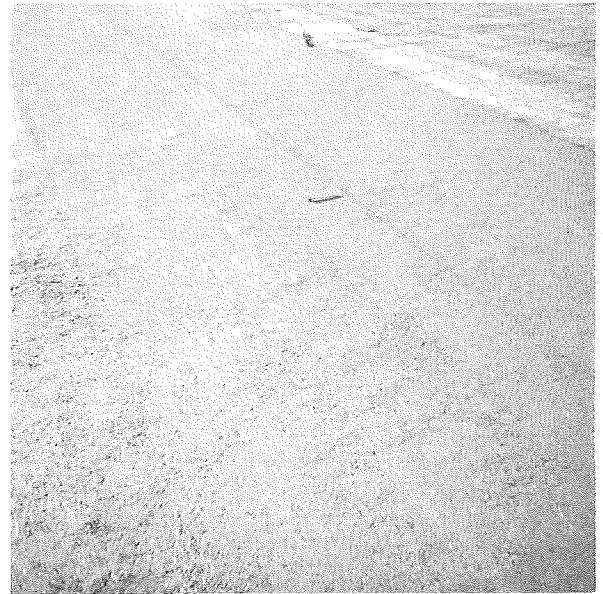
Ripples and cracks in the first 1" course of pavement were caused by the roofing sheet.

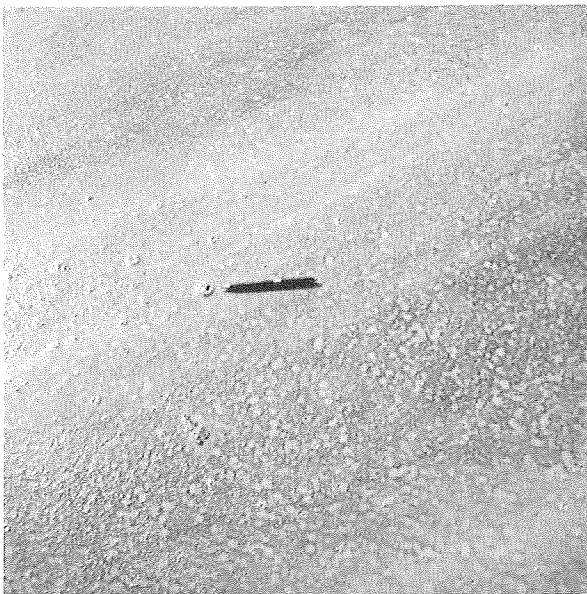
Air bubbles and pinholes were noted in both coats. Note air bubble clusters in the cured epoxy coating.

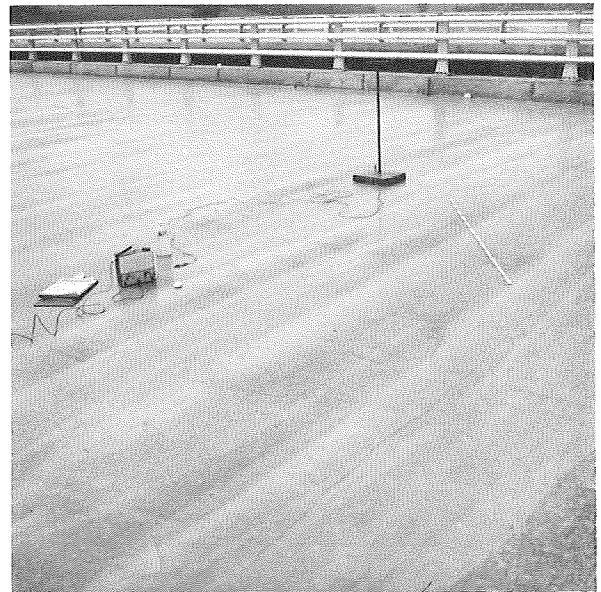
Testing with hydrochloric acid disclosed that the air bubbles and pinholes were not open to the concrete. Resistance readings were high, averaging 1.2 million.
