EVALUATION OF A LINSEED OIL AND MINERAL SPIRITS

BRIDGE DECK SEALANT

Report 73-4

Bridge #124 on Vermont Route 14

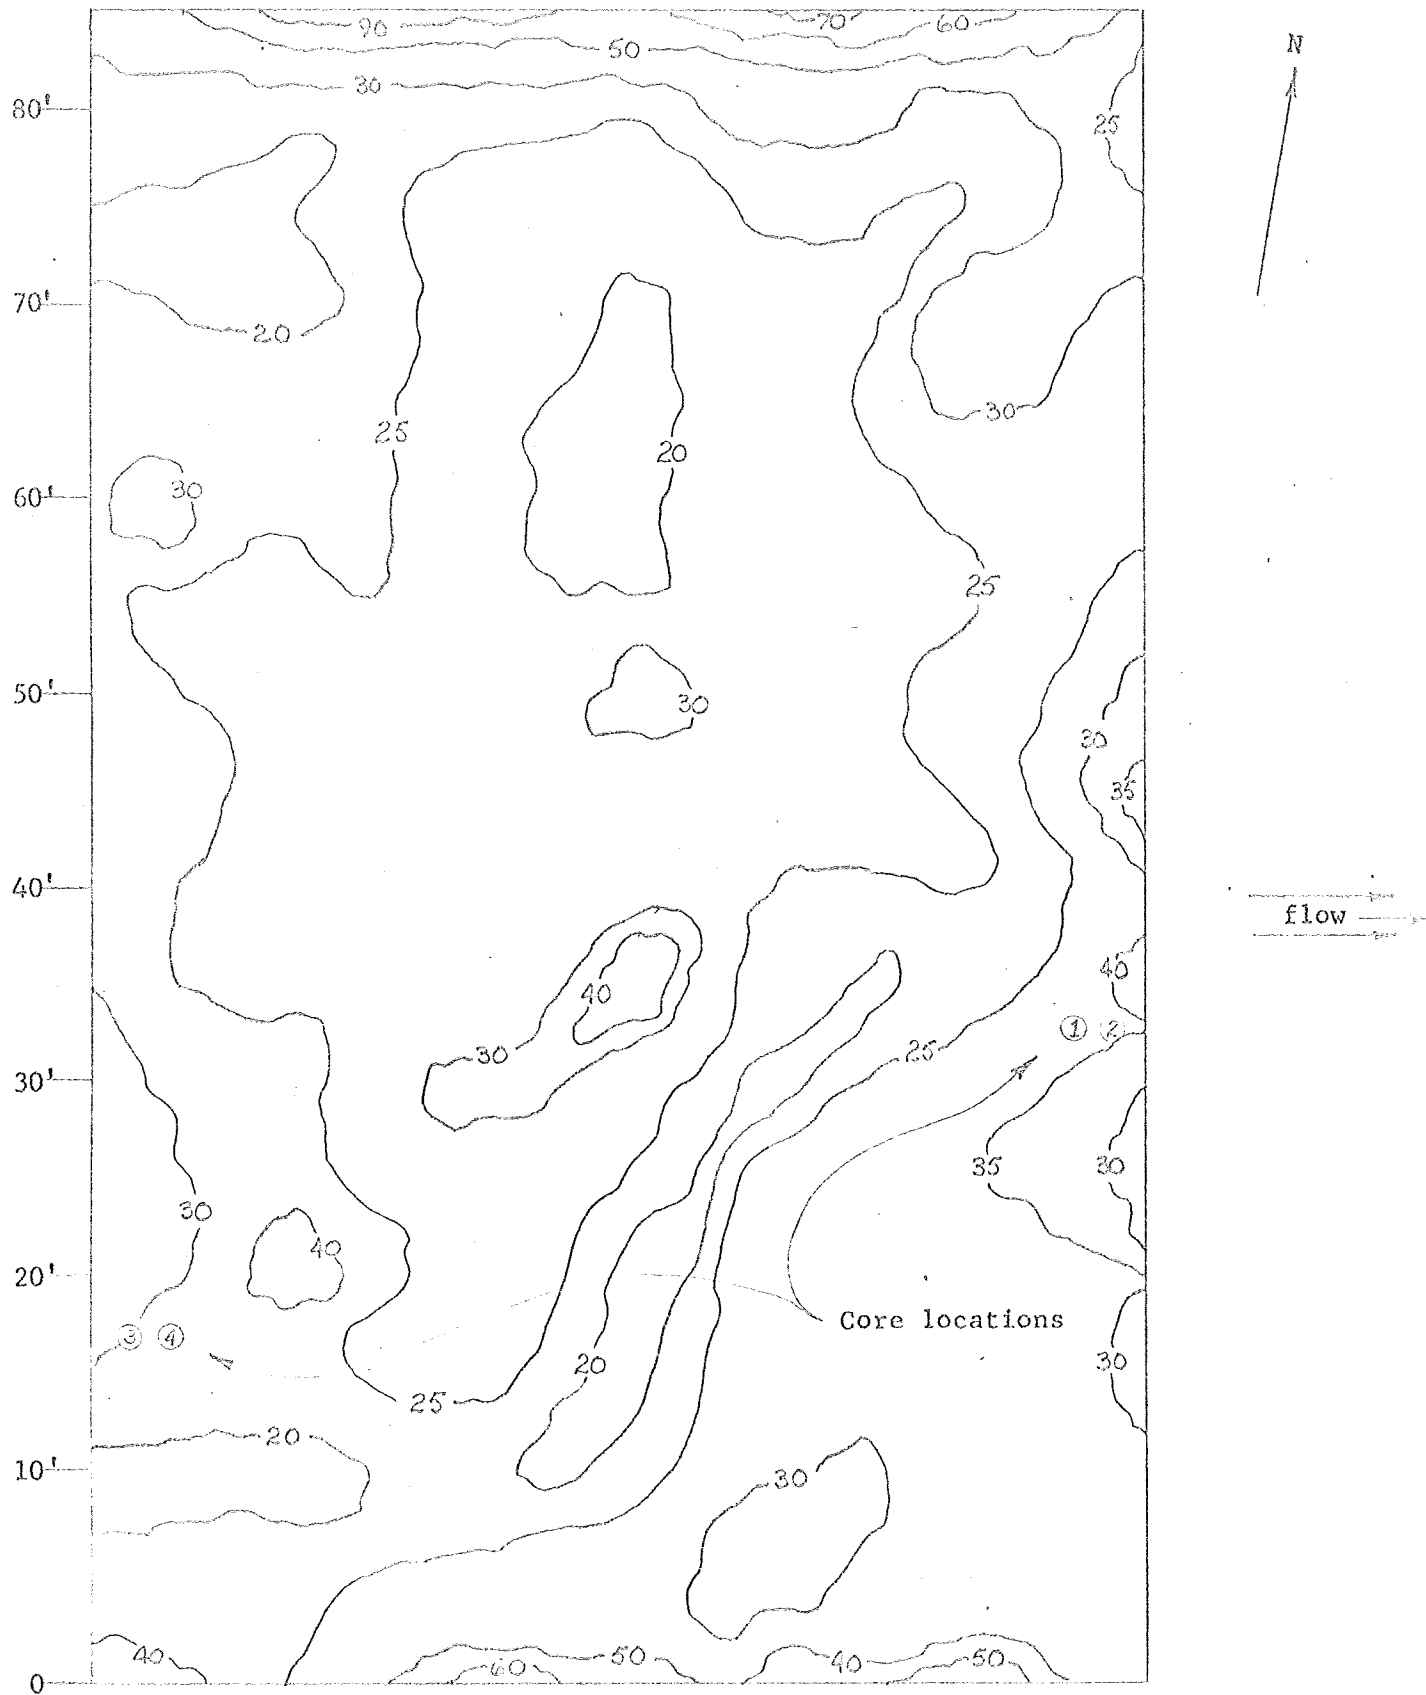
EQUI-POTENTIAL CONTOURS - VOLTS  $\times 10^{-2}$

Upon finding chlorides at the level of the steel, electrical potential measurements were taken on the deck. Most of the readings ranged from 0.2 to 0.3 of a volt. Such readings generally indicate that the steel is in a passive condition. However, readings over 0.35 volts were found in 5 areas which encompassed approximately 9% of the deck area. Such readings indicate active corrosion of the steel within these areas.

The electrical potential measurements taken on the northbound lane show an average increase of 0.04 volts when compared against readings taken 9 months earlier at the same location. The increase in the electrical potential readings was no doubt due to the increased depth of chloride intrusion which had occurred since the first readings were taken.
