EXPERIMENTAL BRIDGE DECK MEMBRANE

APPLICATIONS IN VERMONT

REPORT 74-4

Initial Report

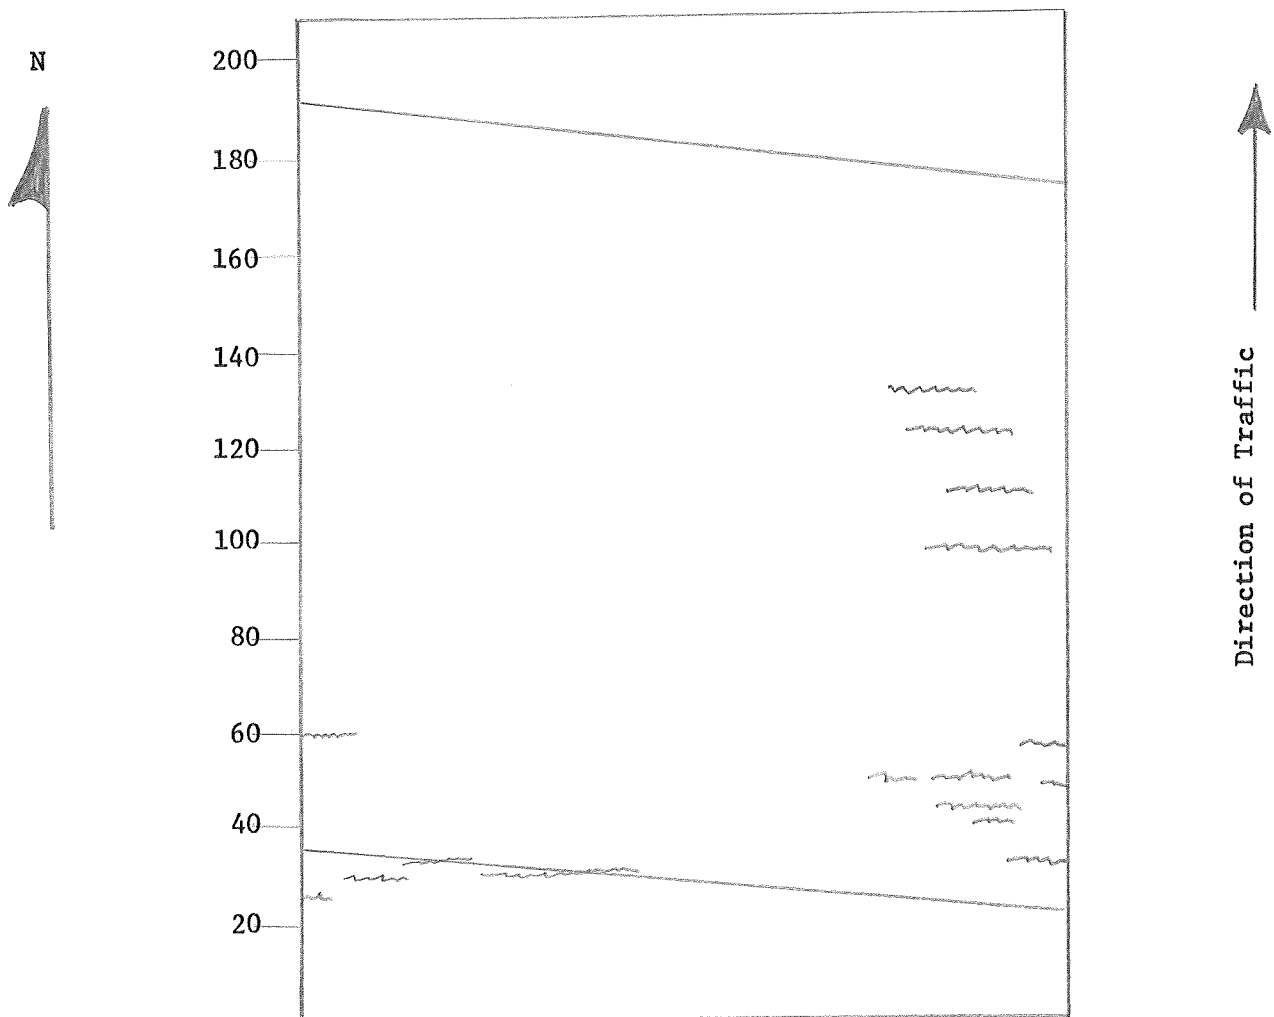
Cracks in Concrete Deck

Cracks - Fifteen transverse cracks averaging 3.5' in length were noted in the deck. Most were found at a point 1' to 3' out from the curb in the negative moment areas on the low side of the banked deck. See crack layout on Figure 1, Page 10.

All cracks were noted on both the surface and bottom of the deck, length of cracks and their locations are to scale. Vertical scale 40'/in. Horizontal scale 10'/in.

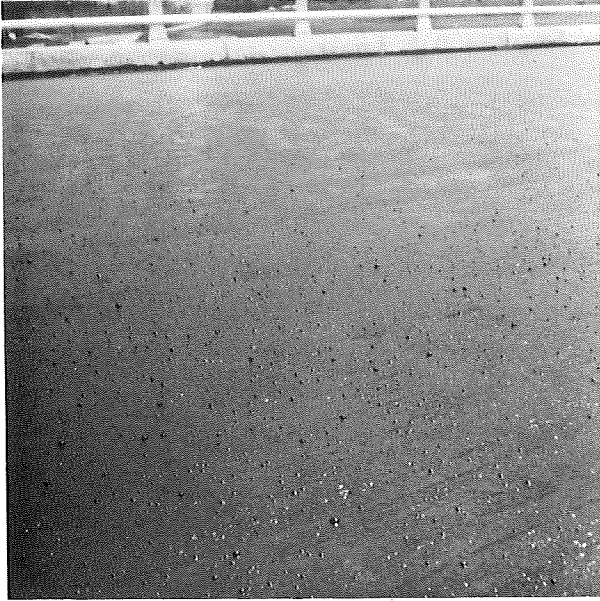
The deck was primed with a cutback asphalt applied at an average rate of 125 square feet per gallon. Air bubbles up to 1/2 inch in diameter were noted in the prime coat with a reduction in number noted as the application proceeded. Although the prime coat was allowed to dry over a 40 hour period, a few soft puddles of primer were noted in surface depressions before the hot asphalt treatment began.

Bubbles up to $\frac{3}{4}$ inch in diameter appeared in the cut-back asphalt prime coat shortly after application.

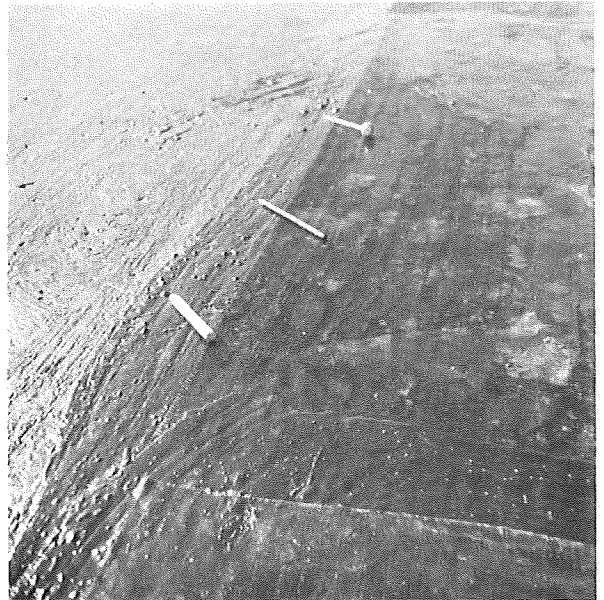
Bubbles and pinholes in the first coat of asphalt.

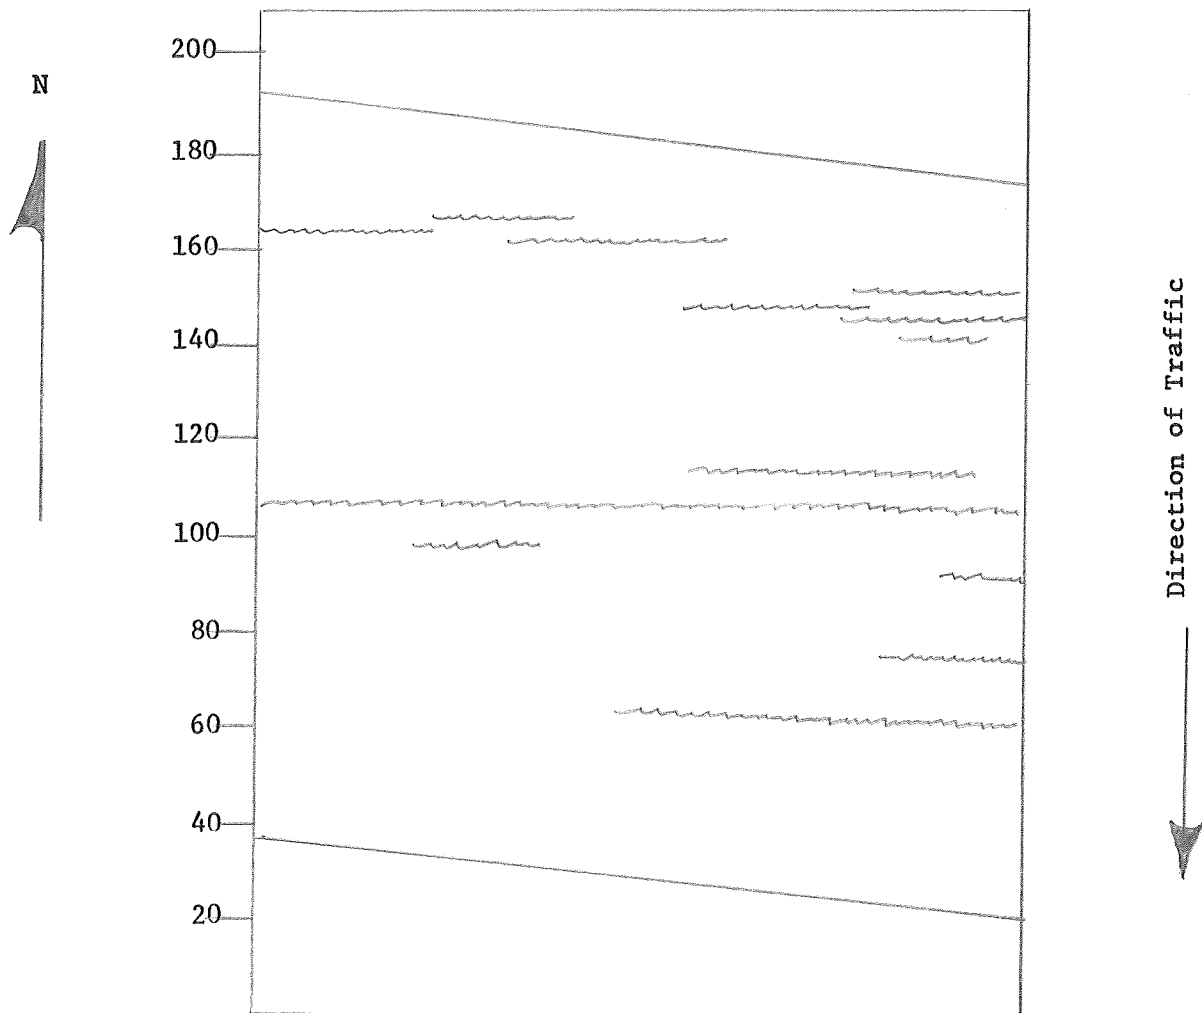
Cracks in Concrete Deck

Cracks - Seventeen transverse cracks averaging 9.7 feet in length were noted in the deck with 53% of the cracks also visible on the bottom of the deck due to heavy staining. Many short transverse and pattern type cracks were also noted in the deck surface. See crack layout on Figure 2, Page 15.

Fifty-three percent of the cracks noted on the deck surface were also visible on the bottom of the deck. Length of cracks and their locations are to scale. Vertical scale 40'/in. Horizontal scale 10'/in.

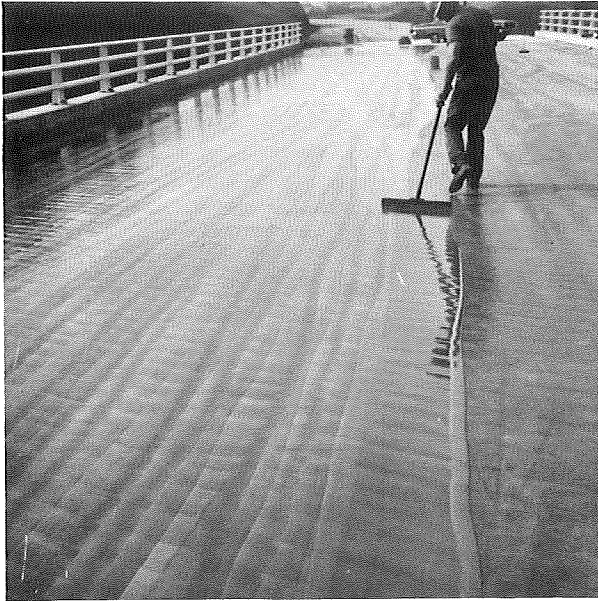
Inspection of the coating 24 hours after application disclosed an average of 78 holes per square foot (see Table 1, page 16). Such holes in the coating were believed to be primarily caused by the outgassing of air and moisture vapor from pores in the concrete surface which normally occurs when air temperatures are on the increase or barometric pressures are declining. This is illustrated by the fact that the areas treated between 3:00 P.M. and 5:30 P.M. when air temperatures were stable had an average of 31 holes while the areas treated earlier during a period of rising air temperature had an average of 90 holes per square foot. The crater shaped holes ranged from 1/4 inch to 1/32 inch in diameter. Although concrete was visible at the bottom of only a few holes, electrical resistance readings were low averaging 11,700 ohms per square foot which indicates that moisture was able to pass through the coating at many locations.

The application of multiple coats of epoxy reduced but did not eliminate all pinholes.

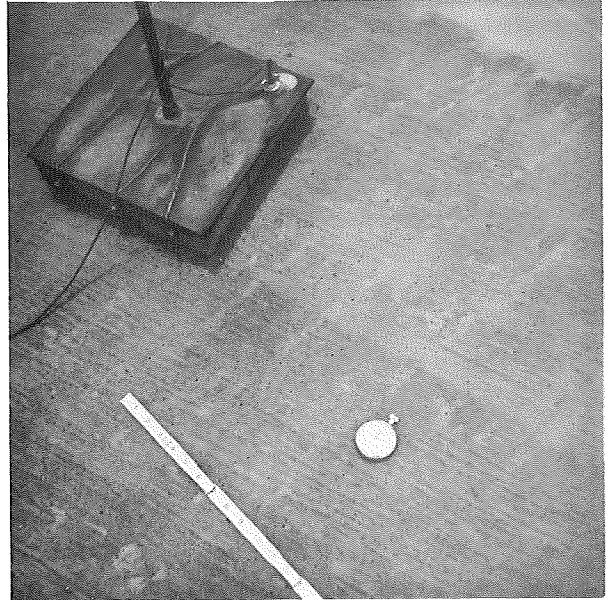
Electrical resistance readings averaged 41,500 ohms per square foot which indicates that some of the holes were open to the concrete.

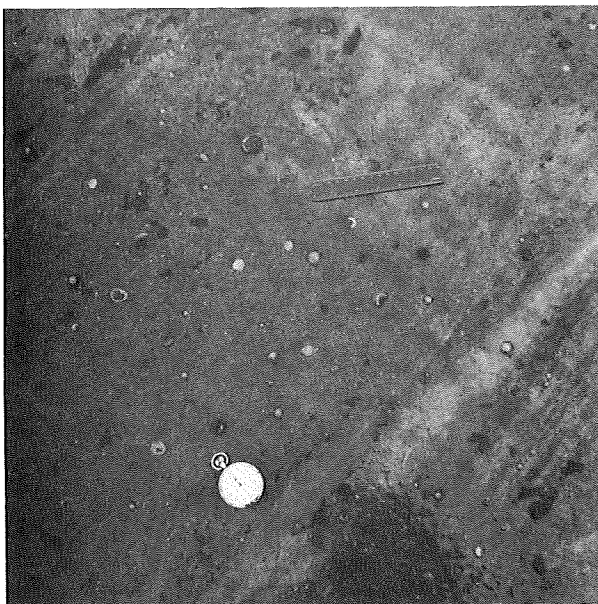
Bubbles formed in the epoxy coating 16 to 20 hours after application.

the system when the final coat was applied. When the system was inspected the following morning there still were no pinholes or bubbles; however, when the system was checked later that afternoon, many air bubbles were noted throughout the coating. The failure of the epoxy to resist the air and moisture vapor pressure from the concrete was believed due to lack of sufficient overnight cure prior to the rise in air temperature the following day. Inspection of the coating the following day disclosed that most of the air bubbles had receded and were in the shape of craters. Spot checks of the membrane system revealed an average of 91 bubbles or craters per square foot with the size ranging from 1/16 to 3/4 inch in diameter (see table 2 page 36).

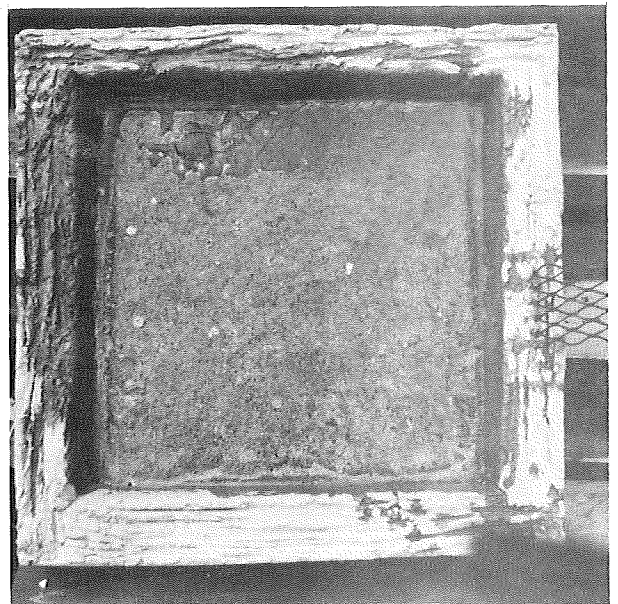
Blister and cohesive cracks occurred on field treated test slabs 6 months after application.

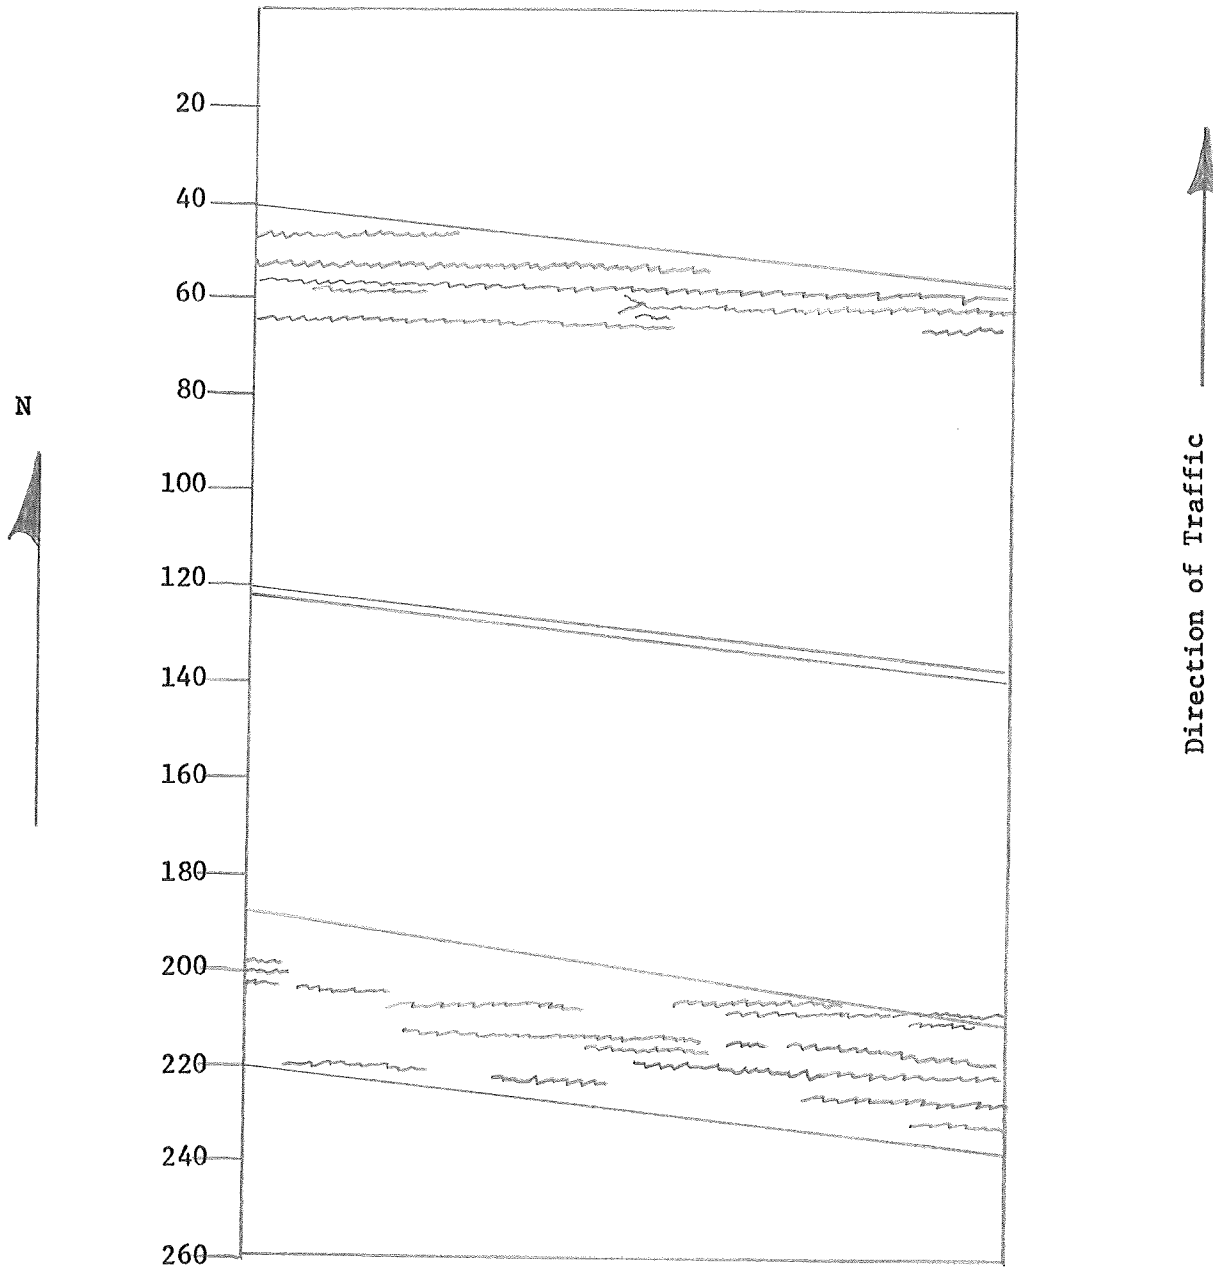
Cracks in Concrete Deck

Cracks - Thirty-three transverse cracks ranging from 1.2' to 35.4' in length were noted in the deck. All cracks observed on the surface could also be detected on the bottom of the deck where heavy calcium carbonate deposits were visible along the edges of many of the cracks. See crack layout on Figure 3 , Page 26.

All cracks were noted on both the surface and bottom of the deck. Length of cracks and their locations are to scale. Vertical scale 40'/in. Horizontal scale 10'/in.

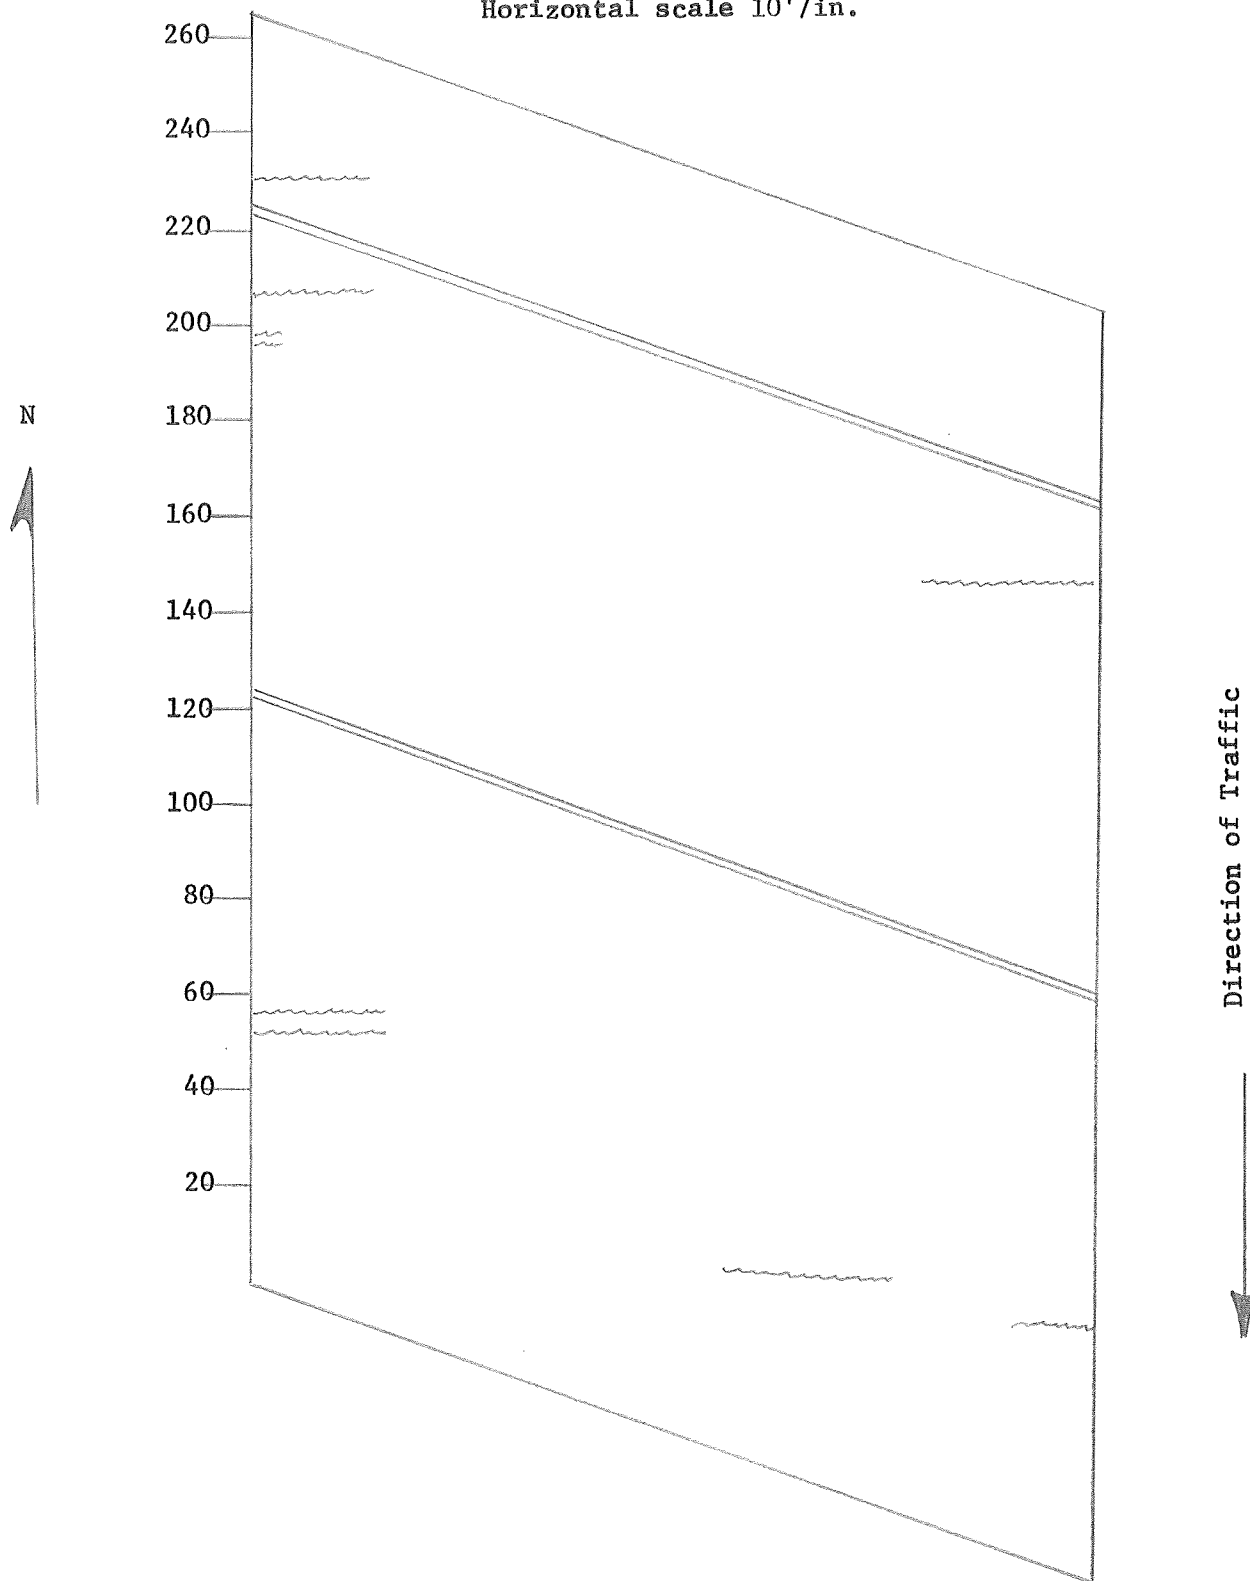
Cracks in Concrete Deck

Cracks - Nine transverse cracks ranging from 1' to 8.5' in length were noted in the deck. See crack layout on Figure 4, Page 32.

All cracks were noted on both the surface and bottom of deck.
Length of cracks and their locations are to scale. Vertical scale 40'/in.
Horizontal scale 10'/in.

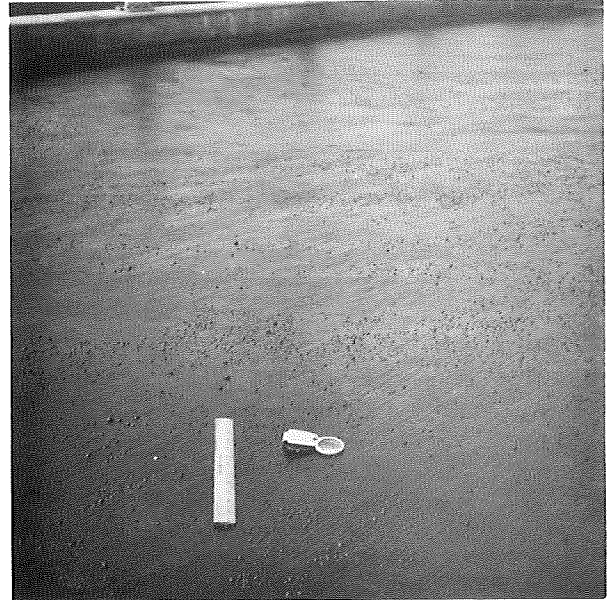
Air bubbles in the solvent cut prime coat were broken with a squeegee prior to placing the membrane sheets.

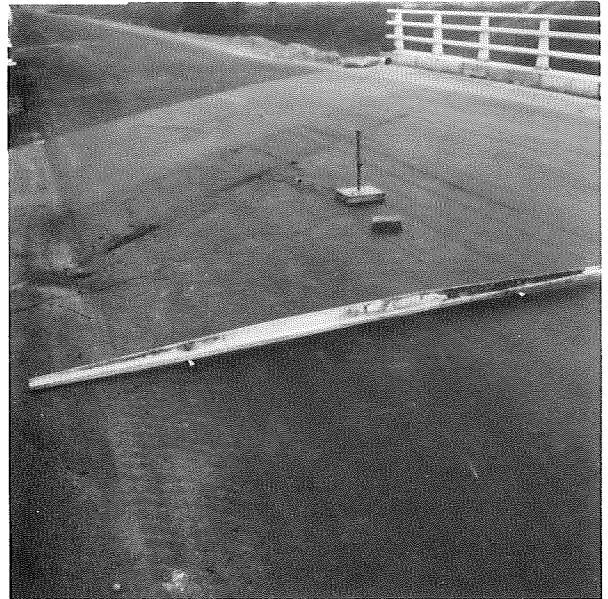
High construction traffic volumes on the first one inch course of pavement resulted in migration from the wheel paths. Resistance tests indicated slight damage to the membrane at several locations.
