ALTERNATIVE REFLECTION CRACK TREATMENTS
PULVERIZATION AND RUBBERIZED SLURRY SRI

INITIAL REPORT 75-1

March 1975

VERMONT DEPARTMENT OF HIGHWAYS

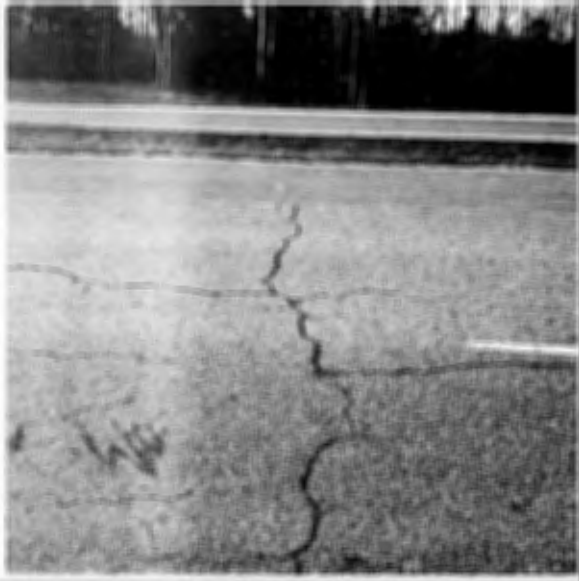
MM 172/95. Condition of pavement in area to be pulverized. October, 1973.

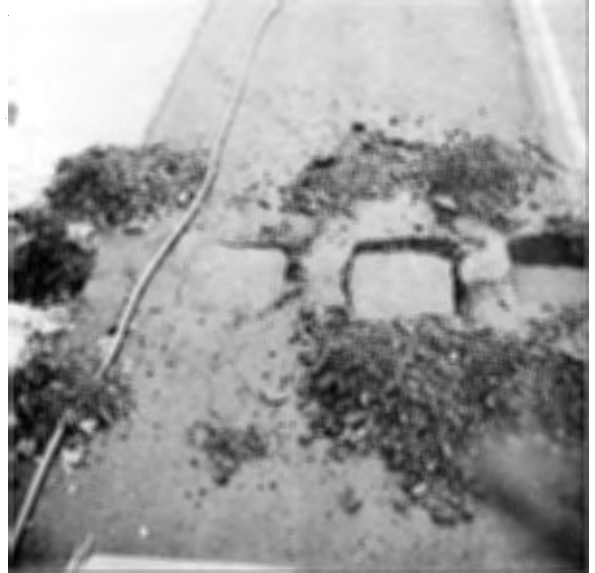
The penetration base course appeared loose and the asphalt binder no longer effective. This material had an average of 97% passing the 2" sieve, 48% passing the 3/4" sieve, 14% passing the #4 sieve and 2% passing the #200 sieve. There was considerable water flow through this base course as shown by the photographs in Appendix A.

MM 172/95. While opening test pits — free water seeking own level. Note snow on bank. December, 1973.

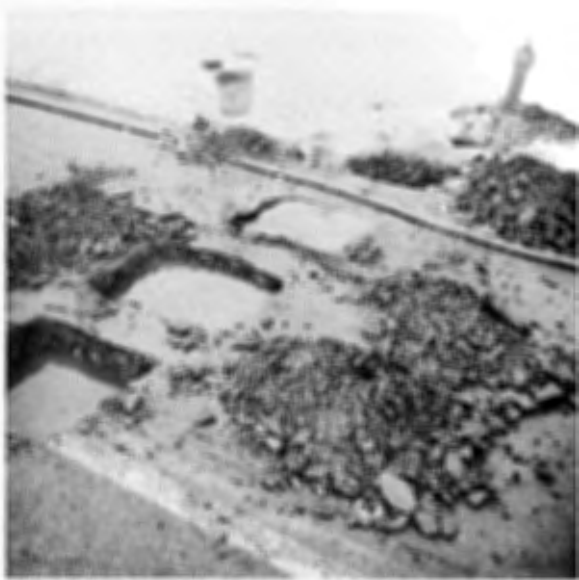
MM 172/95. 2' x 2' holes separated by 1' to edge of shoulder. Running out of third hole. December, 1973.

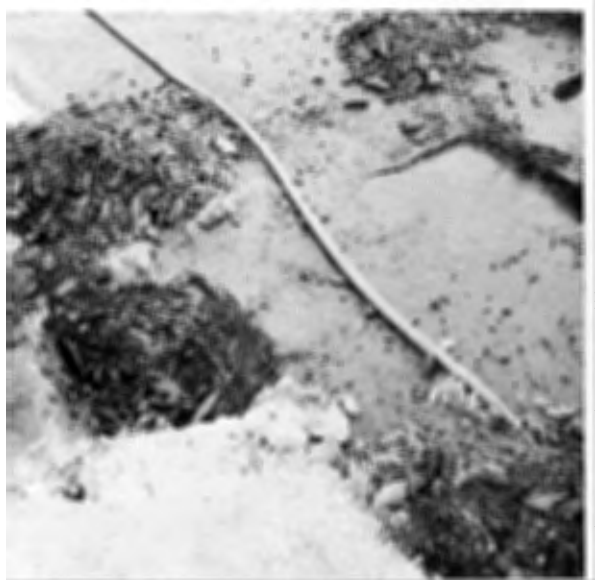
MM 172/95. Hole off point of shoulder dry except for some spillage. Note snow. December, 1973.

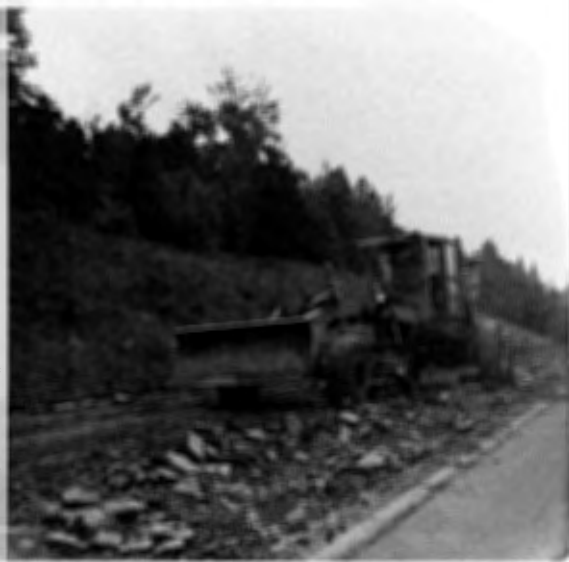
Windrowing pavement between shoulders during pulverization process.

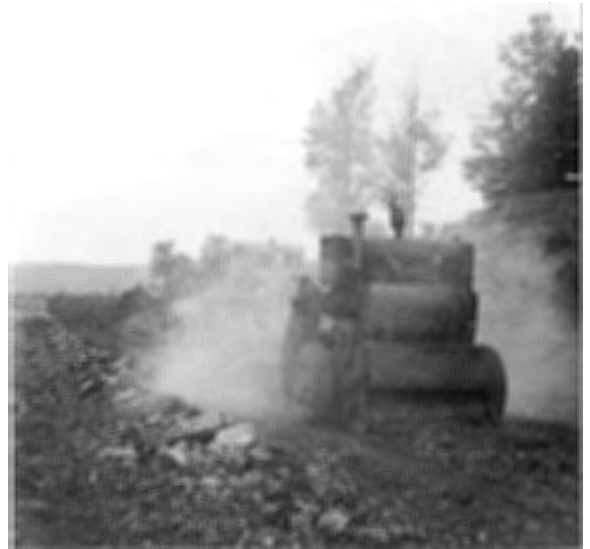
Motorized pulverizer drawn by front-end loader.

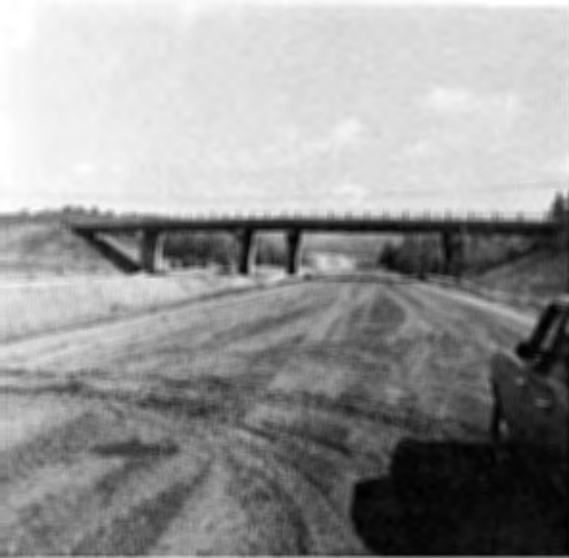
View of pulverized area after grading prior to addition of emulsion and rolling.

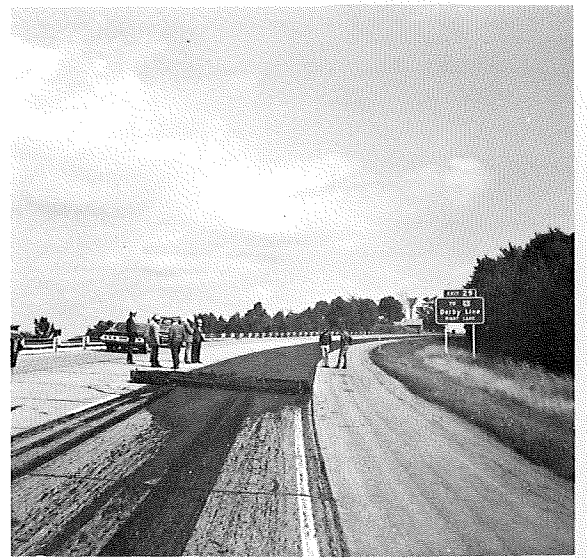
Laying first course of SRI. Note crack filler and shoulder overlap.
