EXPERIMENTAL BRIDGE DECK MEMBRANE

APPLICATIONS IN VERMONT

REPORT 75-2

National Experimental & Evaluation Program
Bridge Deck Protective Systems
Work Plans #24 - #32 & #34
Initial Report

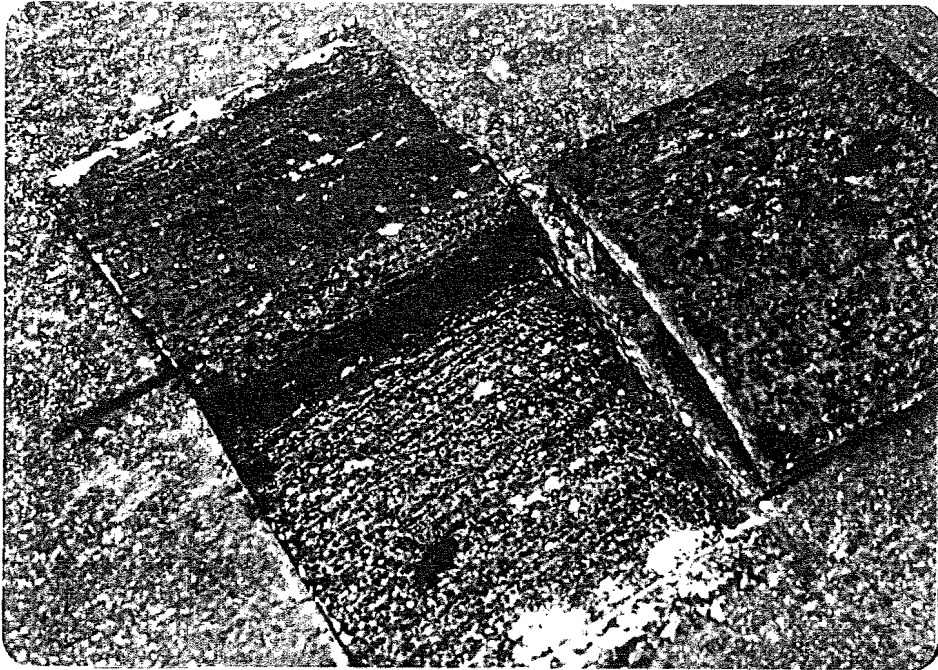
I 91 NB over Waits River

The membrane appeared undamaged at the above location where bituminous lay-down temperatures were recorded at 335°F. Bond between membrane and pavement resulted in adhesion of 90% of the mylar coating and 25% of the membrane surface to the bituminous mix. Membrane bond to the concrete appeared adequate with 10% of the membrane remaining on the deck.

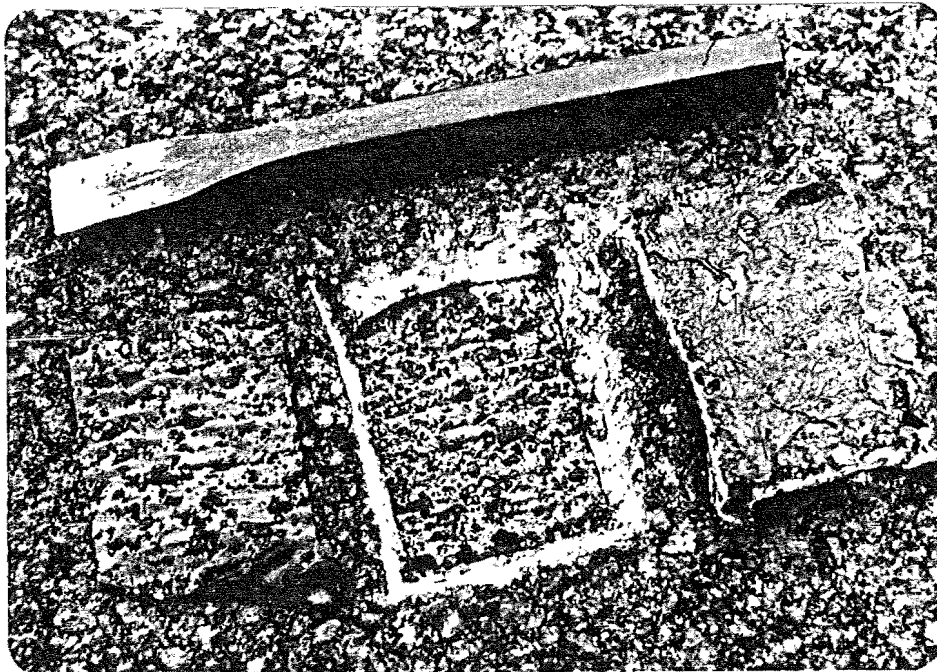
Bituminous lay-down temperatures of 315°F to 320°F also appeared to promote adequate adhesion between substrate, membrane, and pavement.

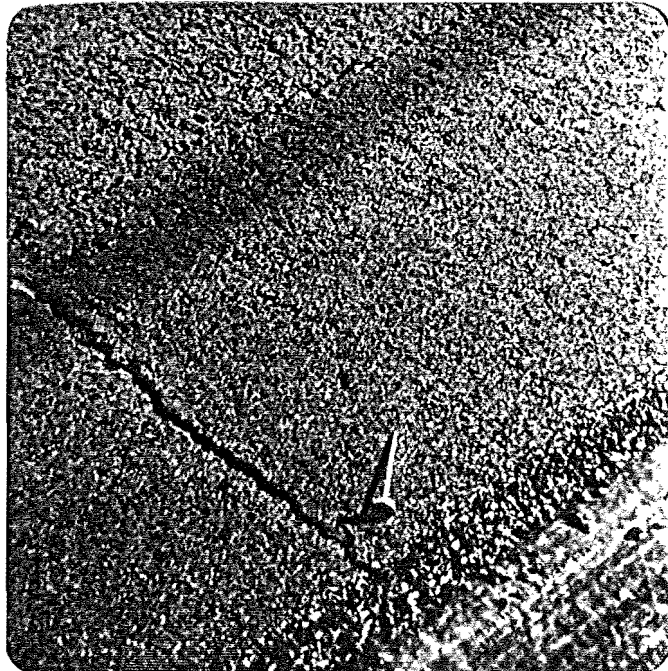
The initial in-place mix temperatures ranged from 260°F to 290°F, with an average temperature of 272°F. Cracks appeared in the bituminous mix 2 to 3 minutes after the material was placed. All were over the edges and ends of individual sheets and comprised about 20% of the total sheet perimeters. The cracks were believed due to contraction of the woven polypropylene mesh, which was caused by the heat of the bituminous mix. The cracks ranged up to 1/2-inch in width prior to compaction. Approximately 50% were eliminated during compaction with a 6 to 8 ton double axle steel wheeled roller. The compacted mix varied from 7/8-inch to 1-5/16-inch in thickness. Part of the variation may have been due to unevenness in the surface of the concrete deck. The overall appearance of the pavement was poor, due in part to a number of porous surface areas.

Initial cracks in pavement over ends and edges of membrane sheets due to shrinkage of polypropylene reinforcement.

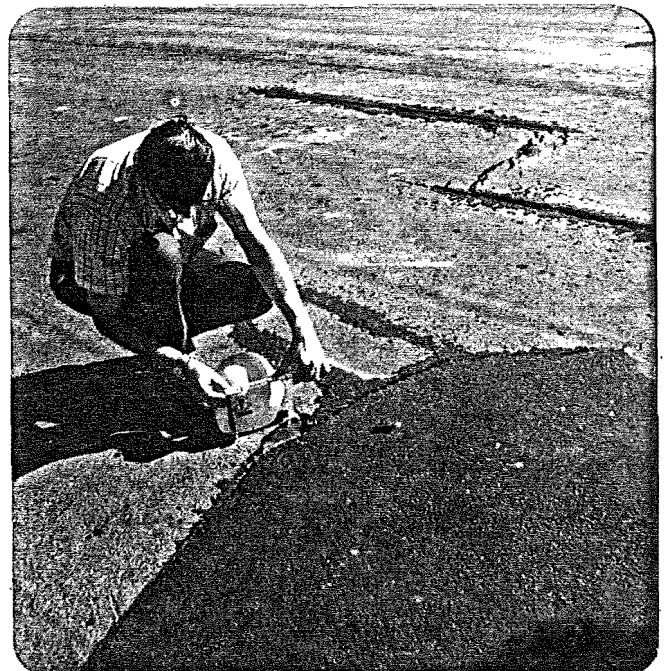
Pavement repair required on first course due to combination of initial cracks, thin pavement, and construction traffic.

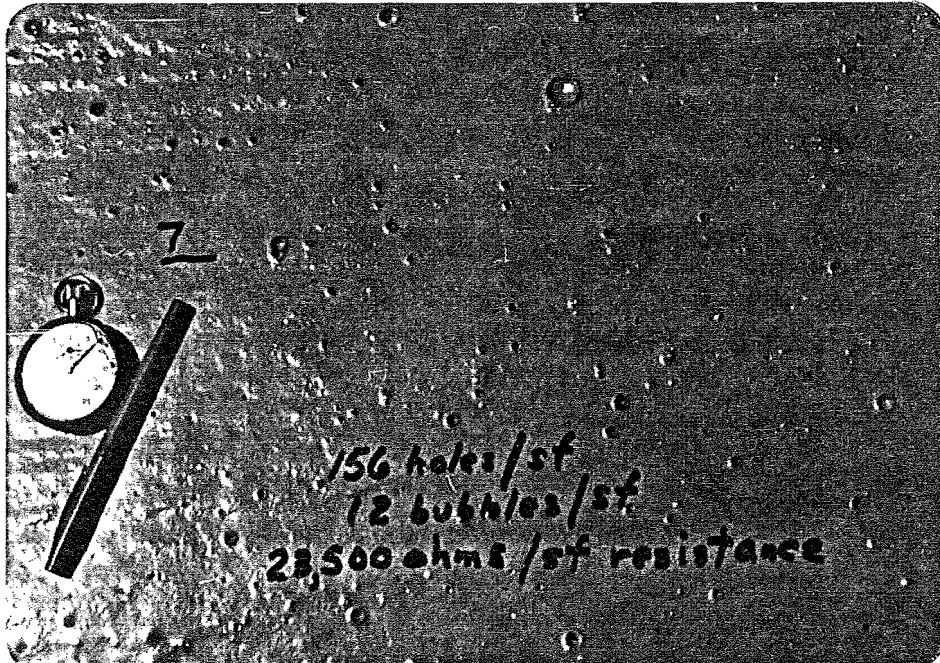
The primer and polyurethane membrane were completed on the morning of May 18, 1974, when additional material was received. Rising air temperatures which occurred during the morning application resulted in from 100 to 200 holes and 25 to 75 air bubbles per square foot of area treated. Since the condition of the membrane was not considered satisfactory, a second coat was applied 3 days later over the 1410 square foot area, using material donated by the manufacturer.

Air and/or moisture vapor outgassing from the concrete resulted in an average of 89 pinholes, craters, and bubbles per square foot.

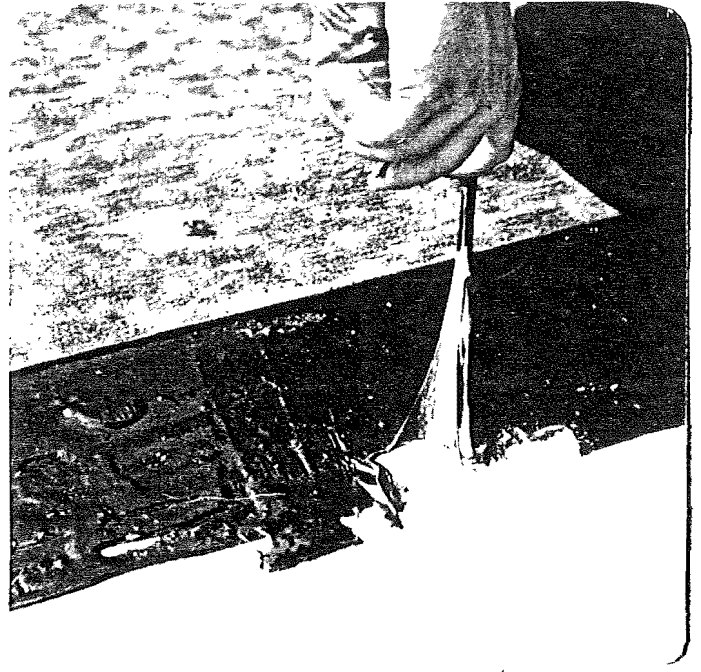
Membrane adhesion varied with the texture and quality of the substrate.

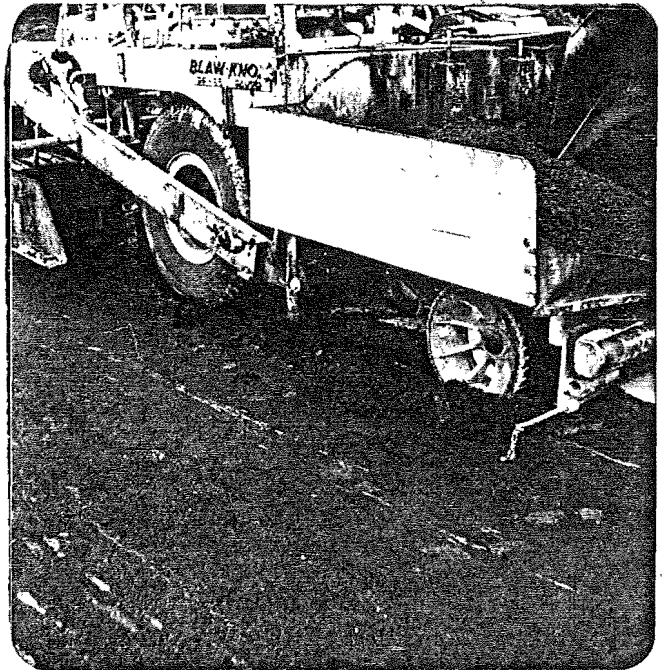
Problems due to the paving procedure combined with reduced pavement stability over the membrane.

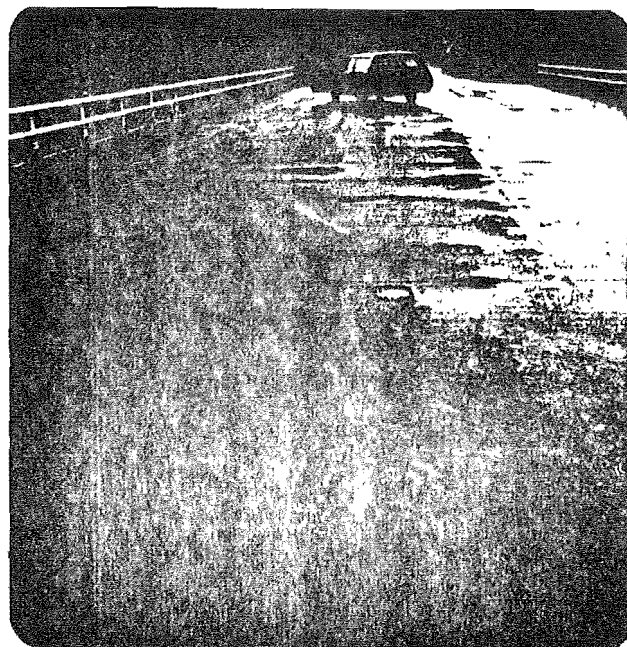
Blisters in Membrane and first course of pavement.

A recommendation has been made to cut out and repave patched areas and apply a third lift of pavement over the deck. The third course should be as thick as possible, since additional dead weight on the membrane is probably the best insurance against further blistering.

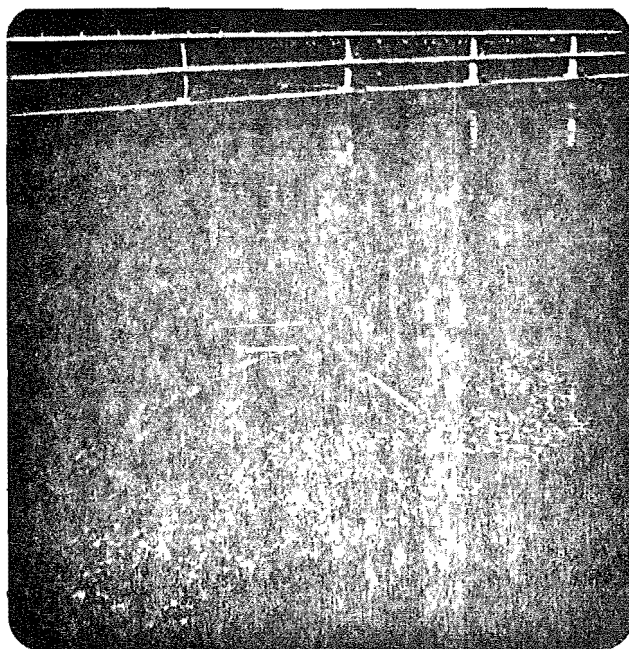
Blisters which rose daily with the increase in ambient temperature ranged up to 18" x 36" in size.

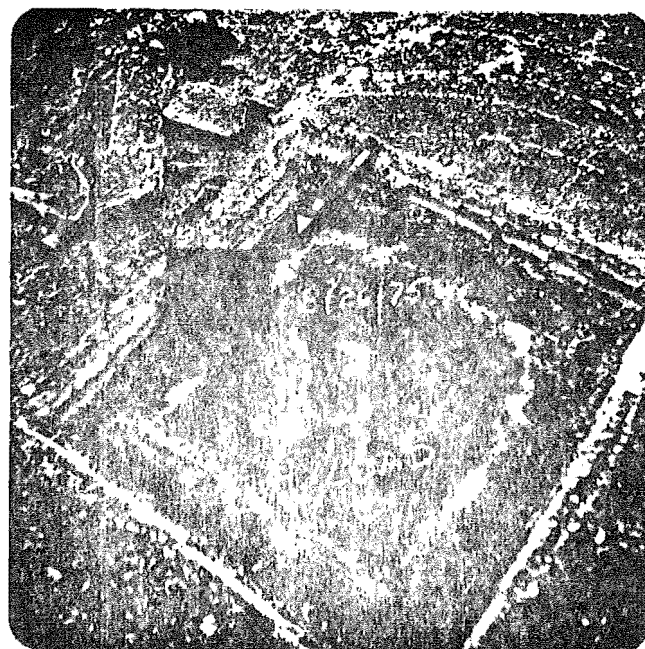
The inspection appears to confirm that the system is free of voids or punctures which would allow the deck to breathe and apparently developing pressures are simply finding it easier to lift the membrane and pavement rather than move laterally across the deck and vent via the drain tubes. It is possible that the blistering problem would not have occurred if both pavement courses had been placed shortly after the membrane application and if the total pavement thickness was closer to the 3 inch range rather than 2 inches.

Inspection did not disclose any reason why pressures should not have dispersed laterally via the ventilating underlayment.

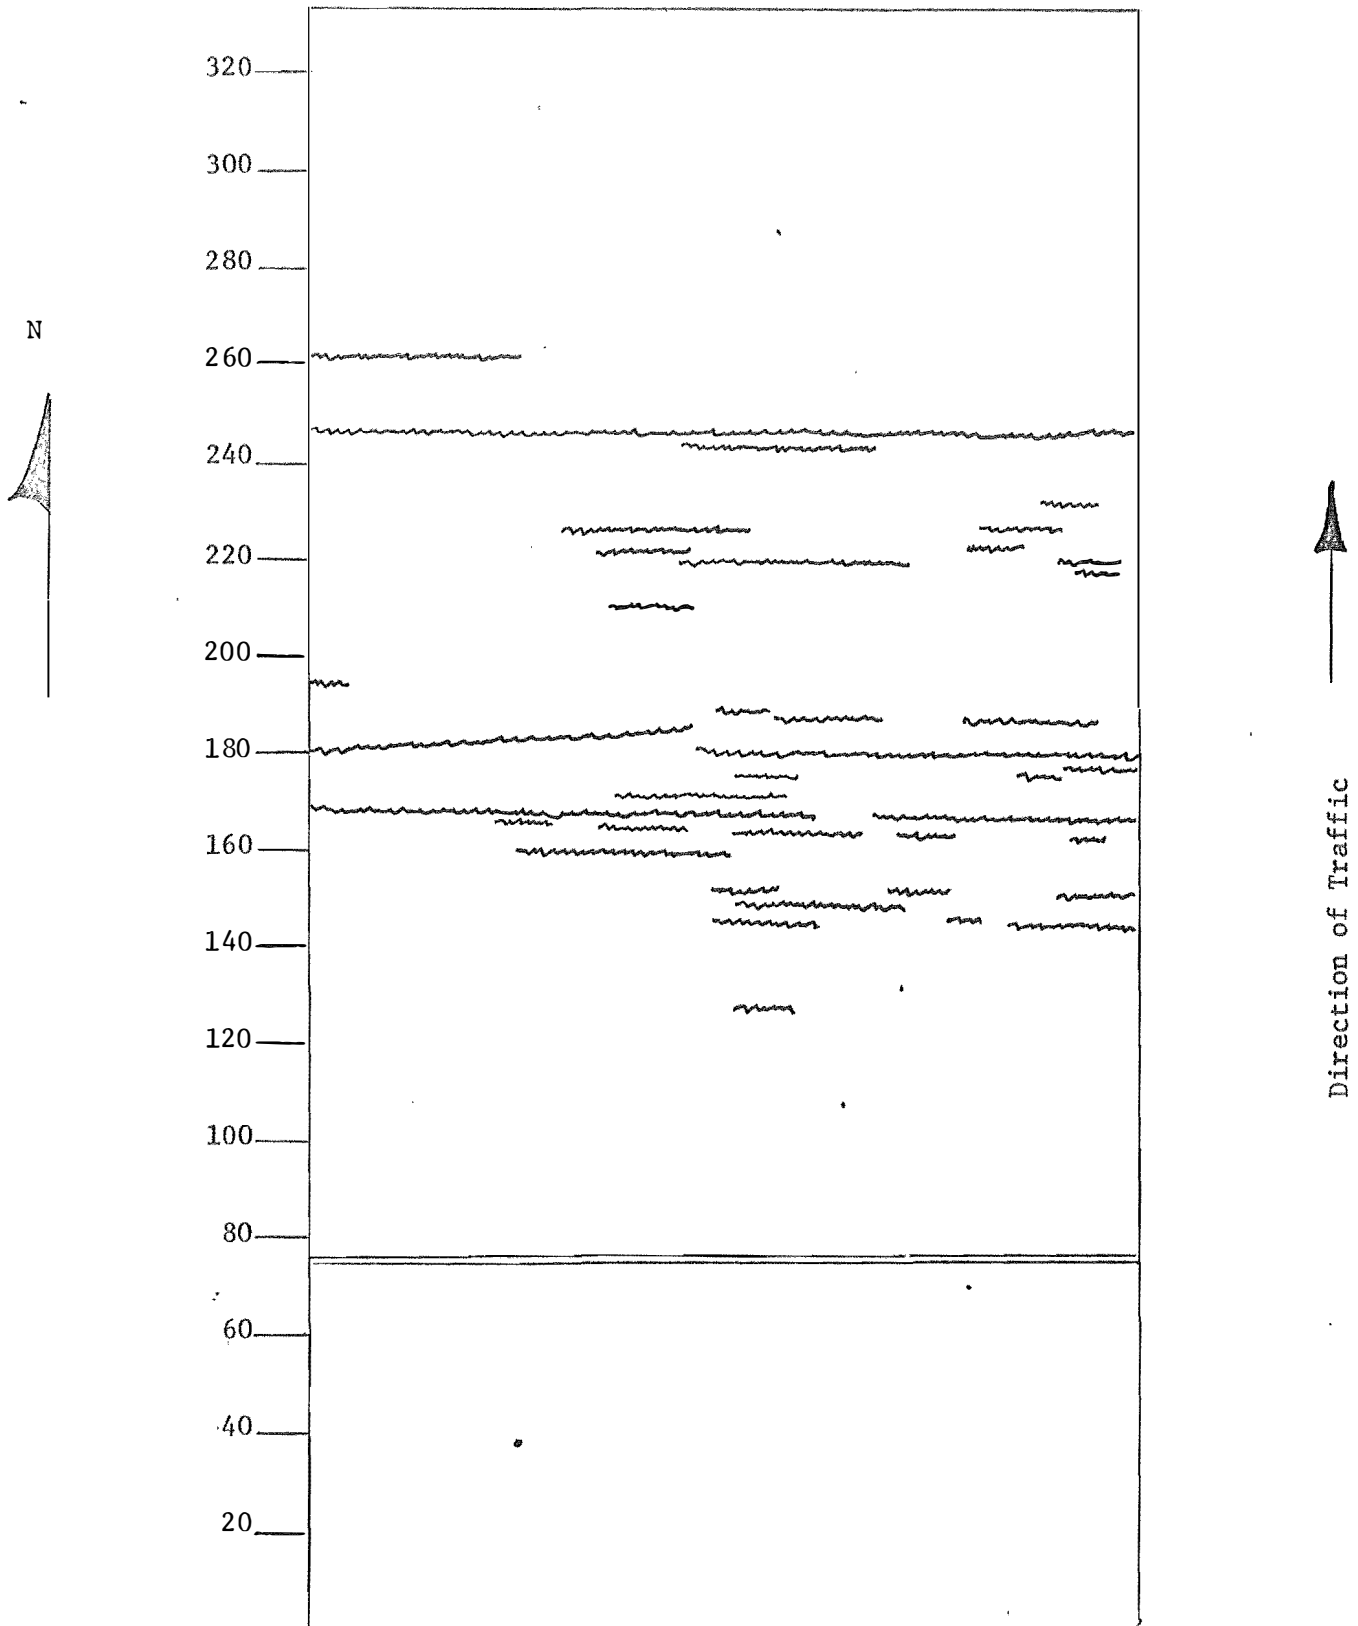
Cracks in Concrete Deck

All cracks were noted on surface of deck. Length of cracks and locations are to scale. Vertical scale 40'/in. Horizontal scale 10'/in.

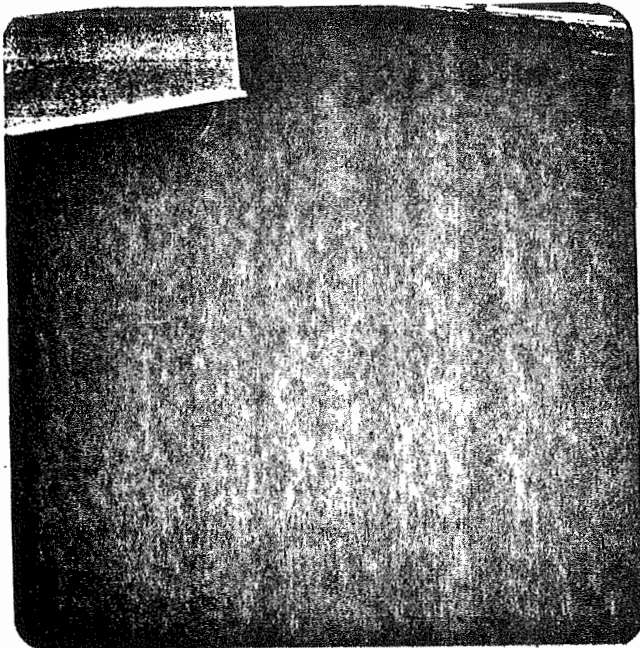
Blisters in membrane and pavement prior to compaction.

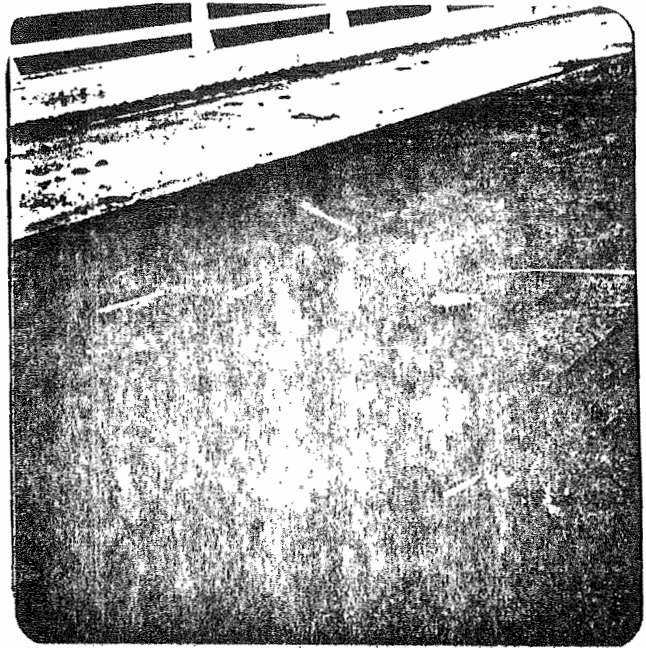
Cracks in first course of pavement after compaction.

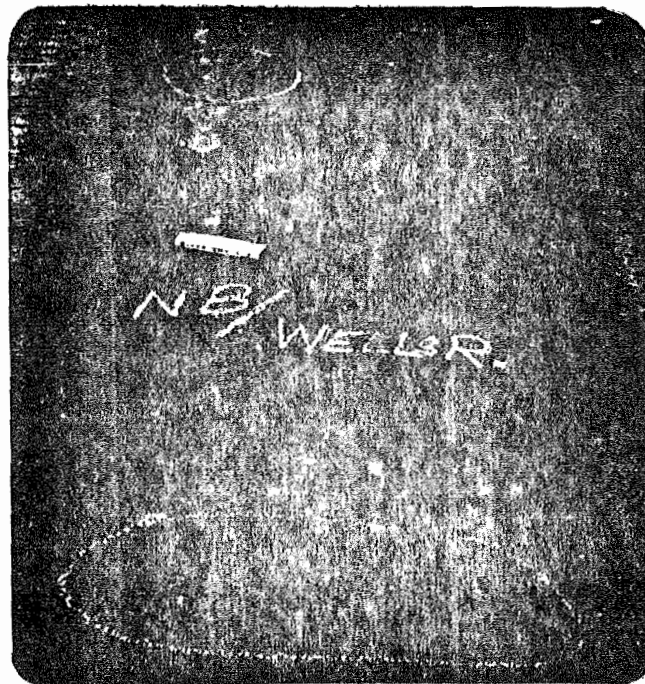
Irregular cracks in 3-month-old first course of pavement believed due to air and/or moisture vapor pressures beneath the membrane.

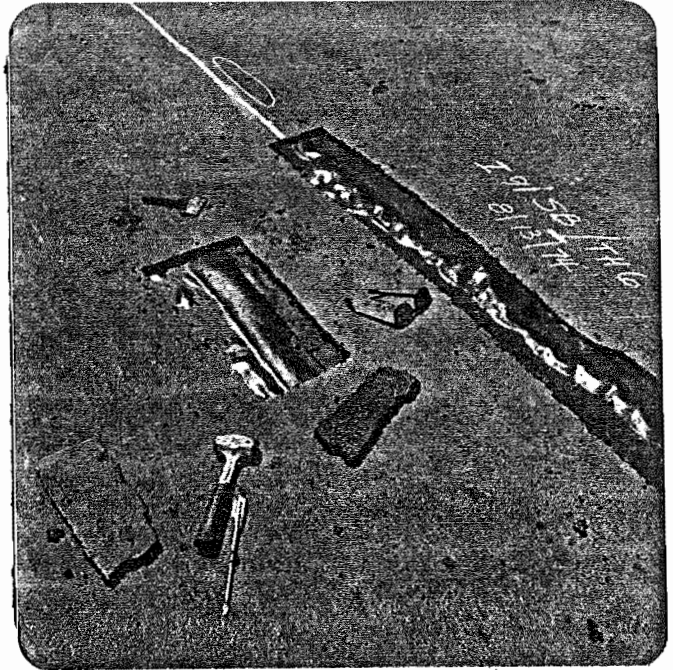
Cracks occurred in the first course of pavement where air pressure lifted the membrane.

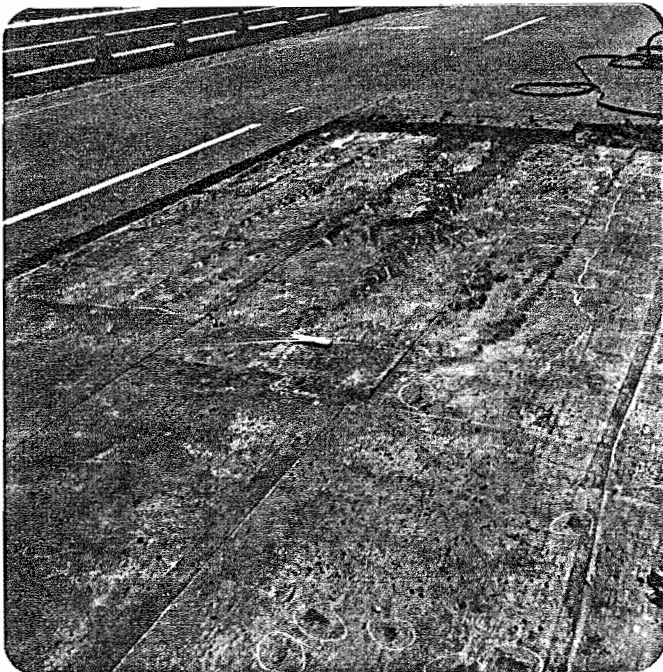
coating which had been applied over 24 of the 42 lineal feet under repair apparently had an adverse effect on membrane bond since in excess of 70 percent loss of adhesion was noted on the area so treated, as compared to 10 percent loss on the uncoated sheet membrane. The removal of the sheet membrane also revealed the existence of flowable concentrations of water on the deck surface in areas where the membrane was not adhered to the concrete. Such moisture originated from within the concrete deck since there were no tears or holes in the neoprene sheets which could have resulted in moisture leakage. Repair of the system consisted of an application of UWM-28 polyurethane and the installation of protection boards. There have been no post repair problems with the pavement-membrane system.

Removal of the pavement revealed up to 70% of the neoprene sheet coated with polyurethane was no longer bonded to the concrete.

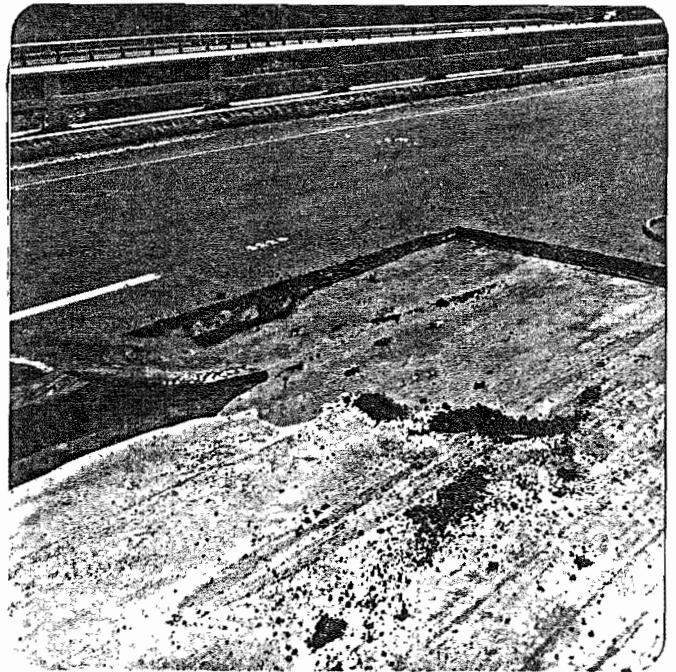
Measurable amounts of water were noted on the concrete in areas where the impervious membrane was not bonded.

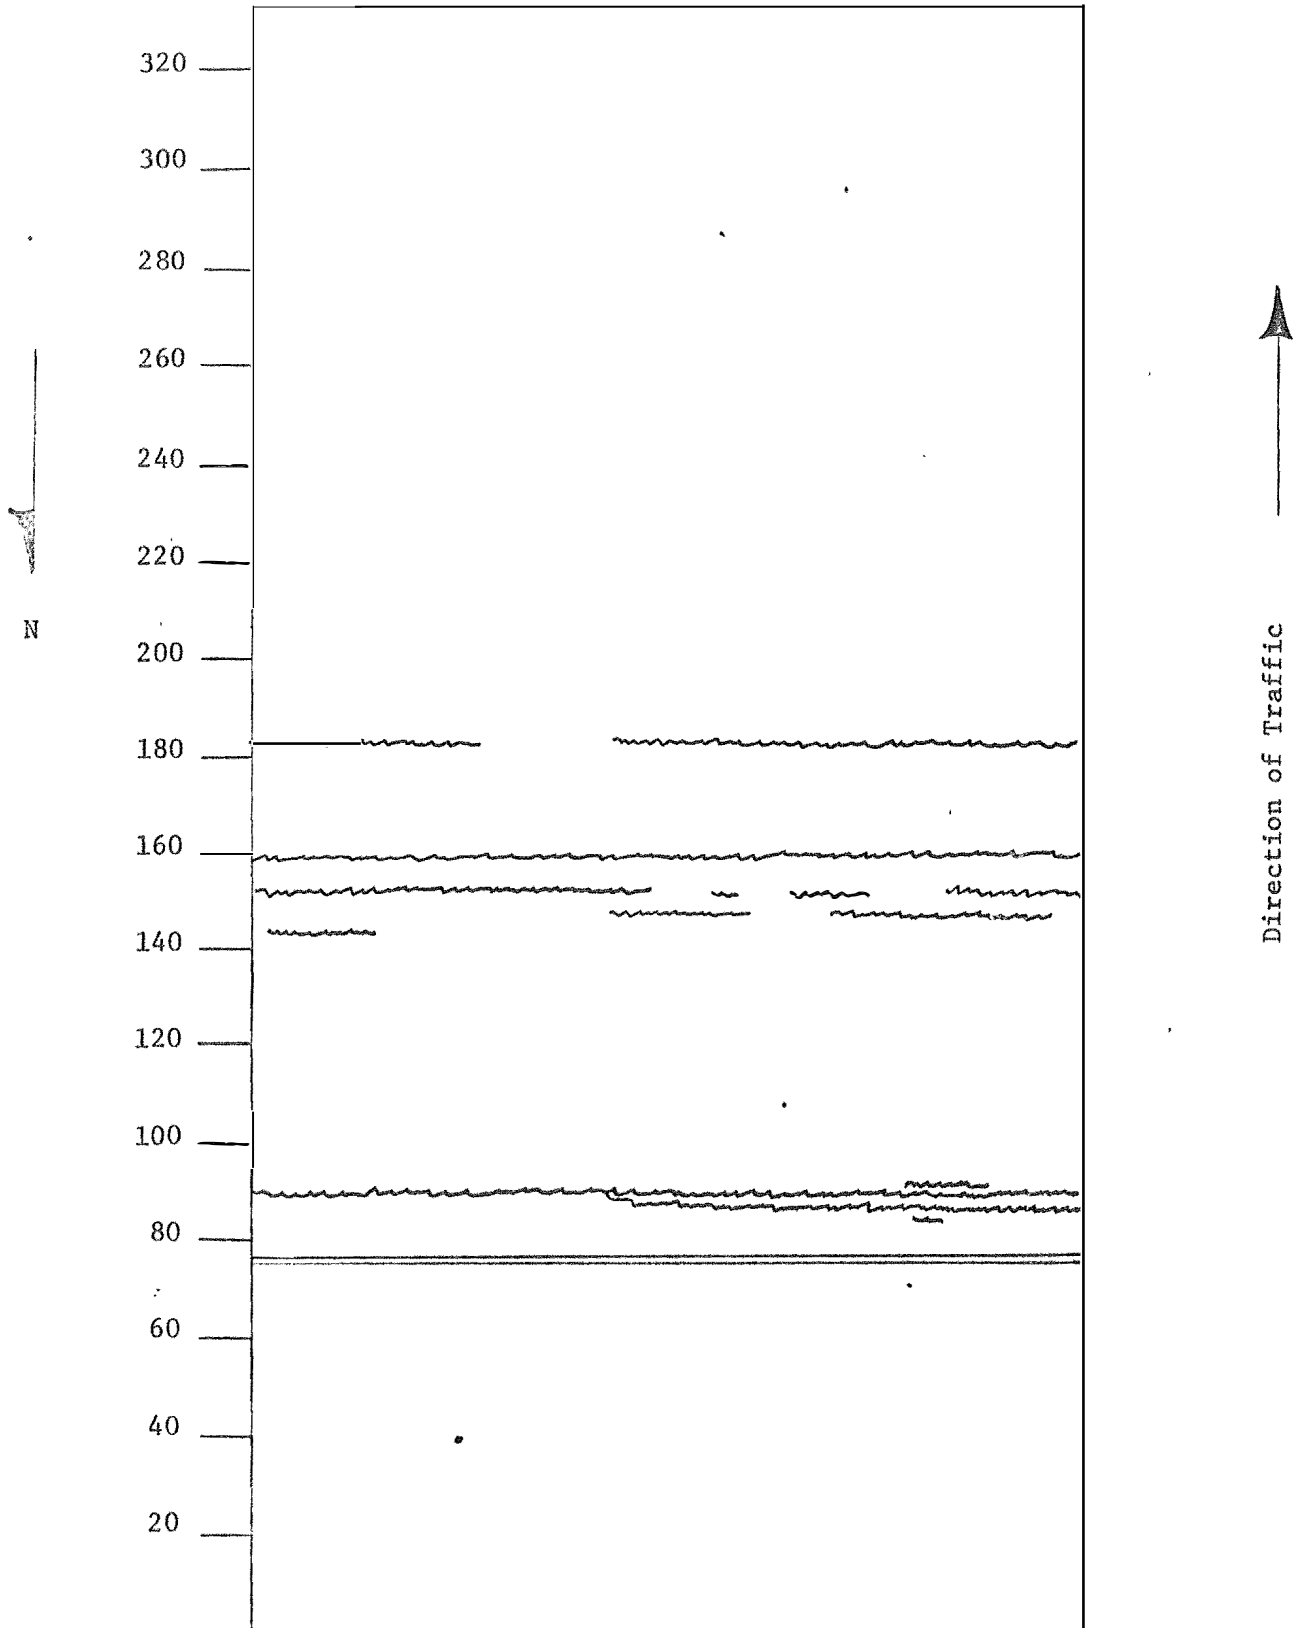
Cracks in Concrete Deck

All cracks were noted on surface of deck. Length of cracks and locations are to scale. Vertical scale 40'/in. Horizontal scale 10'/in.

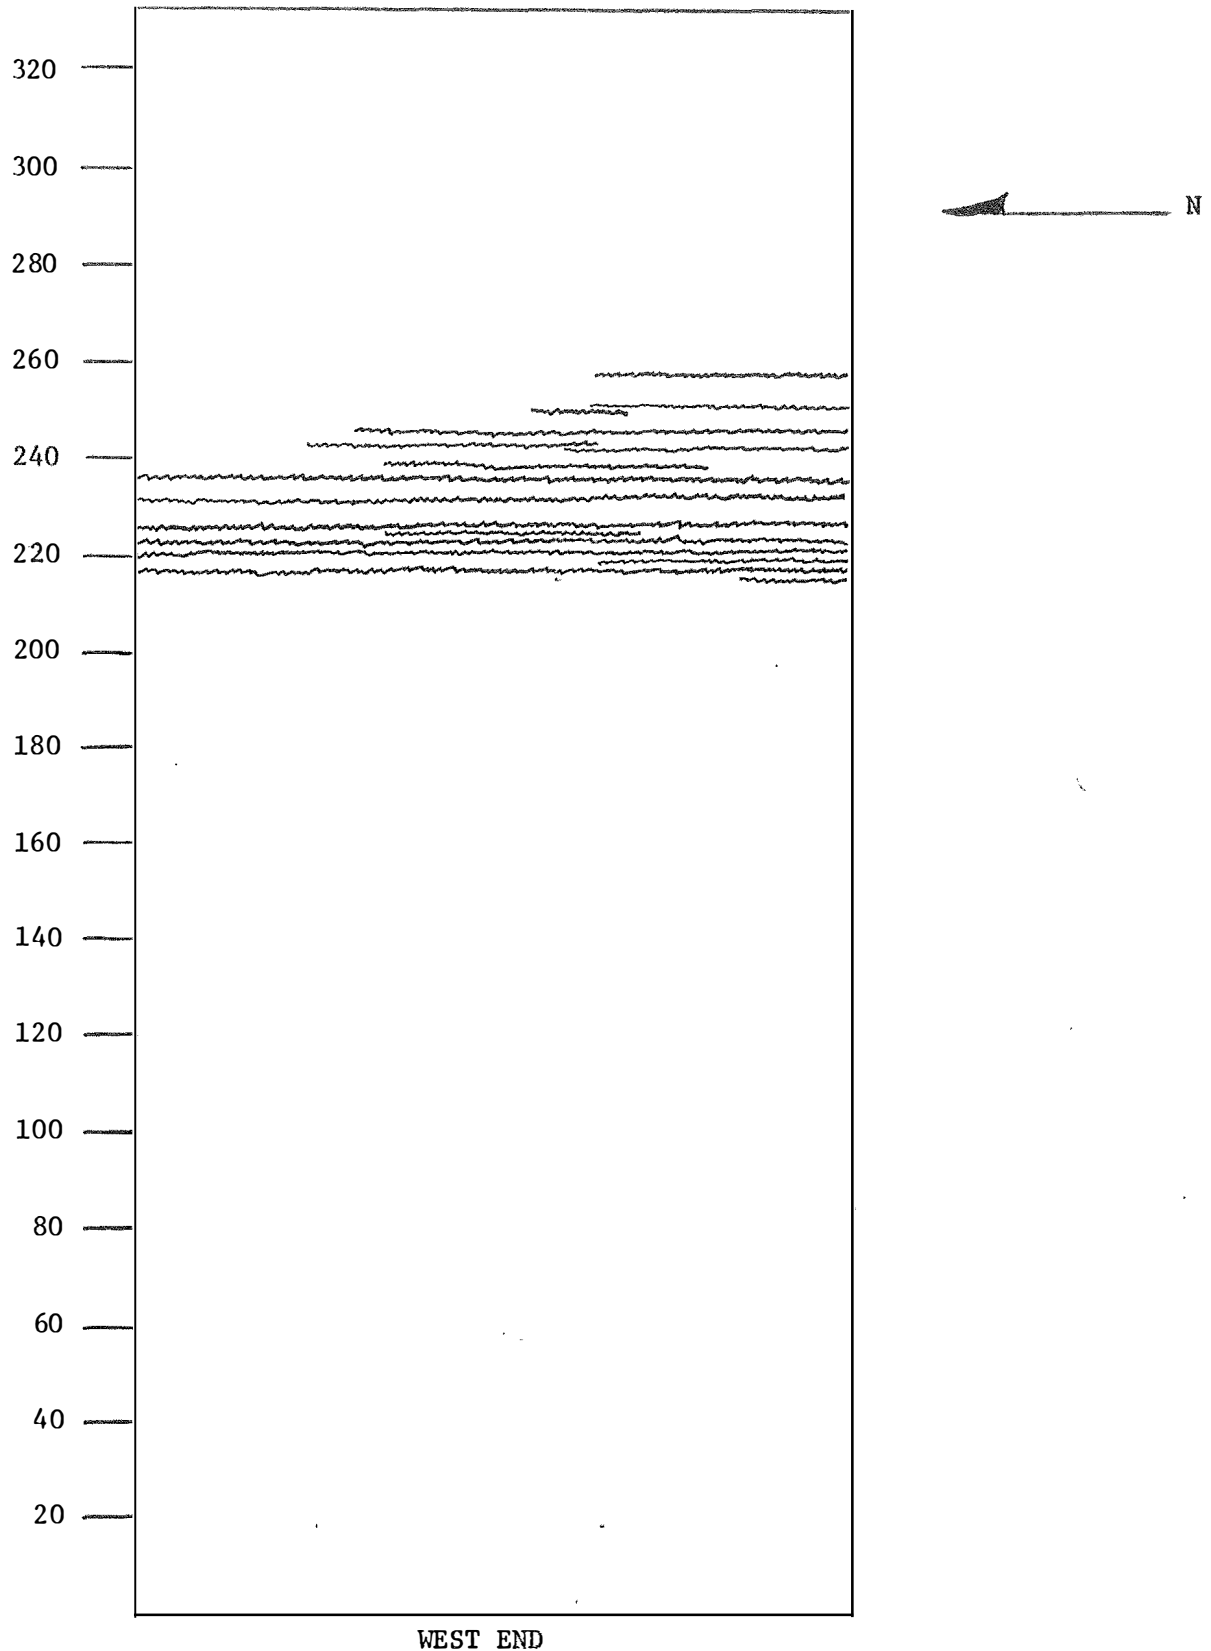
Cracks in Concrete Deck

All cracks were noted on surface of deck. Length of cracks and locations are to scale. Vertical scale 40'/in. Horizontal scale 6'/in.
