GUSSASPHALT BRIDGE DECK  
PROTECTIVE SYSTEM

FINAL REPORT 76 - 2  
October, 1976

VERMONT DEPARTMENT OF HIGHWAYS

CRACKS IN GUSSASPHALT PROTECTIVE SYSTEM  
ROUTE 62/BLACKWELL STREET, BARRE

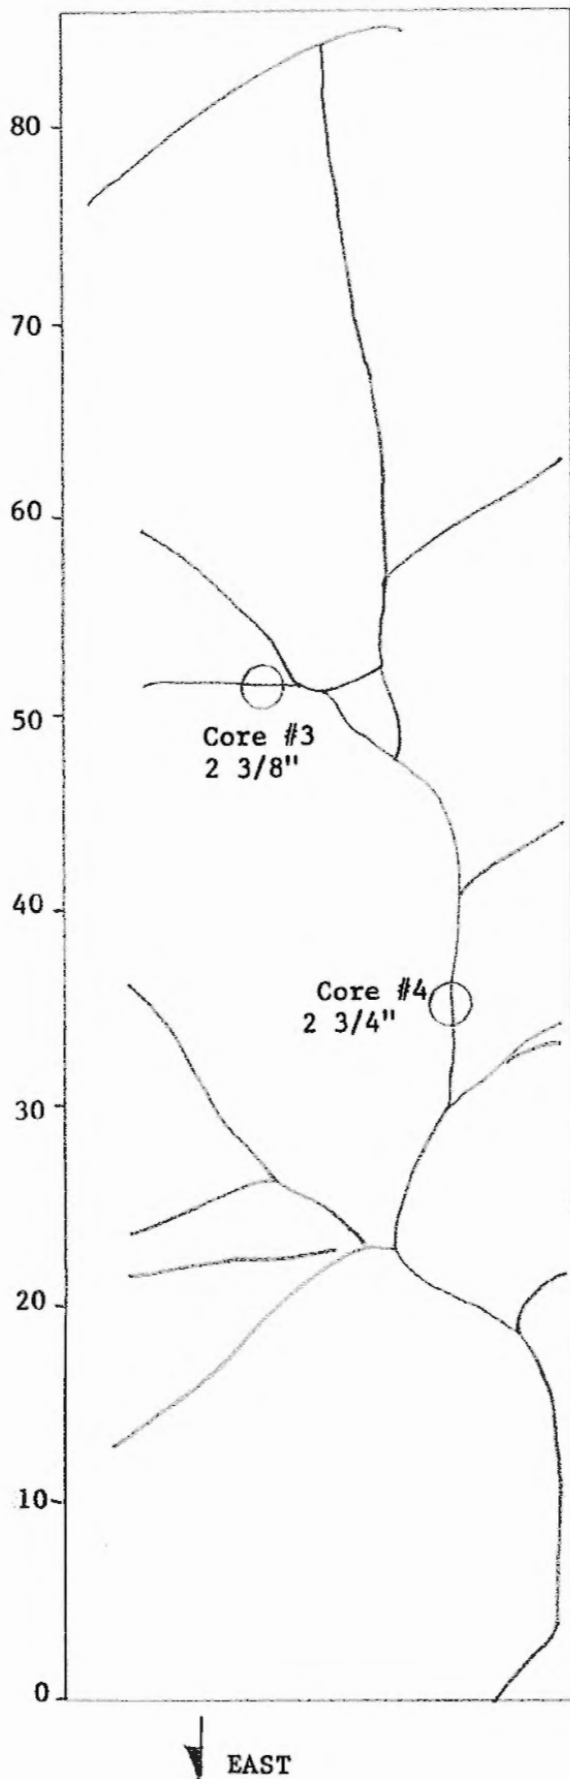
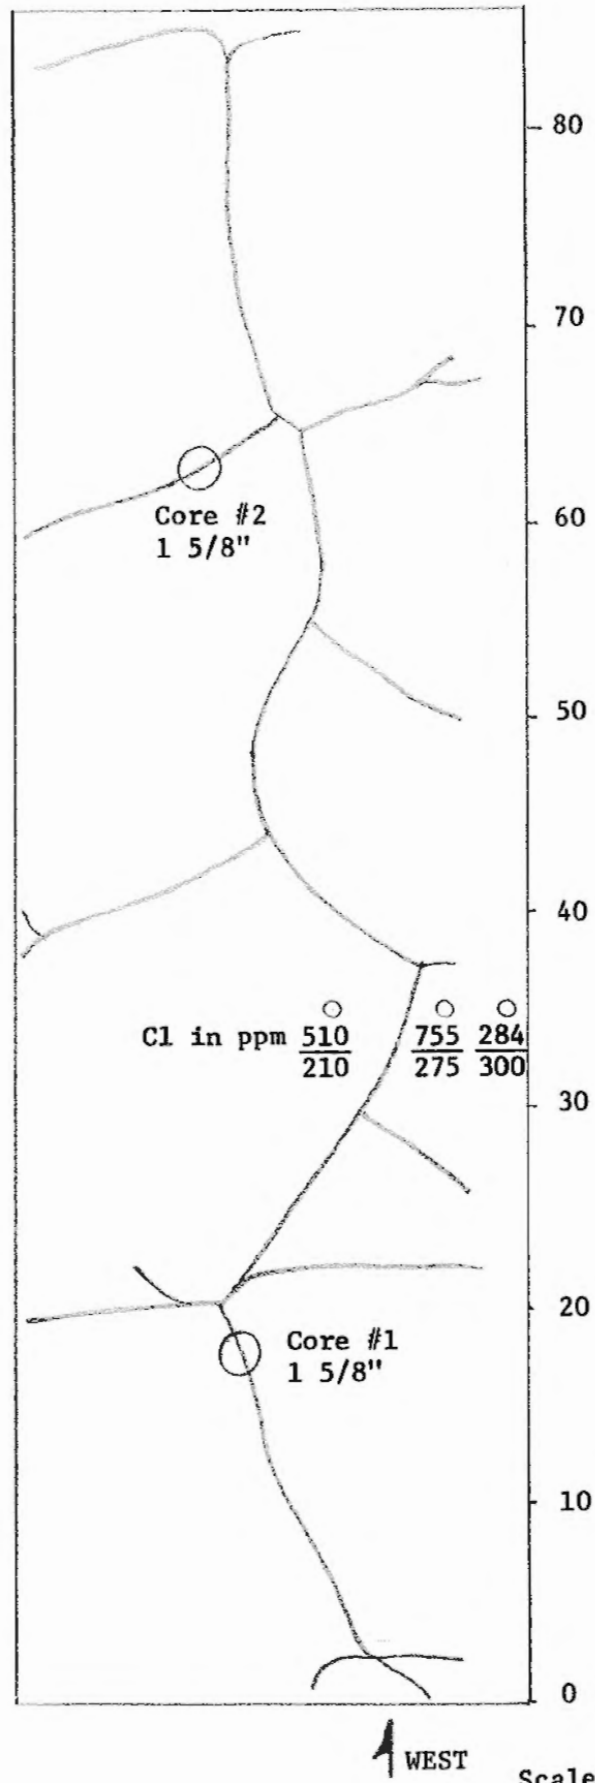
No further evaluations of the system were made in 1975 with the exception of visual observations. On February 22, 1976, a visual inspection of the Gussasphalt pavements revealed the existence of a network of connected random cracks in both spans (see crack layout on page 7). Approximately 170 lineal feet of cracks were noted on each span but the total footage could not be initially determined due to the existence of snow banks along three of the four curb lines. The exposed curb line revealed that a number of the cracks extended towards the curb line but all stopped short of the curb face. The average width of the cracks at the riding surface was  $1/16$  inch while the maximum width was measured at  $3/16$ th inch. The cracks extended through the full depth of the Gussasphalt and mastic asphalt membrane as evidenced by cores taken through four crack locations and chloride concentrations recorded on ice and water samples taken from curb line drain tubes. The latter may also have been due in part to leakage at the curb line since inspection of such areas after the snow had melted revealed a definite loss of adhesion between the Gussasphalt and granite at numerous locations. The formation of an additional crack was noted in each span on March 18, 1976.

Repair of the system was carried out in April, 1976. The procedure included routing of the cracks, burning to remove moisture and sealing with a hot poured joint sealer which was certified to meet Federal Specification SS-S-1401A. The routing was done with  $1/2$  inch bits for an average depth of  $5/8$  inch. The sealing procedure along the outer curb lines included removal of the Gussasphalt along a 2 inch wide by 2 inch deep area. Treatment along

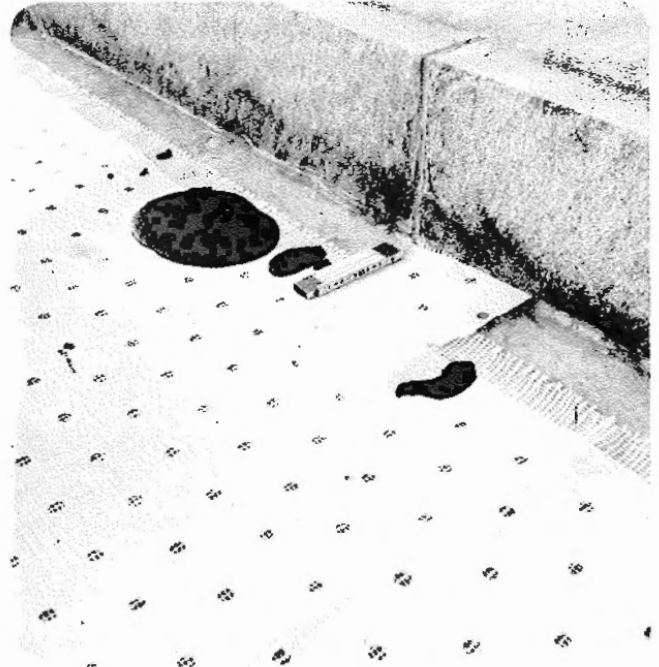
**Fiberglass vapor release system. Note extension of system over drain tube near curb face.**

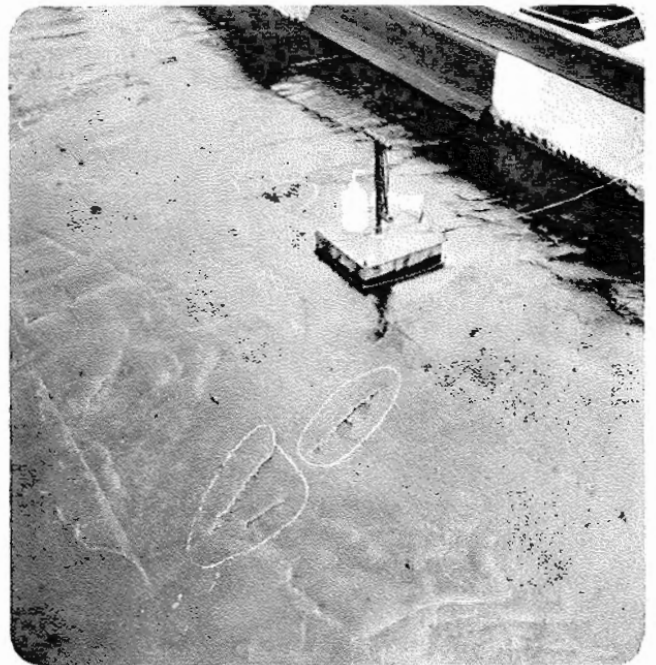
**Voids in mastic asphalt prior to touch-up.**

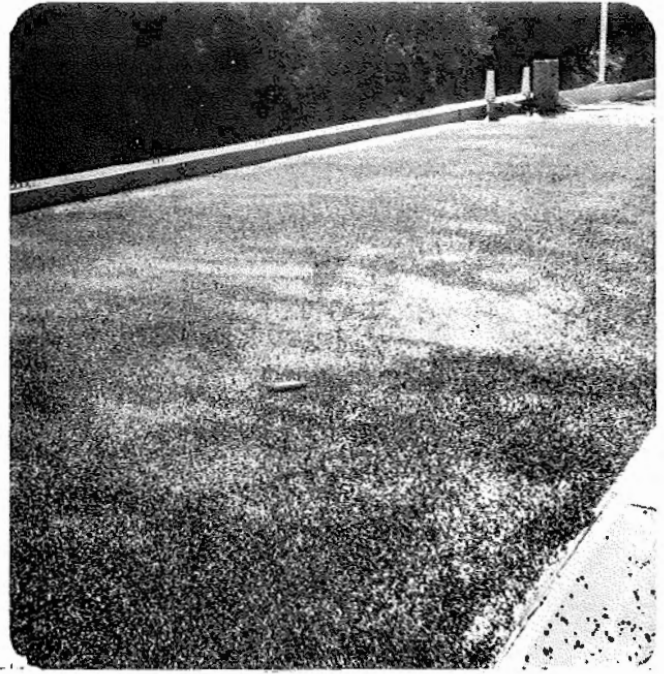
Eastbound lane complete. Note where stone chips penetrated into the Gussasphalt.

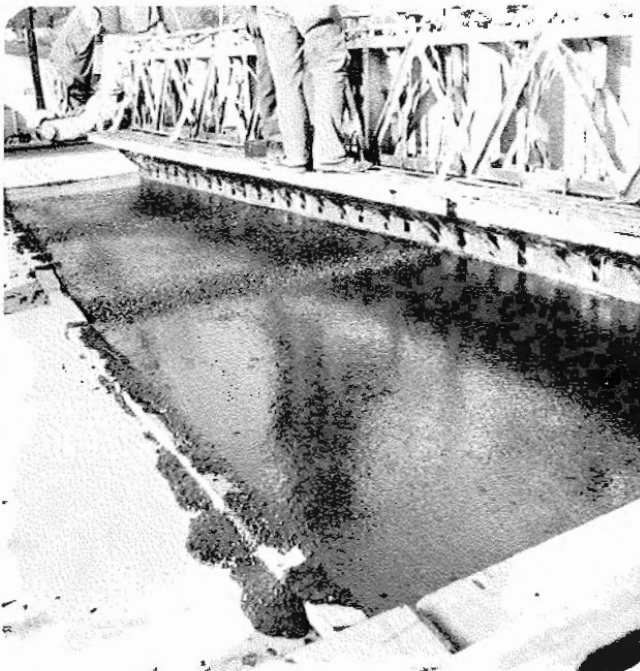
Difficulties with the leveling screed dragging the mix.

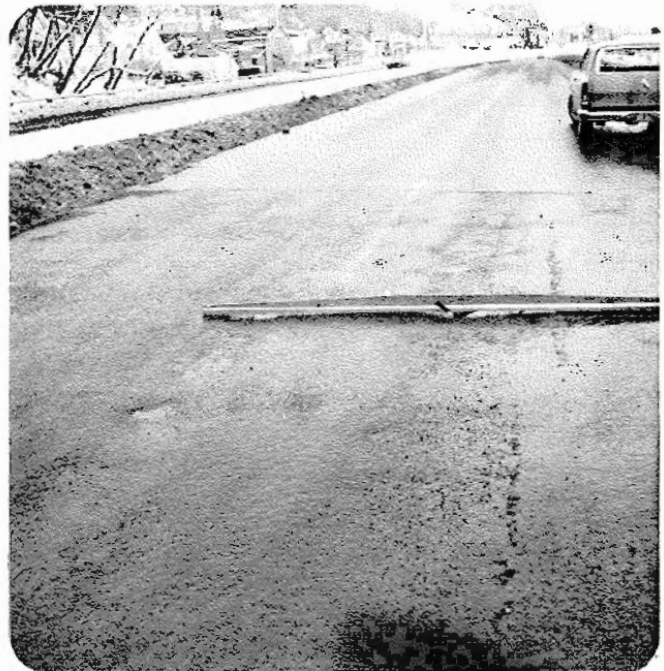
Depressions in the finished surface at locations where the mix was dragged.

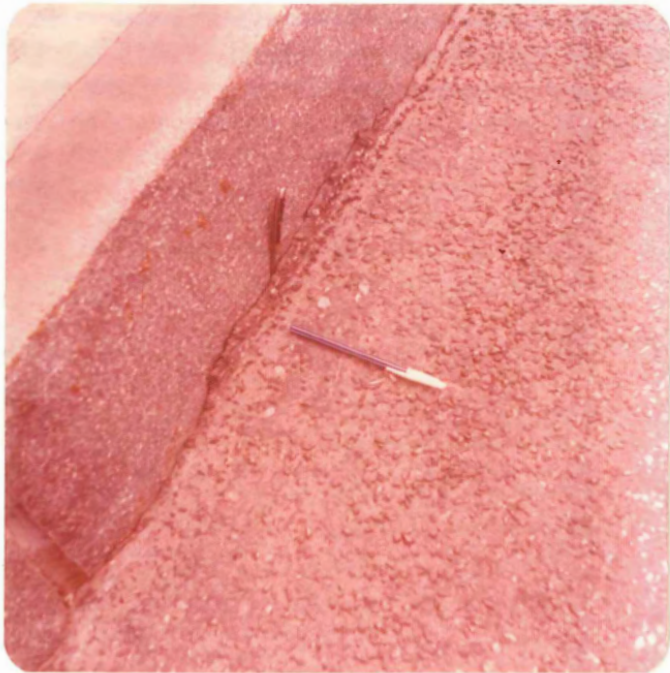
Loss of seal at curb line

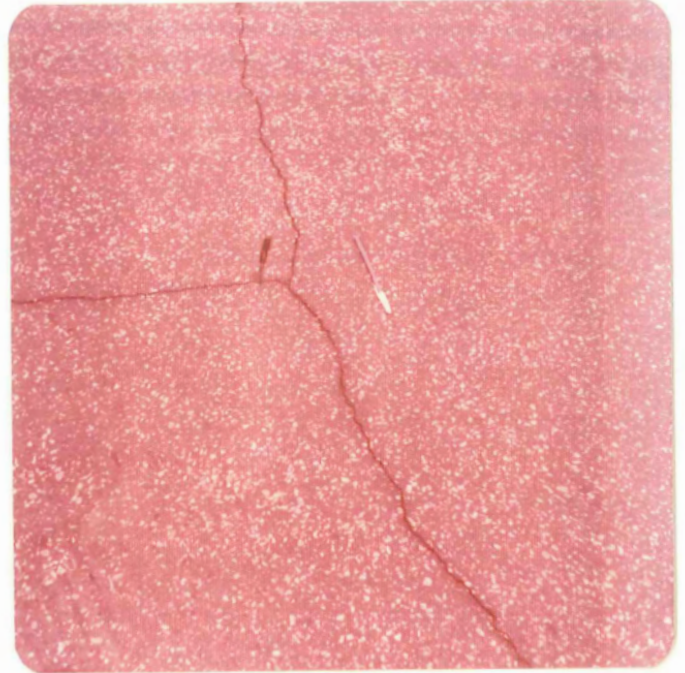
Cracks in Gussasphalt

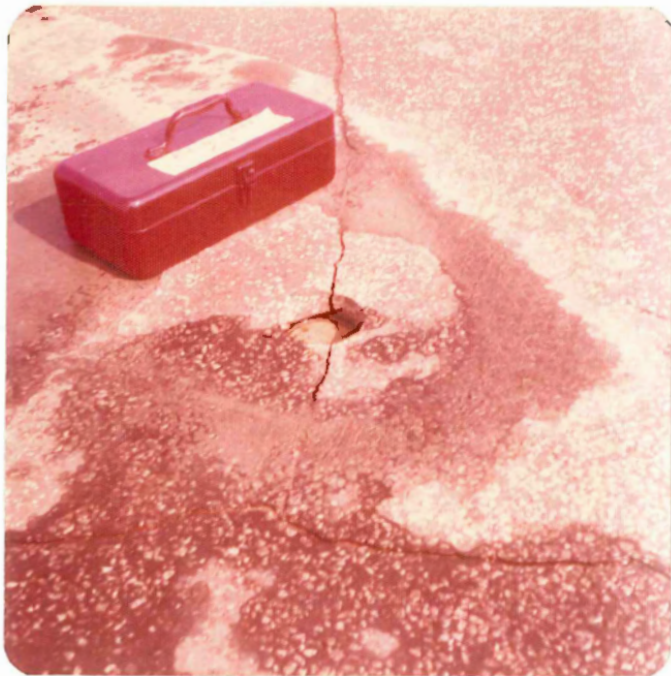
Core hole showing full depth  
crack
