STATE OF VERMONT
AGENCY OF TRANSPORTATION
MATERIALS DIVISION - STRUCTURAL CONCRETE SUBDIVISION

Report of Bridge Cores Taken On
Barnet-St. Johnsbury I 91-2 (59) C/3 I 91/U.S. Route 5

CORE LOCATIONS

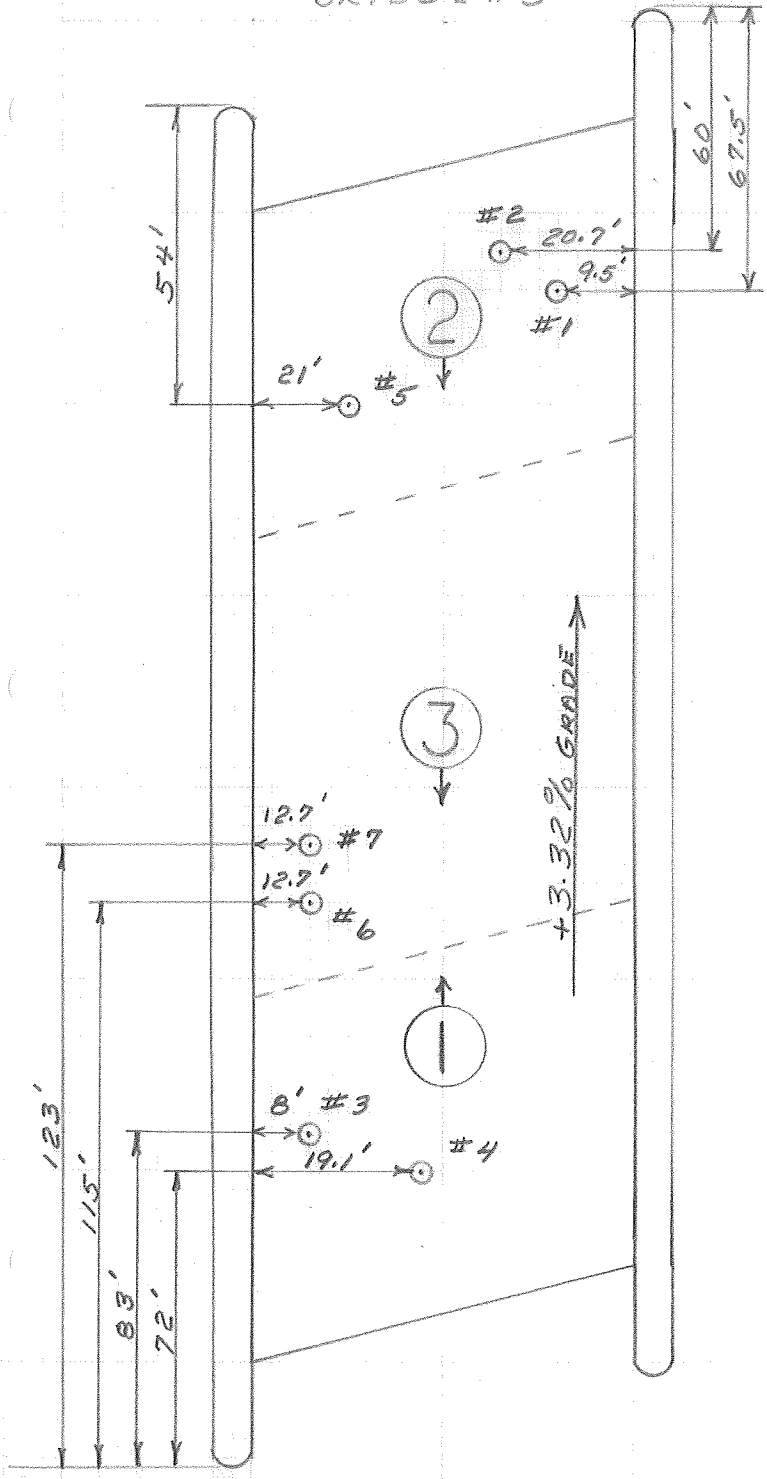
SB
BRIDGE #3

Numerous transverse cracks have been observed in the southbound deck. The northbound deck appears to be relatively free of these cracks even though both bridges are very similar in design. Both structures are two span bridges.

This section of the deck showed transverse cracks in areas over the beams. The lengths of the cracks are about 18" long. These cracks do not appear evident between the beams. The spacing of the cracks is about 12" on center, the same spacing as used for the shear connectors. Measurement from the centerline of bearing to the spacing of the cracks appears to agree with the spacing of the shear connectors.

Core No. 3 was taken over a transverse crack, shows the top transverse rebar at a depth of 1 1/4 inches, the crack extended to the top of the rebar. The longitudinal rebar was found at a depth of 2 1/2 inches. The difference in elevation between these rebars may be the result of a broken tie wire.

Core No. 4 - A line connecting transverse cracks over two beams was drawn on the deck. Core No. 4 was then taken over this line in an area between the two cracks to determine the depth of rebar. No cracks were found. This core just cut the corner of a transverse rebar. The depth of cover was 1 5/8 inches.

Before the pour was completed, transverse cracks were observed at the north end of Pour Sequence No. 2 within a few feet of the end of the bridge. Several transverse cracks were also observed over several of the transverse bars in the top mat 30 feet south of the north end of the deck. Contractors personnel worked with the retarded concrete, which by this time, began to loose plasticity. These cracks were smoothed out at this time. The next morning numerous transverse cracks spaced at intervals of 6" were observed over the area of the top mat of transverse bars. Unlike Pour

Sequence No. 1, these transverse cracks extended further across the deck, being visible between the beams as well as over them. Shadows in the deck follow the pattern of the top mat of steel.

Core No. 1 was taken over a transverse crack. Depth of cover is $1 \frac{5}{8}$ inches. The crack extends beneath the bar to a depth of about $3 \frac{3}{4}$ inches. Voids are visible in the concrete on the downgrade side of the bars.

Core No. 2 was taken over a crack and transverse bar splice at the junction of a longitudinal bar. Depth of cover is $2 \frac{1}{4}$ inches. The crack extends beneath the top mat of steel to a depth 5 inches on one side of the core and to a depth of $2 \frac{1}{4}$ inches to the steel on the other side. No noticeable voids were observed around the bar.

Core No. 5 was taken over a crack halfway between beams. Depth of cover is $1 \frac{5}{8}$ inches. No visible crack is found on the east side of core where transverse steel is spliced. The west side of core shows a crack to a depth of $1 \frac{5}{8}$ inches.

Core No. 6 was taken over a transverse crack. Depth of cover is $1 \frac{5}{8}$ inches. The crack extends to a depth of $1 \frac{1}{2}$ inches.

Core No. 7 was taken 8 feet north of Core No. 6; no crack was found but core was taken over a transverse bar. Depth of cover is $2 \frac{3}{8}$ inches. Cracks are visible in the deck about $1 \frac{1}{2}$ and 3 feet north of this core.

The direction of Pour Sequence No. 2 and No. 3 on the southbound deck is one that, if possible, should be avoided in the future. When a pour is made in a downhill direction each transverse bar acts as a dam holding back the flow of the mix. The mix on the downhill side of the transverse bar, through consolidation and its tendency to flow downhill, pulls away from the mix held by the bar, creating a tensile stress in the mix directly over the bar. Had the deck been poured uphill this portion of the mix would have been placed in compression and aided in the prevention of possible transverse cracks. All other sections of both bridges were poured uphill. None of the other sections exhibit the severity or number of cracks that developed in Pour Sequence No. 2 and No. 3 of the southbound deck.

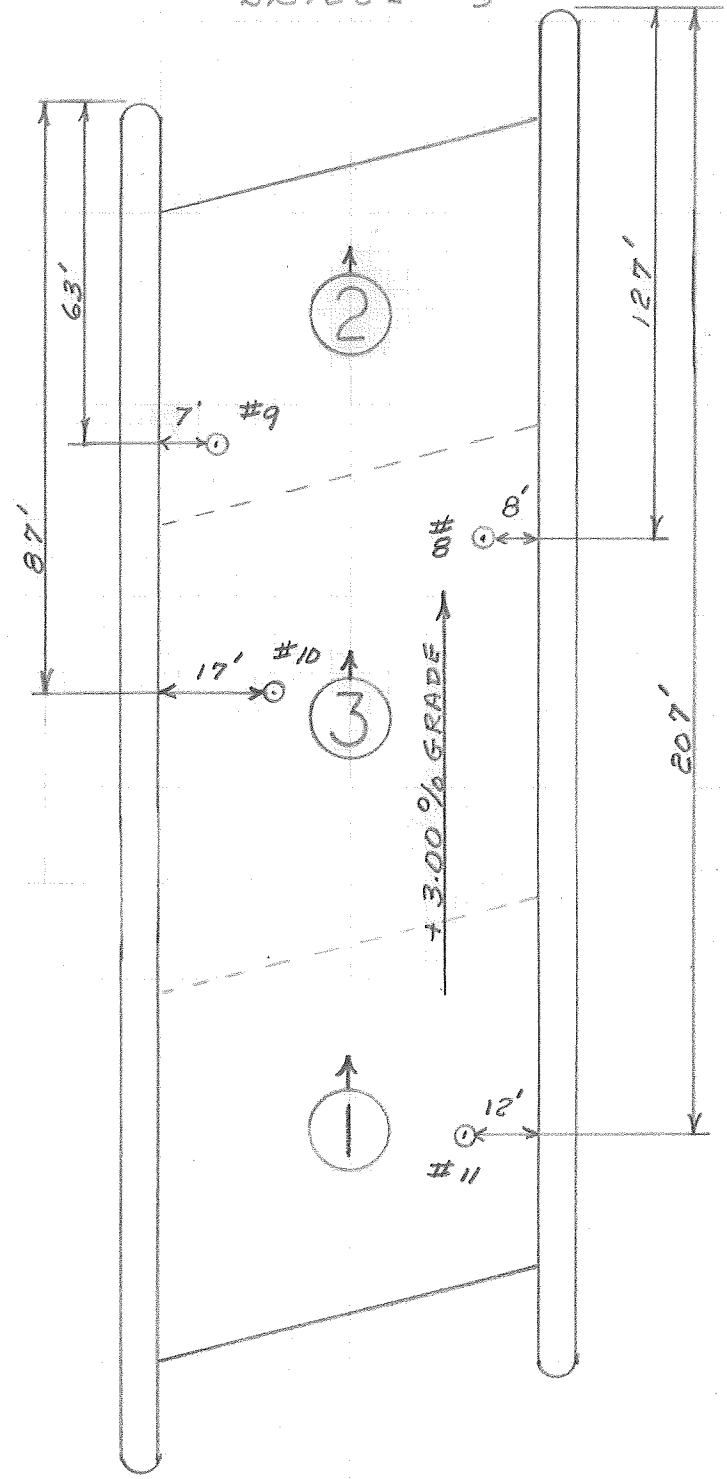
NB
BRIDGE #3

This portion of the deck showed no transverse cracking or shadows. The texture of deck was that of a pan finish.

Core #11 was taken at random and showed the depth of cover to be 2 inches. No signs of any transverse cracks over the steel were observed.

This portion of the deck had been bull floated. No noticeable transverse cracks were found. A few small random shrinkage cracks can be found in the laitance. However, shadows could be seen in the deck surface that reflect the pattern of the transverse bars.

Core No. 9 was taken over one of the shadows and a transverse bar was cut and found below the shadows. The depth of cover over the transverse bar was 1 5/8 inches.

This portion of the deck had been bull floated. A couple noticeable transverse cracks were found. Shadows were also visable on this section of the deck.

Core No. 10 was taken over a high spot in the deck. Shadows were evident both east and west of the core location but were not evident where core was taken. The depth of cover over the transverse bar measured 2 3/16 inches. No visable cracks were observed in the core.

Core No. 8 was taken over one of the few transverse cracks found in the northbound deck. This core revealed a depth of cover of 2 inches over the top mat of steel. The depth of the crack was 3/4 of an inch on the east side and 1 1/2 inches on the west side. A shear connector was evident in the center of this core. The depth of cover over the shear connector was 2 5/8 inches.
