ALTERNATIVE REFLECTION CRACK TREATMENTS
PULVERIZATION AND RUBBERIZED SLURRY SRI

FINAL REPORT 77-4

August 1977

VERMONT AGENCY OF TRANSPORTATION

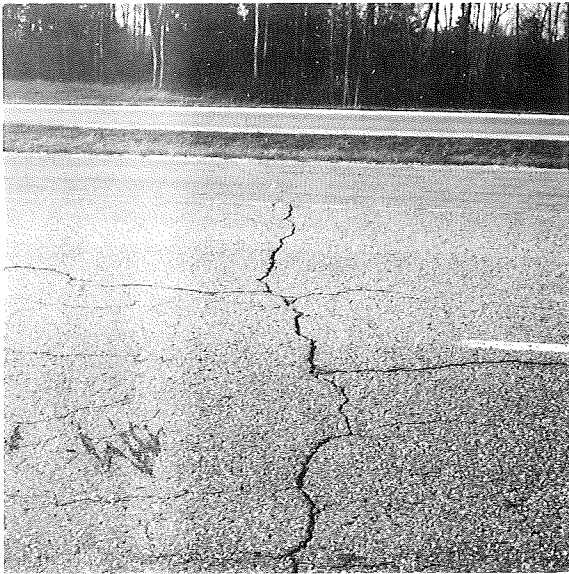
MM 172/95. Condition of pavement in area to be pulverized. October, 1973.

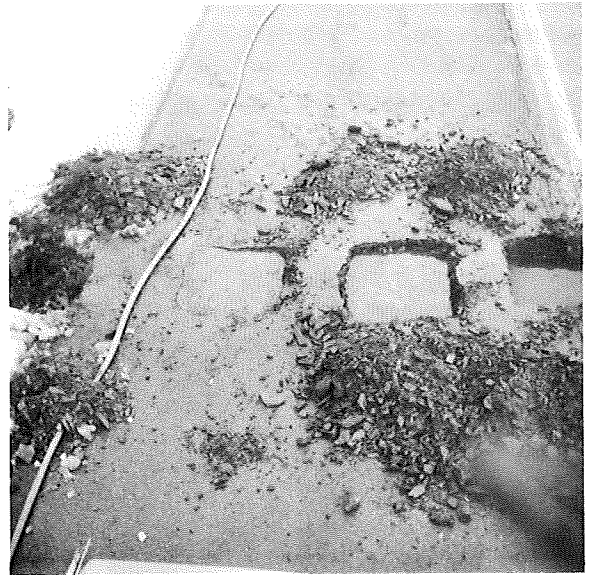
MM 172/95. While opening test pits — free water seeking own level. Note snow on bank. December, 1973.

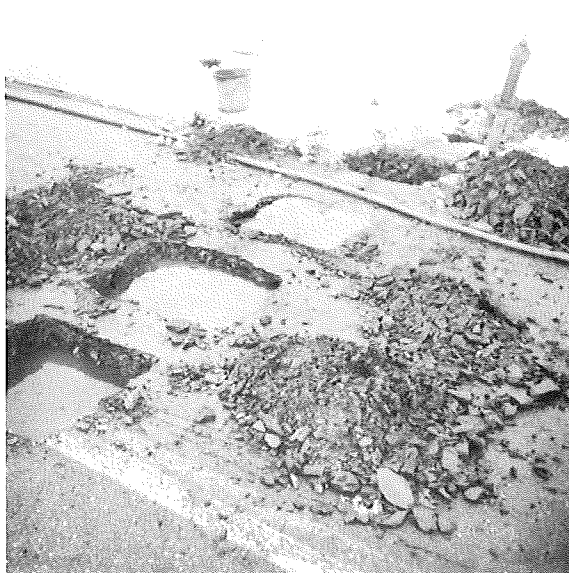
MM 172/95. 2' x 2' holes separated by 1' to edge of shoulder. Running out of third hole. December, 1973.

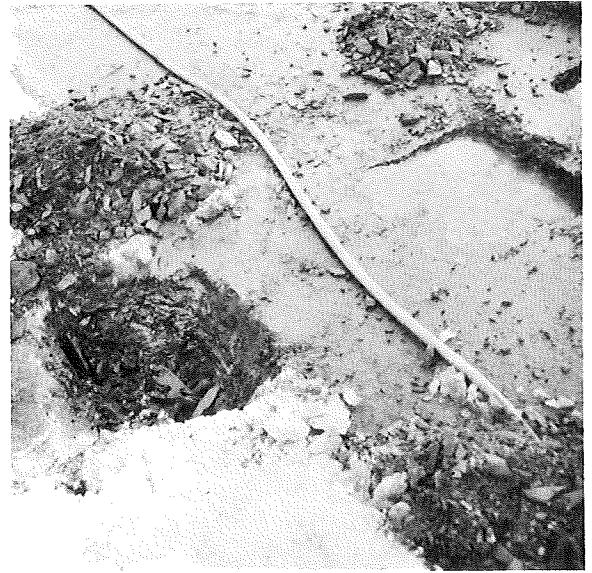
MM 172/95. Hole off point of shoulder dry except for some spillage. Note snow. December, 1973.

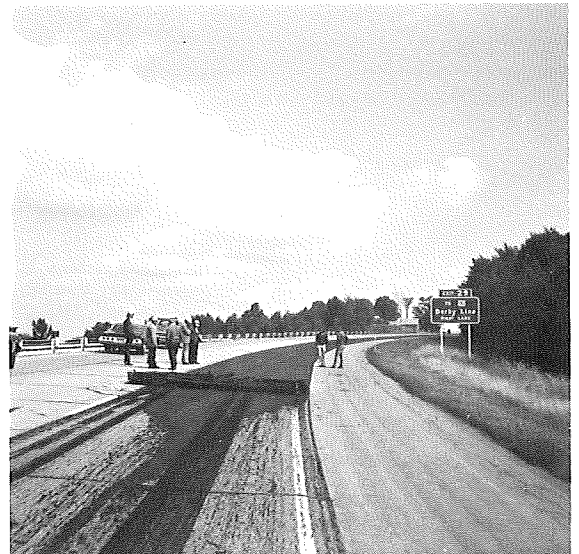
Laying first course of SRI. Note crack filler and shoulder overlap.

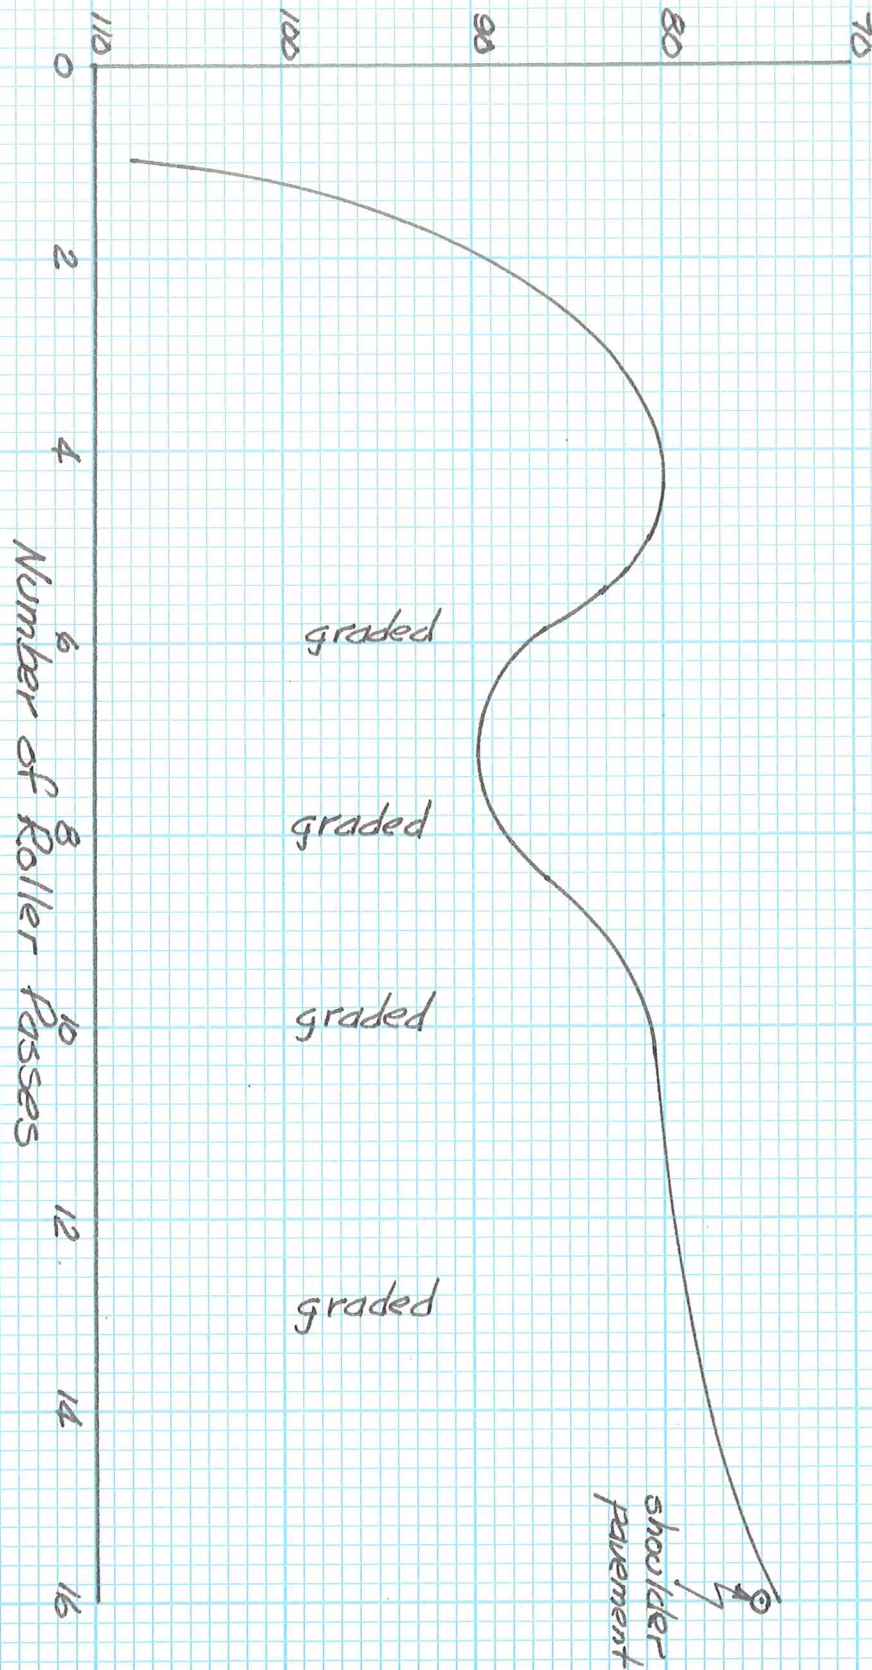
FIGURE 1

The results of Figure 1 indicate that there was a rapid increase in compaction up to 4 roller passes, then an appreciable variance in compaction from 4 to 10 roller passes as the grading process was going on. The final gain from 10 to 16 roller passes was slow, but appreciable.

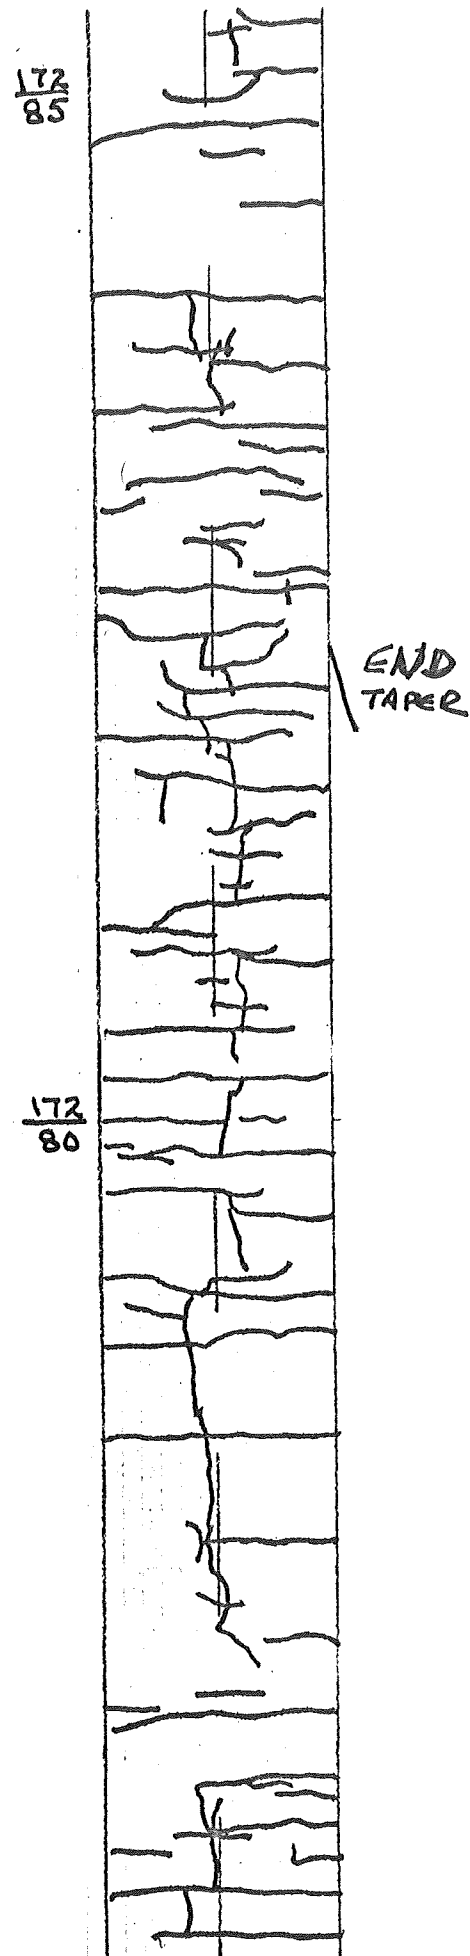
CRACK SURVEY DERBY I 91-3(31)

Start Section #1.
Mile Marker 172.725
Pulverize and Emulsify for 1.91 miles.
Original cracks shown from 1974 survey,
no reflection shown from 1977 survey.
