EXPERIMENTAL USE OF REINFORCED CRACK  
SEALING SYSTEM ON ROUTE 14,  
SOUTH BARRE, VERMONT

INITIAL REPORT 85-2  
January, 1985

REPORTING ON WORK PLAN 83-R-32

STATE OF VERMONT  
AGENCY OF TRANSPORTATION  
MATERIALS & RESEARCH DIVISION

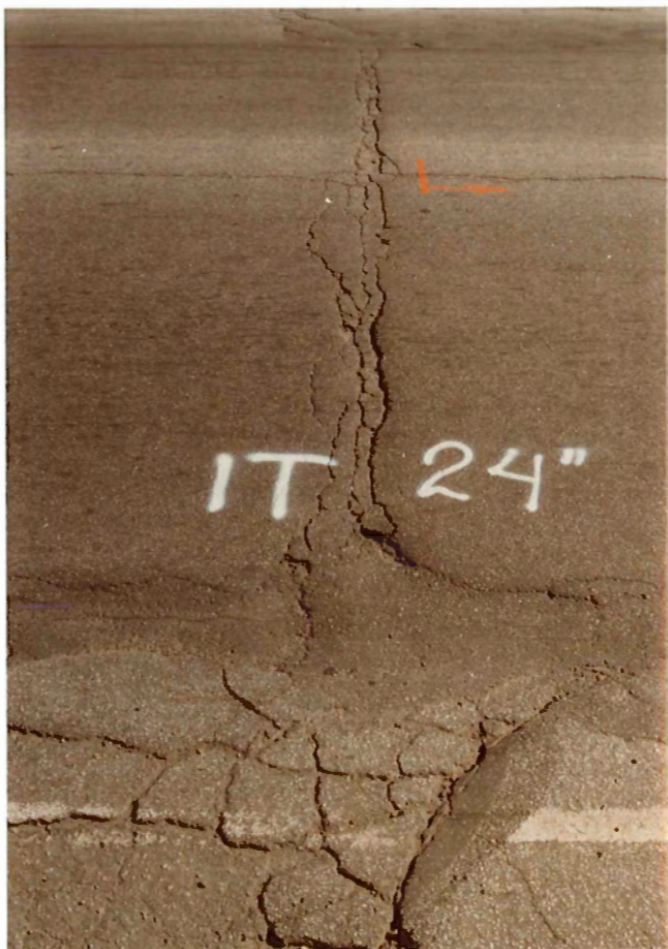
Photo #1 - shows a typical full width transverse crack prior to treatment with 24 inch wide fabric.

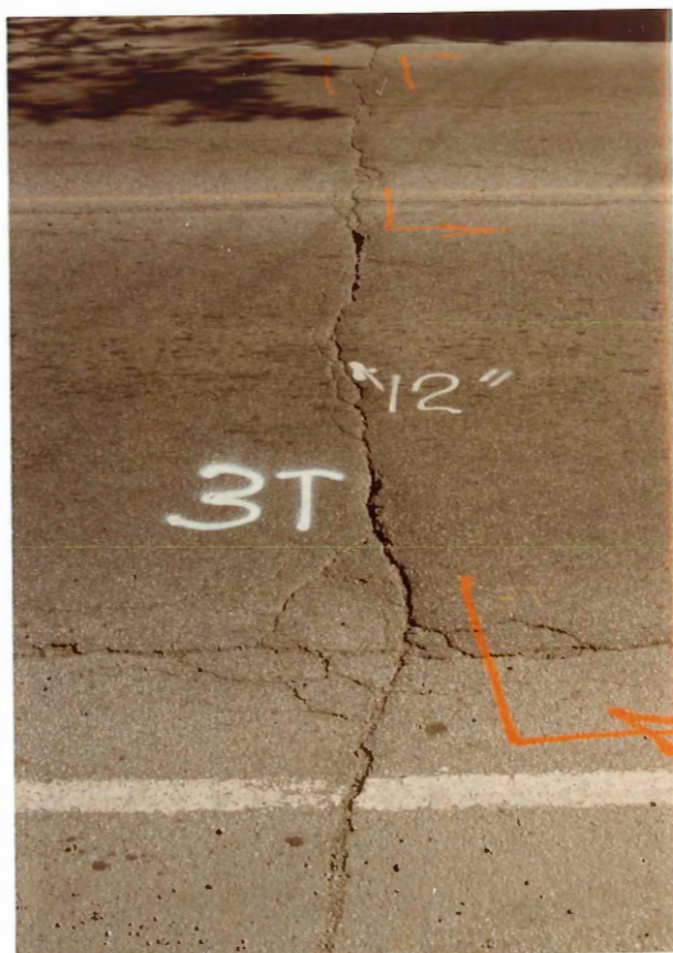
Photo #2 - shows a typical full width transverse crack prior to treatment with 12 inch wide fabric.

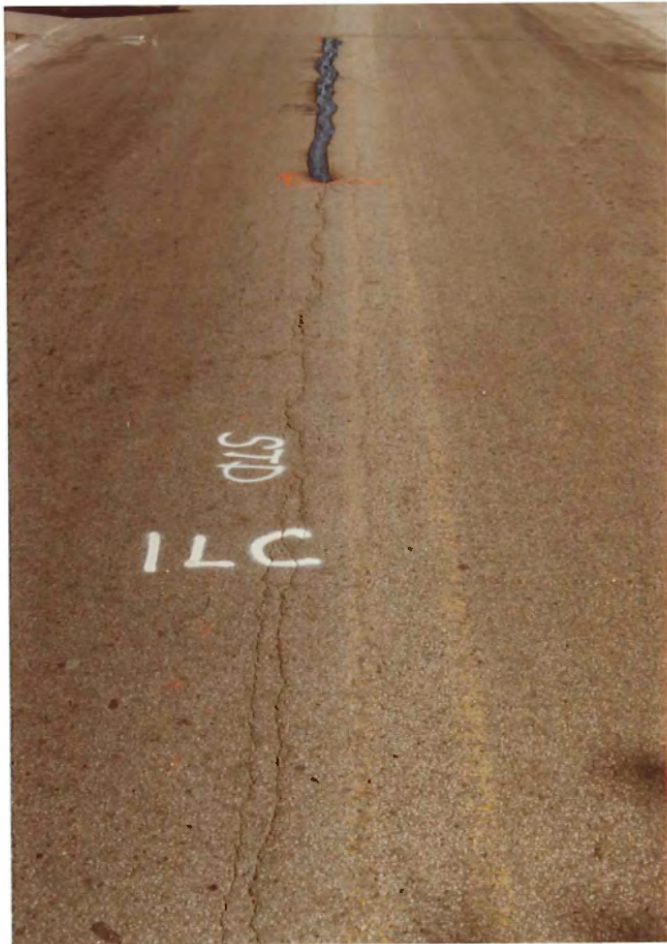
Photo #3 - Example of longitudinal crack prior to treatment with standard crack filler.

Note: This photo was taken while standing on centerline.

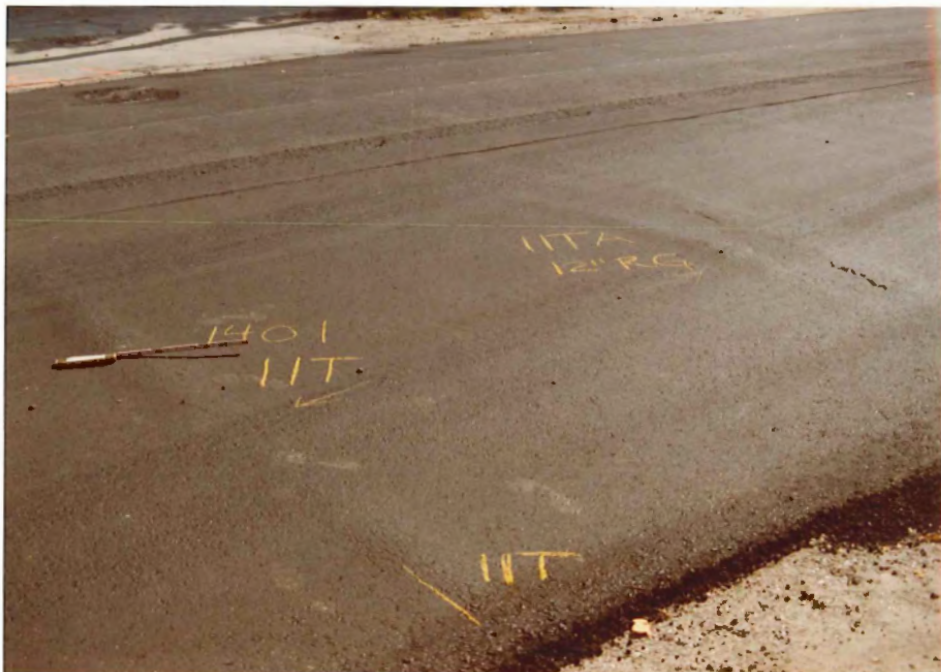
During the rolling operation distress in the form of bumps occurred at seven locations. All were located over transverse cracks, six in the southbound lane and one in the northbound. It is unclear as to

why this problem occurred. A possible explanation may be that, as the roller crossed over the transverse cracks, the hot mix apparently would not adhere to the smoother treated surface. This caused a build-up of hot mix in front of the roller, then, when the mix came in contact with the rougher texture of the existing pavement, the mix would grab and stop, causing a humped effect. The worst of these was at 16T, which was treated with standard crack filler where a bump approximately one foot wide and one inch high formed across the southbound lane. Of the six remaining locations with distress, four had been treated with Roadglas, one with standard crack filler, and one did not have any treatment. The latter occurred in the northbound lane. The photograph below shows distress at two locations, one with the standard crack filler treatment and one with Roadglas treatment. The picture was taken approximately 20 minutes after rolling.

Photo #4 - shows an example of the problems encountered during the rolling operation.

The higher readings in the southbound lane are no doubt due to the bumps which formed during the rolling operation. These areas flattened only slightly in the wheel paths after exposure to traffic.

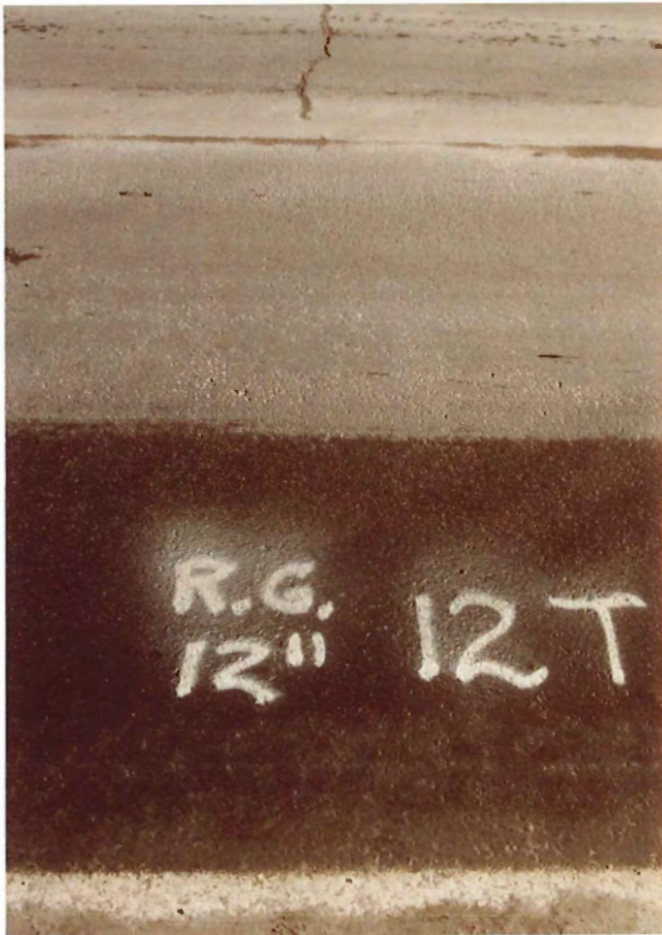
There are several locations where transverse cracks treated with Roadglas have not reflected through and the opposite lane is cracked to or near the centerline as can be seen in the photograph below.

Photo #5 - example of Roadglas performing well. Crack was treated with 12 inch Roadglas.

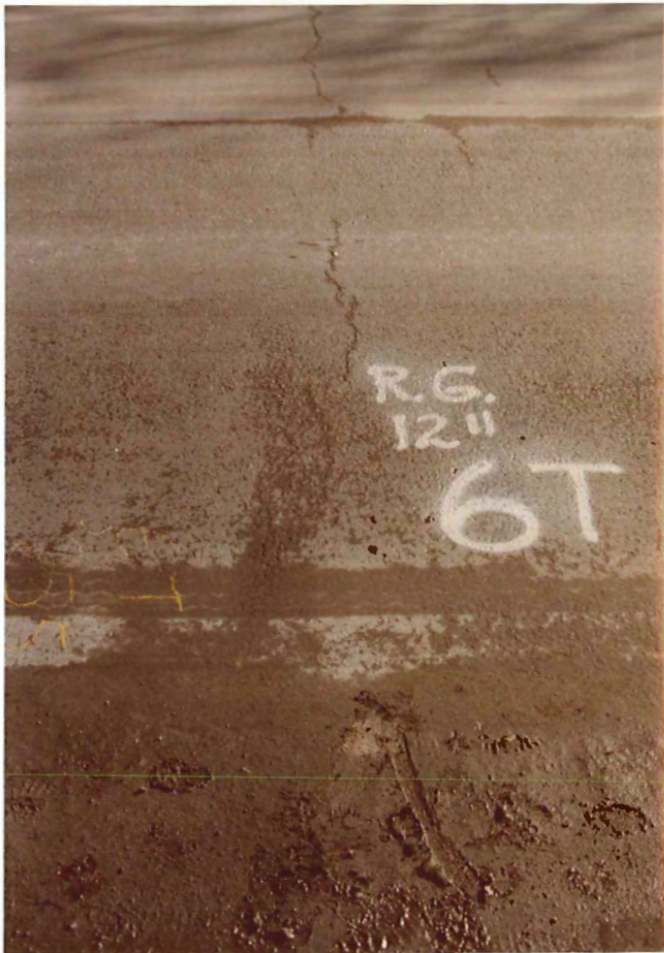
At the locations where Roadglas treated cracks have reflected through, the cracks are significantly tighter than the opposite lane, but in most cases do not run the full width of the lane. The transverse

Photo #6 - Roadglas has reflected through but crack is tight and does not run full width of the lane. Crack was treated with 12 inch Roadglas.

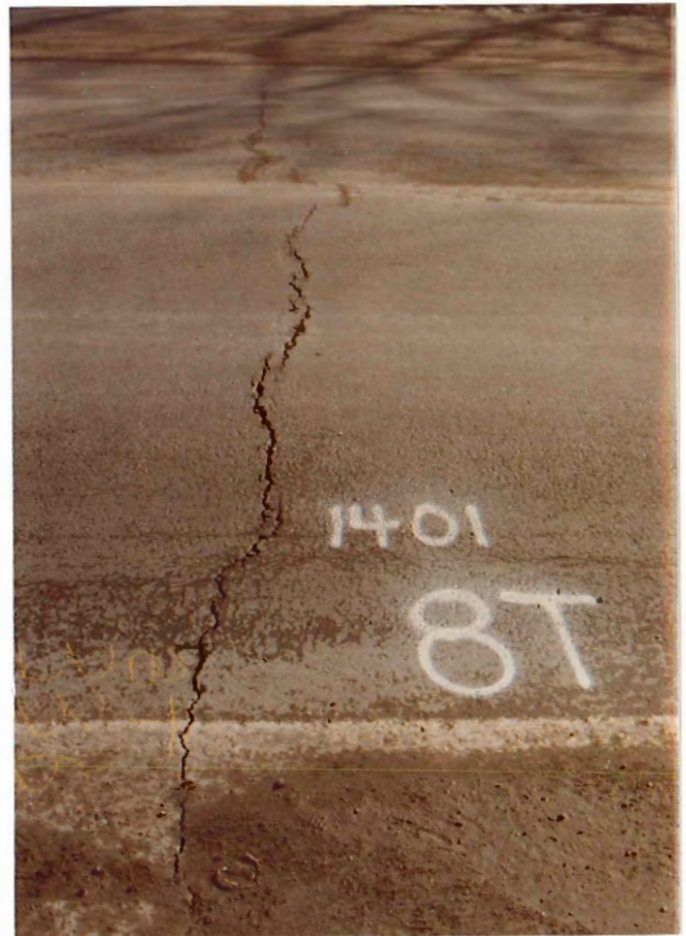
Photo #7 - Standard Crack filler failure.

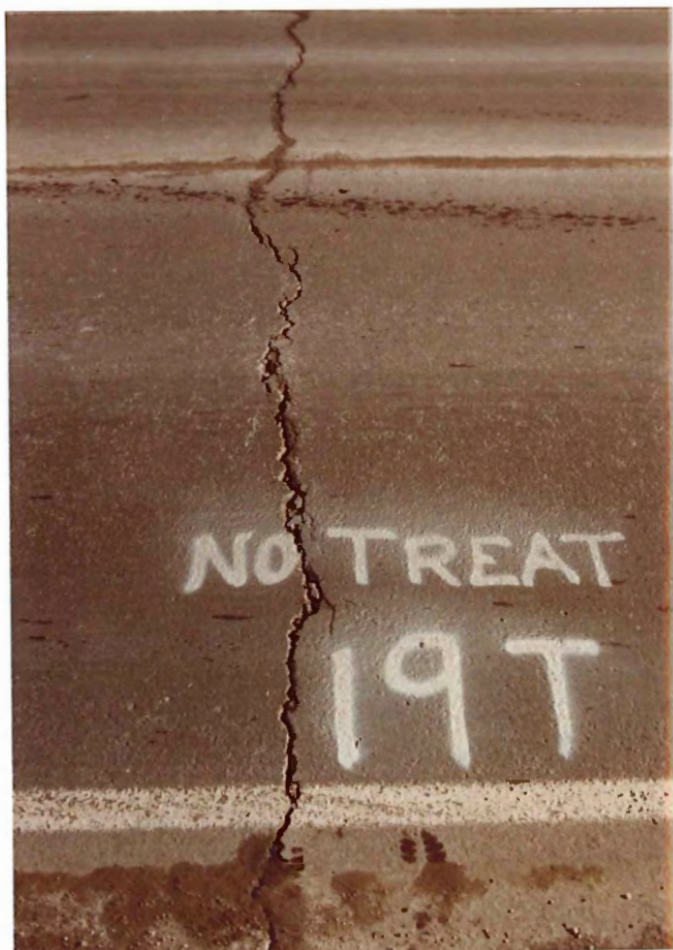
Photo #8 - Example of untreated crack - failure.
