EXPERIMENTAL USE OF
CORRUGATED POLYETHYLENE PIPE
CULVERTS AND STORM DRAINS ON ROUTE 12
MONTPELIER, VERMONT

Initial Report 85-5

Reporting on Work Plan 83-R-1

STATE OF VERMONT
AGENCY OF TRANSPORTATION
MATERIALS & RESEARCH DIVISION

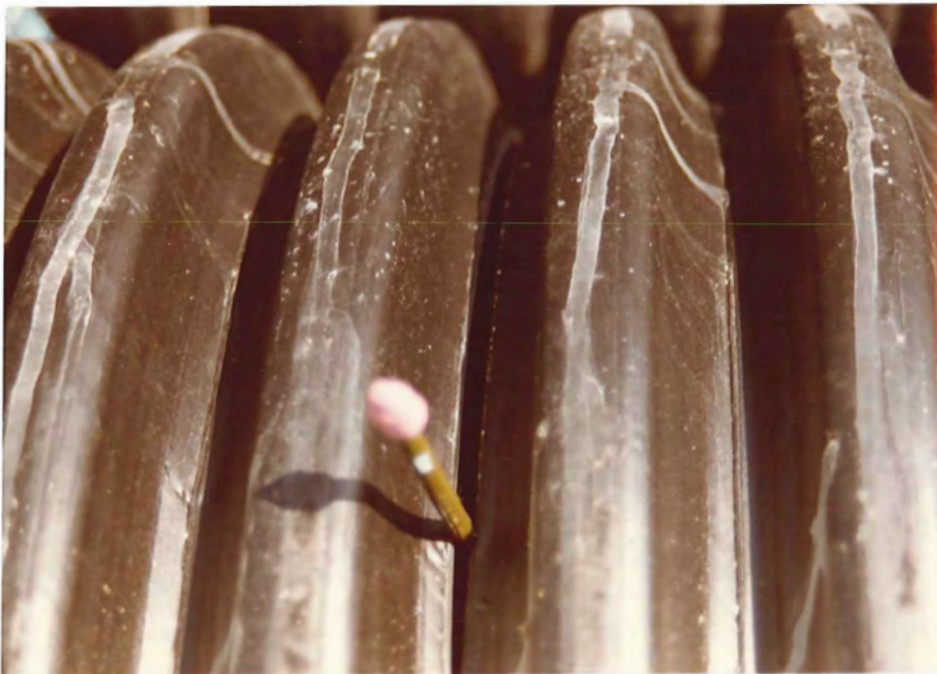
The A.D.S. pipes were delivered to a parking lot on the project for storage until needed for installation. On June 23, 1983, the Resident Engineer discovered that the 24 inch A.D.S. pipe had cracked or separated along the seams. The 18 inch and 24 inch pipes are manufactured using a spiral wrap technique with high heat bonding; the smaller sizes are molded from a seamless continuous extruded cylinder. The cracking had occurred in approximately 30% of the seams in various places and in some instances, ran almost the entire circumference. The distributor was notified of the problem and all of the 24 inch sections were replaced at no charge.

Photo #1 - 24 inch pipe with separated seam.

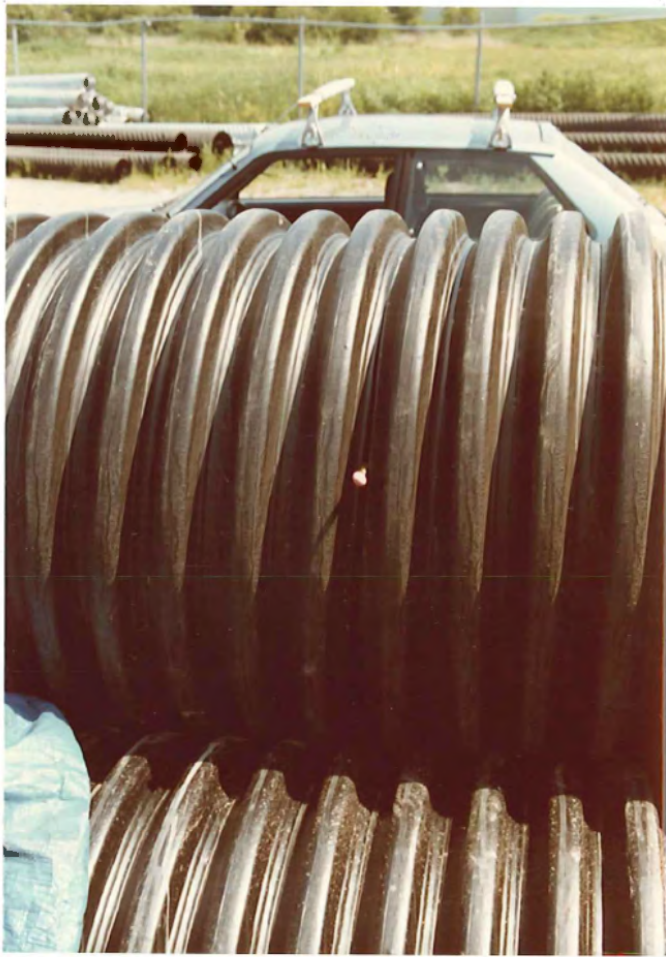
Photo #2 - 24 inch
A.D.S. pipes with cracking
along seams.

Advance Drainage Systems, Inc. was also notified of the problem and responded formally with a letter. The letter stated that the 24 inch pipe had passed all the standard tests including ASTM D2412 "Test for External Loading Properties of Plastic Pipe by Parallel-Plate Loading" and that the damage was believed due to vibration forces between interlocked segments of pipe during transportation. A copy of the letter dated July 26, 1983 can be seen in the Appendix.

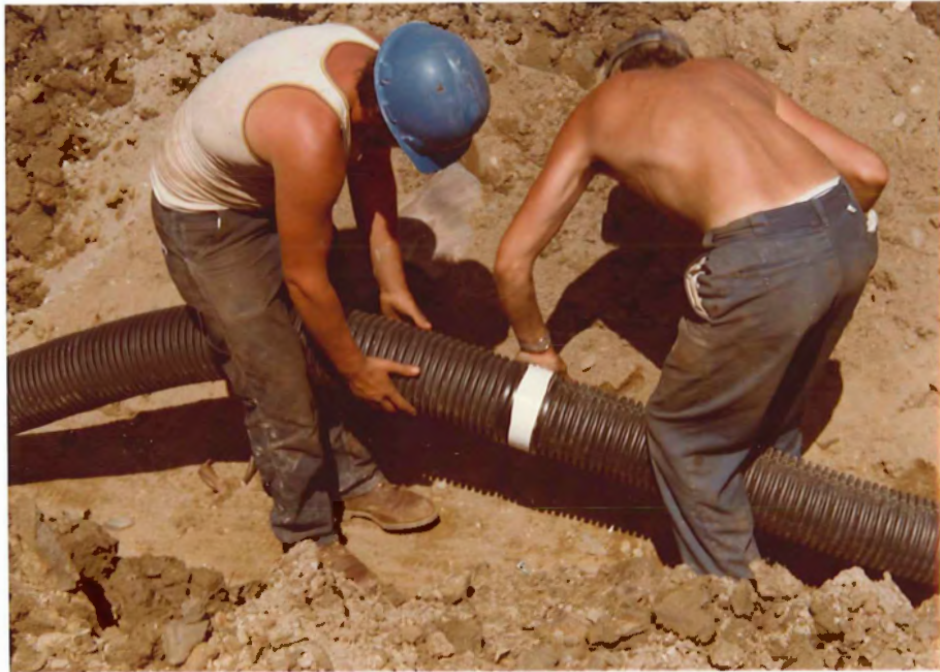
The sections of six inch pipe were connected using a five inch split coupling band. It was found that the coupling did not hold the pipe firmly in place and required a tape wrap to prevent the connection from separating during backfilling. An example is shown in the following photo:

Photo #3 - Workers applying tape to the split coupling for the six inch underdrains.

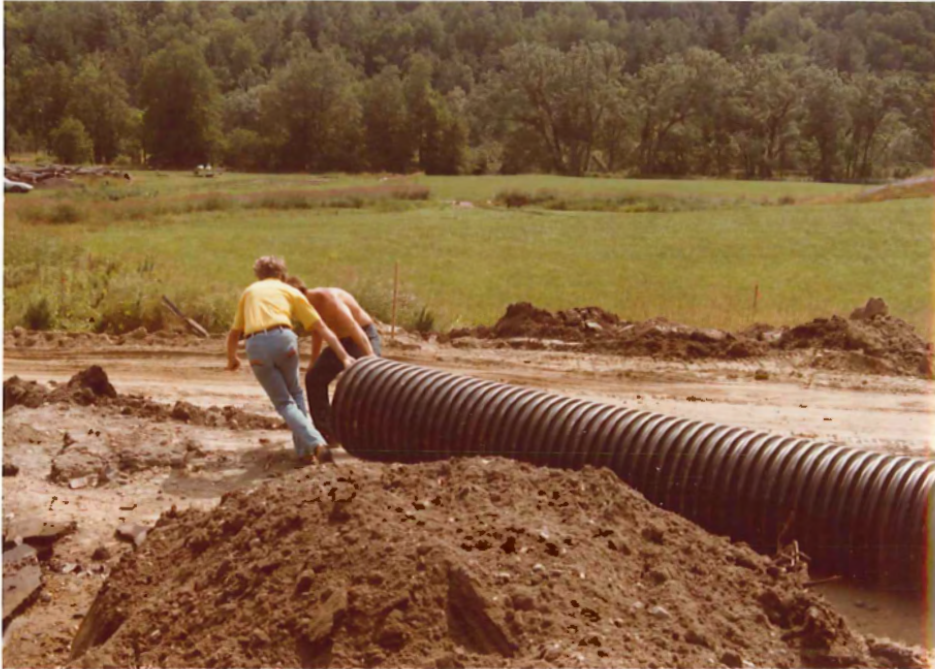
Photo #4

Moving a 20 foot section of the 24 inch pipe to the installation site.

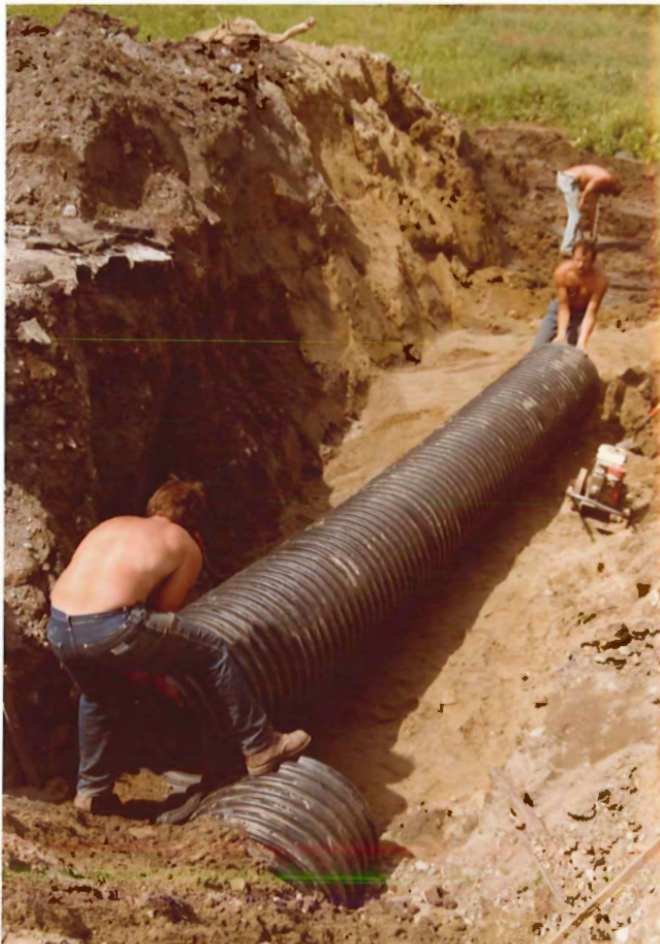
Photo #5

Lowering a 20 ft. long 24 inch pipe into a trench.

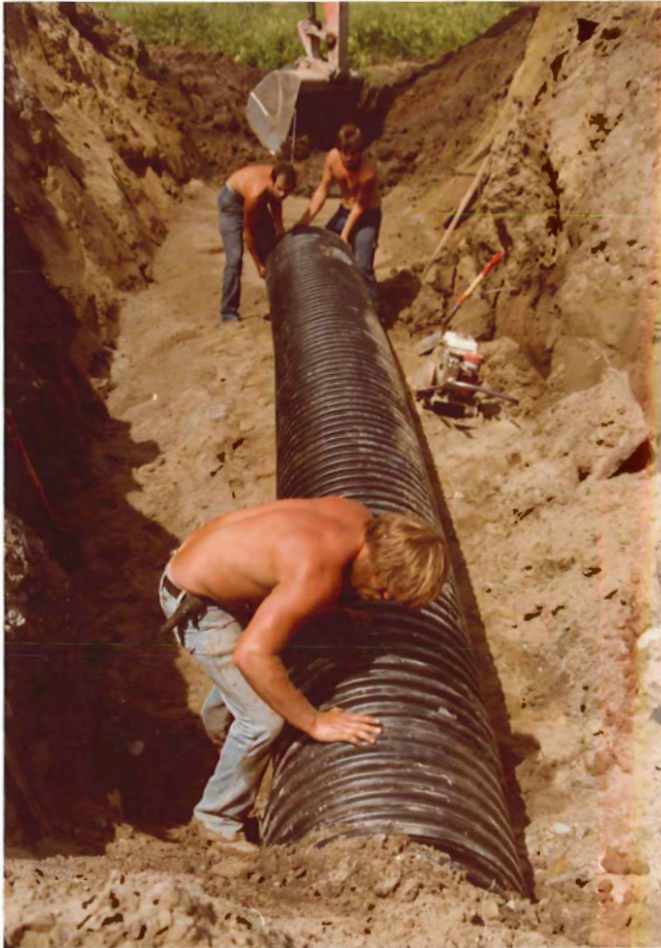
Photo #6

On July 19, 1983, the 24 inch ADS pipe was installed at MM 0339±. The lightweight of the ADS pipe enabled two men to easily maneuver a 20 foot long 24 inch diameter section into the trench. Splices were done using a two foot long spin-on coupling. The system did not work because the coupling band would not spin as designed. It was found necessary to screw the coupling onto the in-place pipe for half the

Threading the 20 foot long 24 inch pipe "into the coupling."

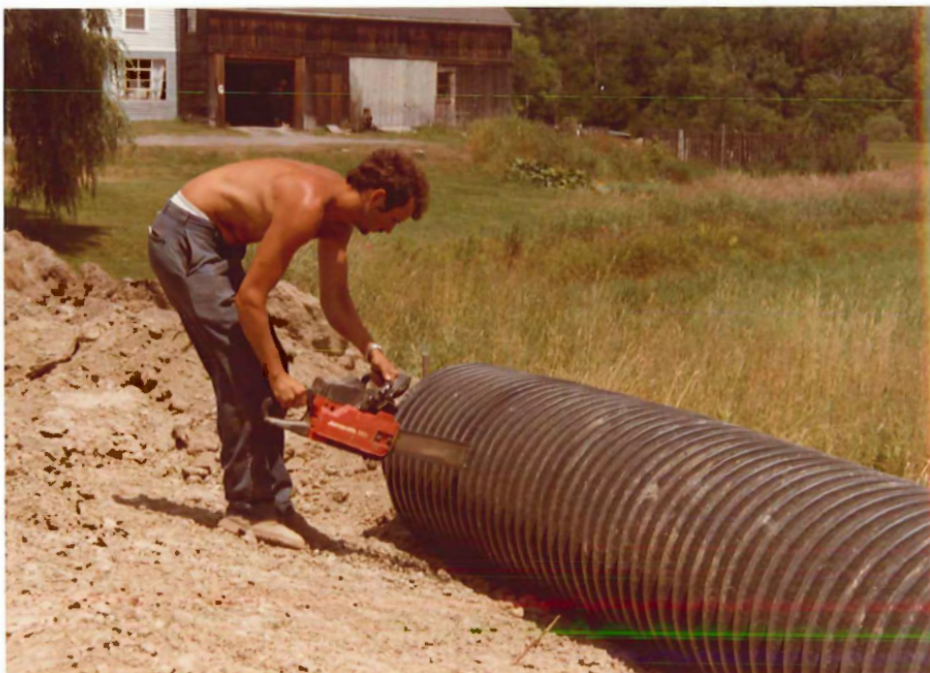
Photo #7

Cutting 24 inch ADS pipe with a chain saw.

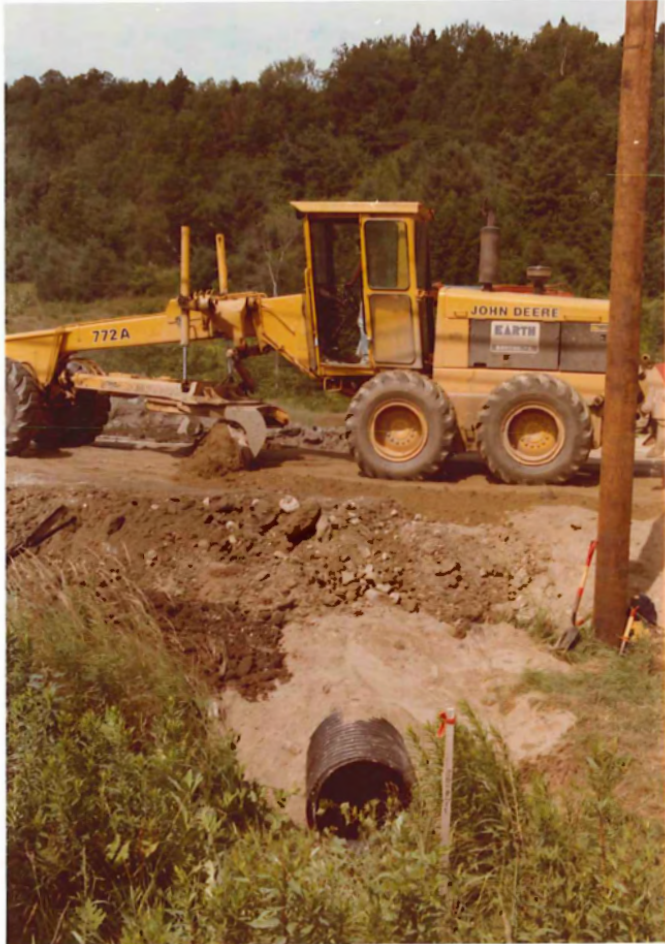
Photo #8 First load over 24 inch ADS pipe.

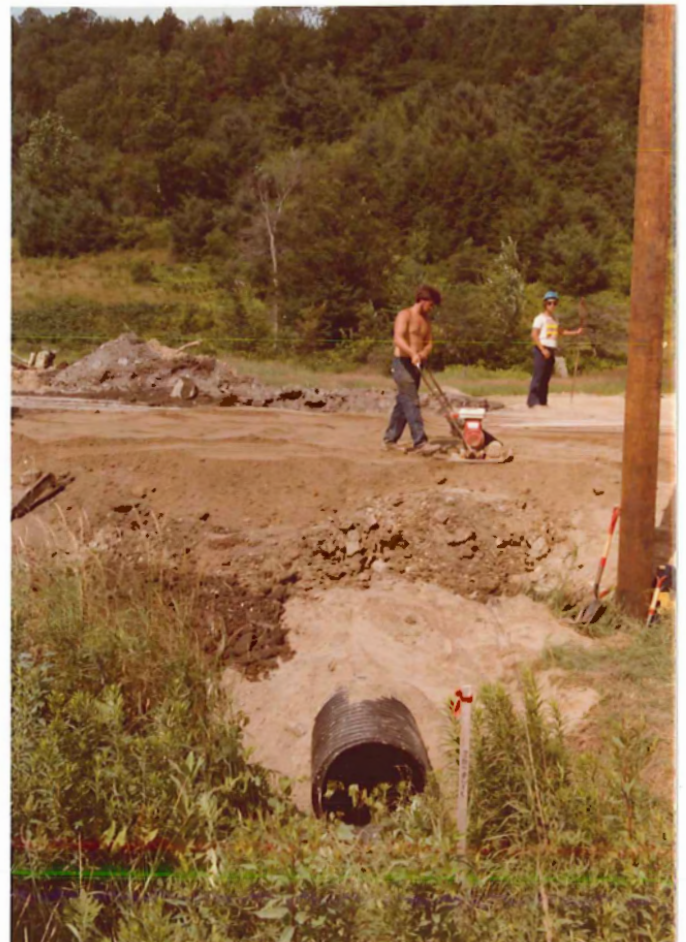
Photo #9 Using vibratory compactor over 24 inch ADS pipe.
