EXPERIMENTAL USE OF  
RAISED PAVEMENT MARKERS  
ON I-89  
WATERBURY, VERMONT

INITIAL REPORT 85-11

Reporting On Work Plan 82-R-13 & 82-R-15

STATE OF VERMONT  
AGENCY OF TRANSPORTATION  
MATERIALS & RESEARCH DIVISION

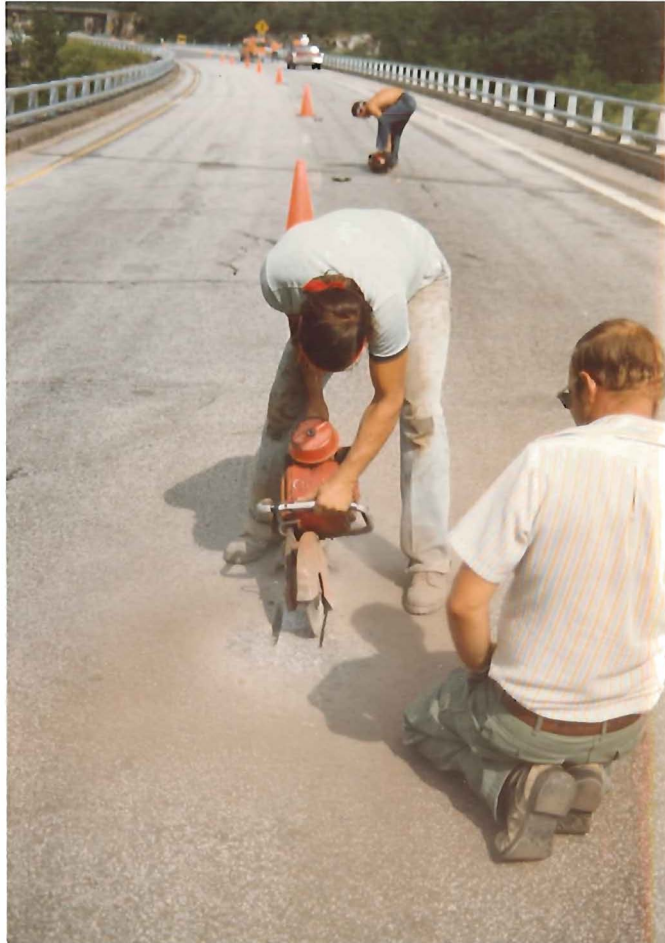
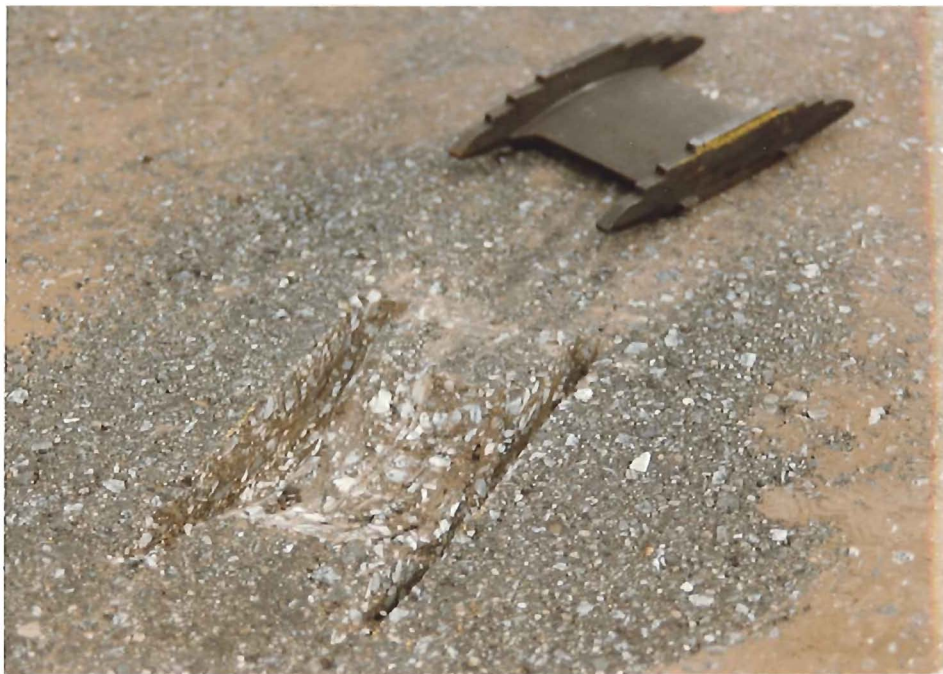
The proper depth saw cut was difficult to obtain, due to lack of previous experience. In many instances, cuts would be made, saw removed, marker tried in cut, only to discover that additional sawing was required. Often the holes for marker legs would be too long and the hole too deep. Photos showing the sawing operation and the hole prior to filling with epoxy can be seen on the following page.

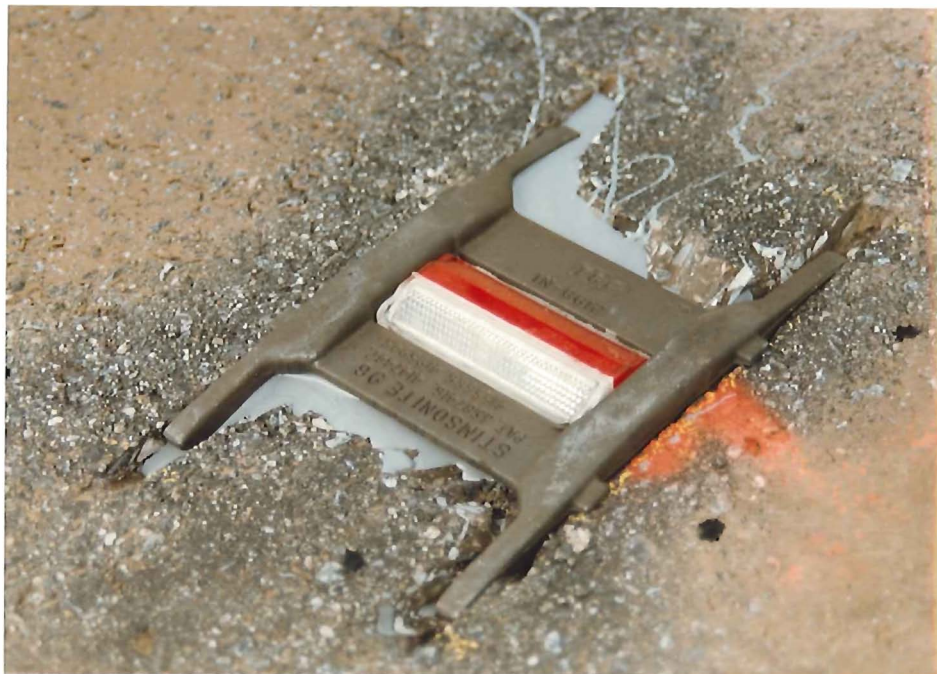
After sawing was completed, the holes were cleaned using compressed air. Initially the two part epoxy was mixed using one gallon of each part which presented a problem. Within eight minutes, the mixture reached its critical point, became too hot and began to set up. A second smaller batch was mixed using one quart measurements which allowed for most of the epoxy to be used before it set up. Overall, the epoxy proved difficult to work with because of the grade and superelevation of I-89 in this area. A small amount of epoxy was poured into the hole prior to installation of the marker. When the marker was pressed into the hole, the epoxy would flow to the low side, as shown in the photograph below:

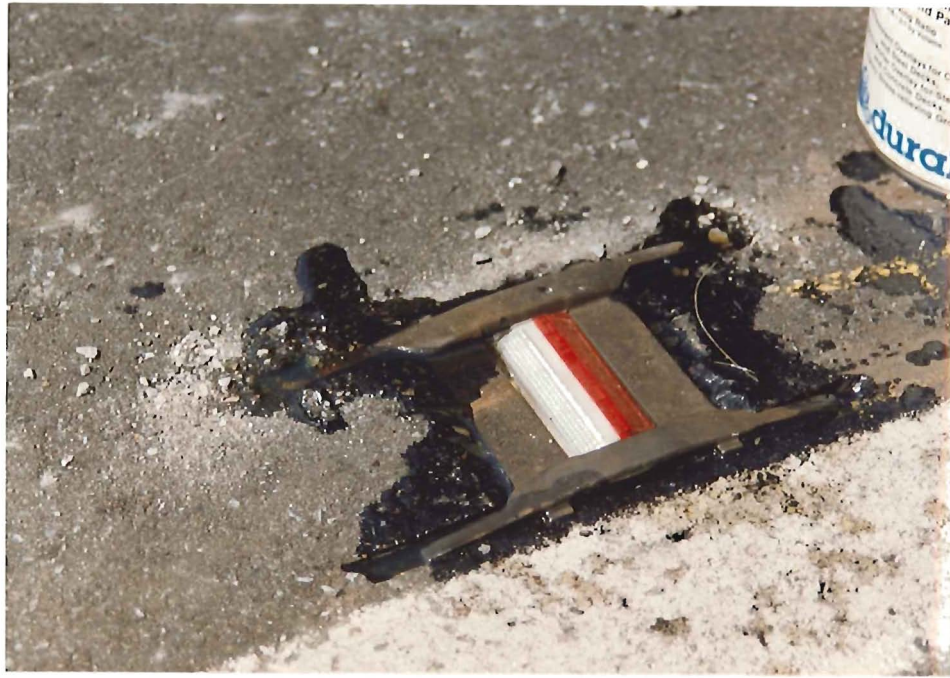
An attempt to remedy the problem by adding epoxy to the high side often caused it to run out onto the pavement. This problem was encountered on many of the markers as shown in the photograph on the following page.

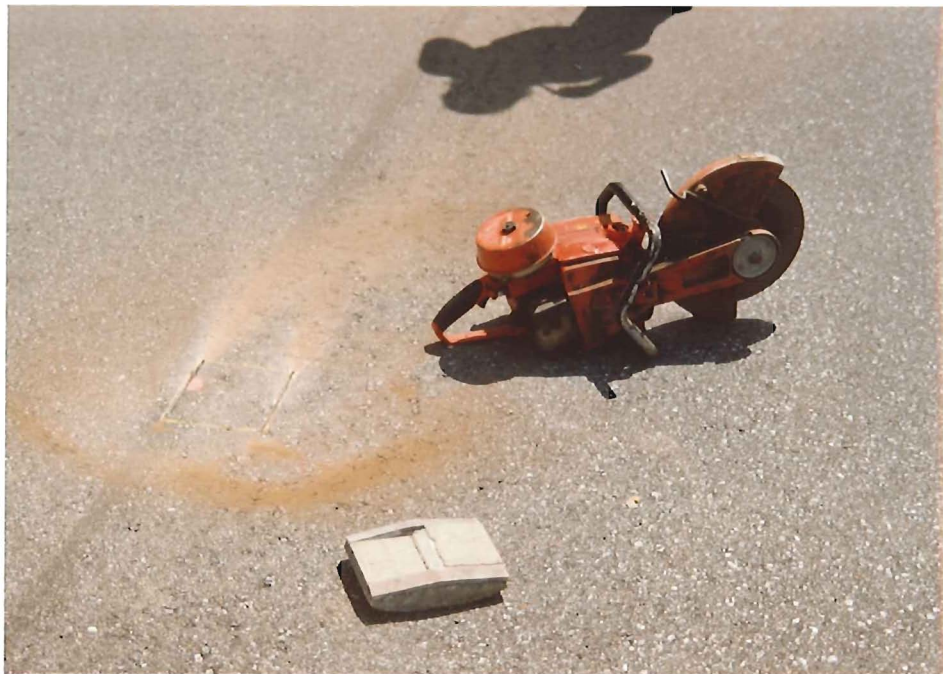
On August 9, 1983, workers began the installation of Durastone raised pavement markers on the centerline of the southbound lanes of I-89 in Waterbury. All holes were cut using a hand-held concrete saw. Two cuts were made along each side and a jack hammer fitted with a spade type blade was used to remove the pavement. The following photograph shows an example of the sawing operation.

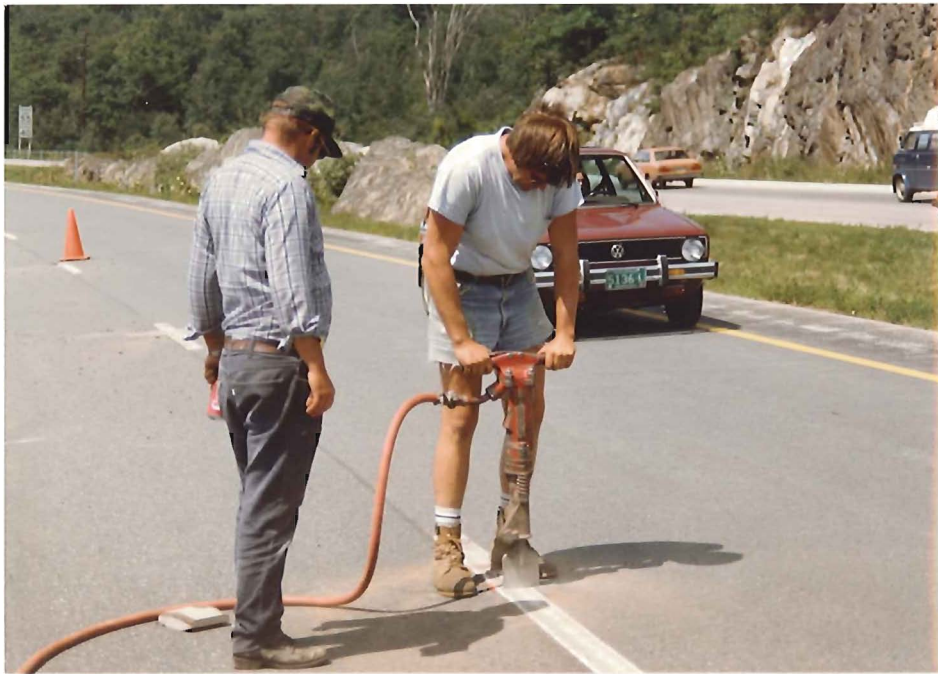
The photograph below shows the removal of pavement using the jack hammer after the two saw cuts are made.

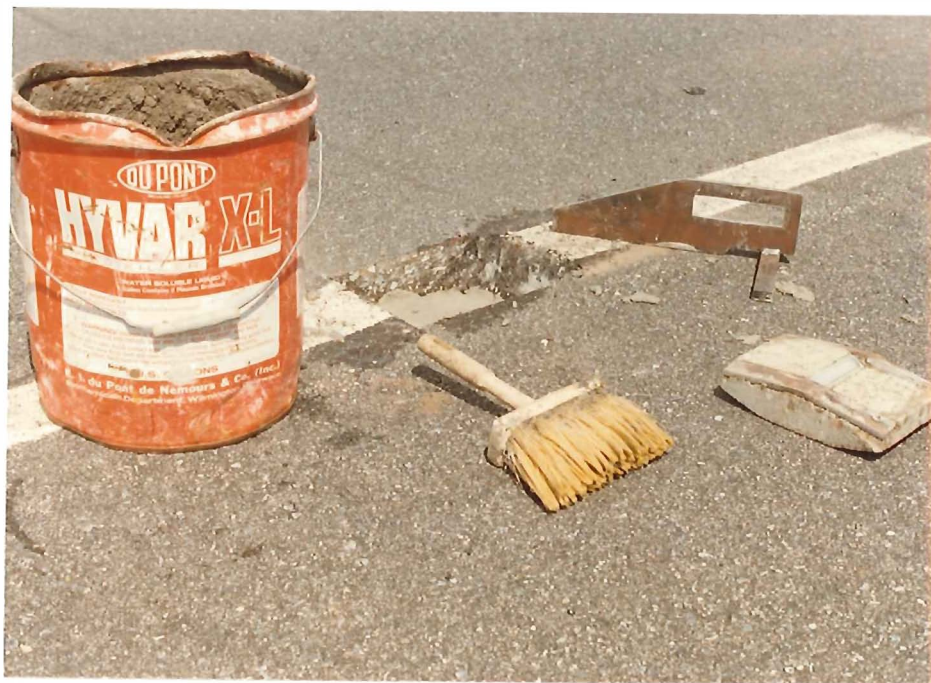
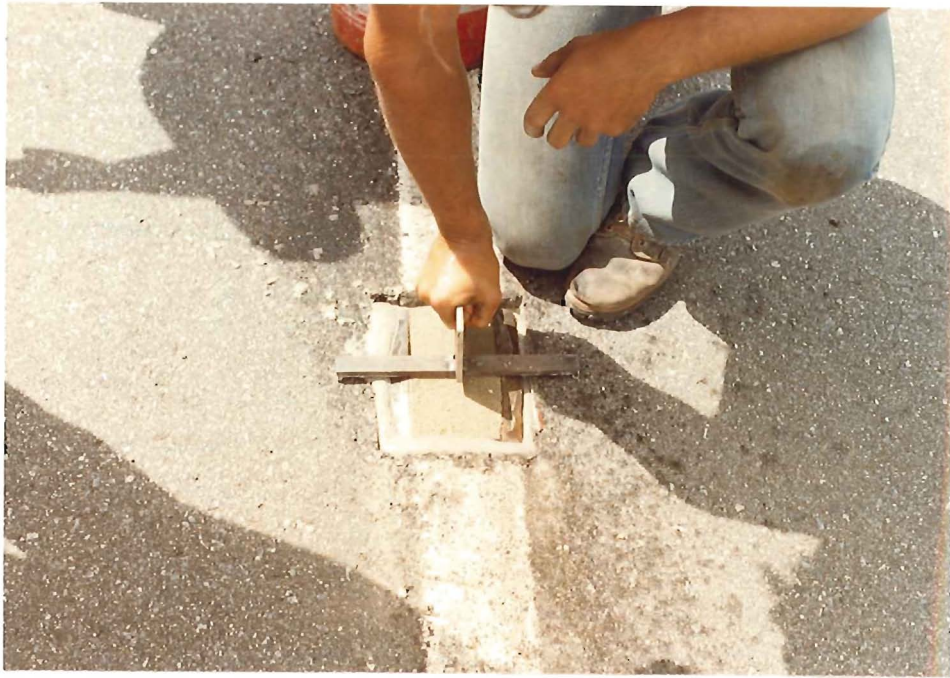
The hole was blown clean with compressed air and then moistened using a pail of water and a six inch brush. SET-45 patching material was used to hold the markers in place. A small amount of material was placed into the hole and the marker was dipped into the bucket of water then placed in the hole and pressed into place using a template. The template was provided by the manufacturer. The following photographs show examples of installation procedures.

When the marker was pressed into the pavement with the template or leveling tool, the patching material would flow up around the sides of the marker. The excess patching material was then smoothed out or removed using a trowel. Caution was needed to mix the SET-45 properly in order to avoid a mix which was too wet, causing the marker to sink below the pavement surface.

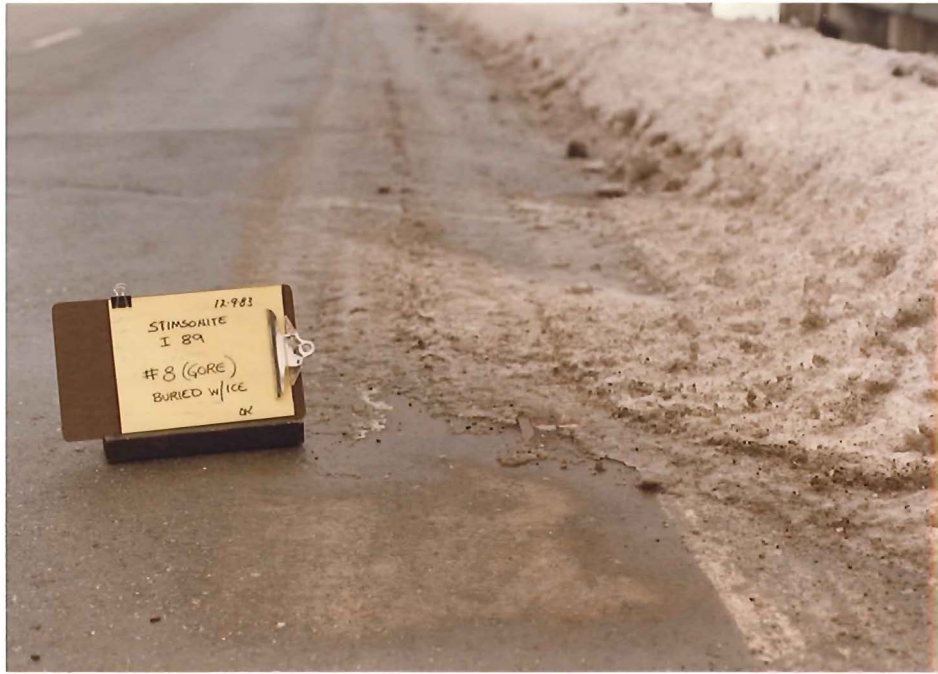
The high profile above pavement surface of the Stimsonite markers also caused problems with the plowing operations. Snowplow drivers commented that it was an inconvenience to plow over the markers and it was necessary to slow down to 15 mph when plowing the area. The carbide tip of the plow blade was damaged after 34 hours of use when normally 140 hours time of plowing is expected. Even plowing at 15 mph, half the normal speed, the plow blade would still jump and in some cases leave a windrow of snow behind the marker. This problem was more prevalent in the gore area as shown in the photograph on the following page.
