EVALUATION OF THERMOPLASTIC
PAVEMENT MARKINGS ON
VERMONT ROUTES 15 & 100

INITIAL REPORT 87-5

MARCH 1987

REPORTING ON WORK PLAN 83-R-29

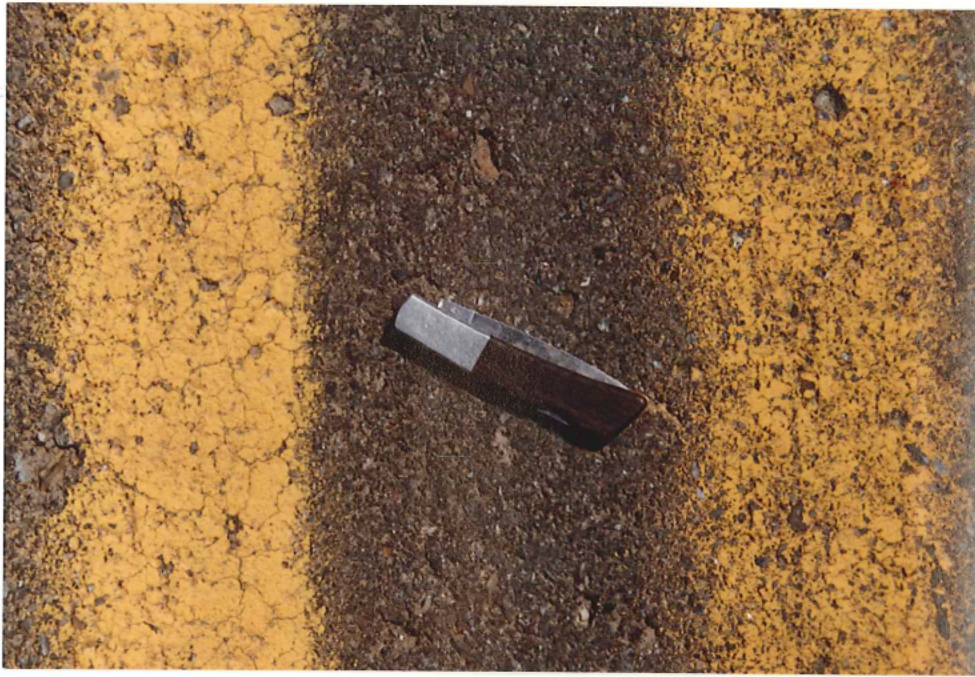
Condition of ten month old traffic paint at test area #1 on Route 15. Paint loss estimated at 5 percent on the left and 20 percent on the right.

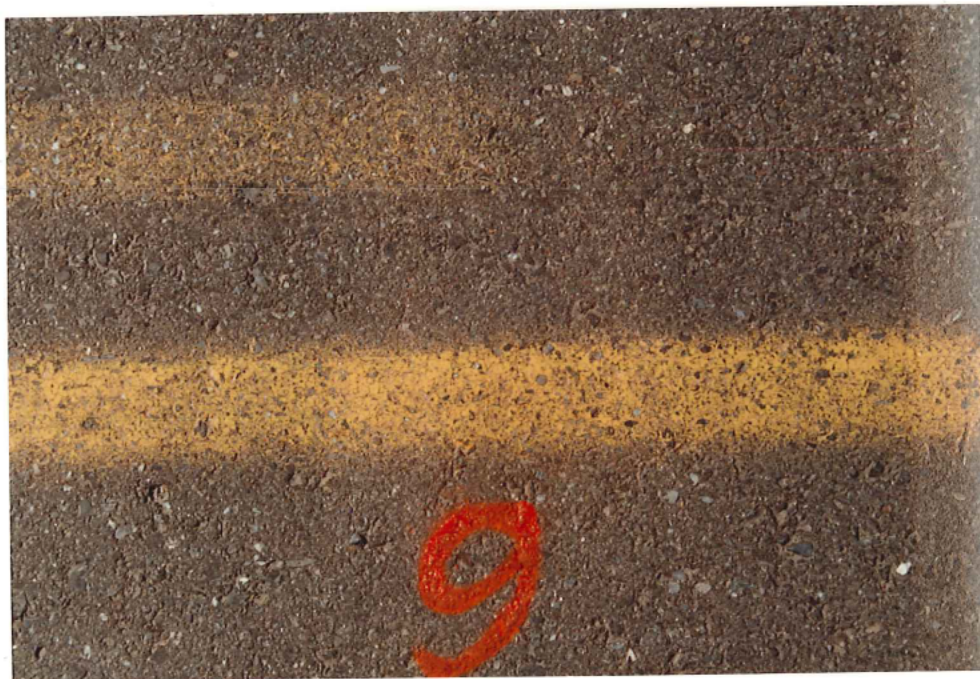
Condition of ten month old traffic paint at test area #9 on Route 15. Paint loss estimated at 85 percent on the top line and 25 percent on the bottom.

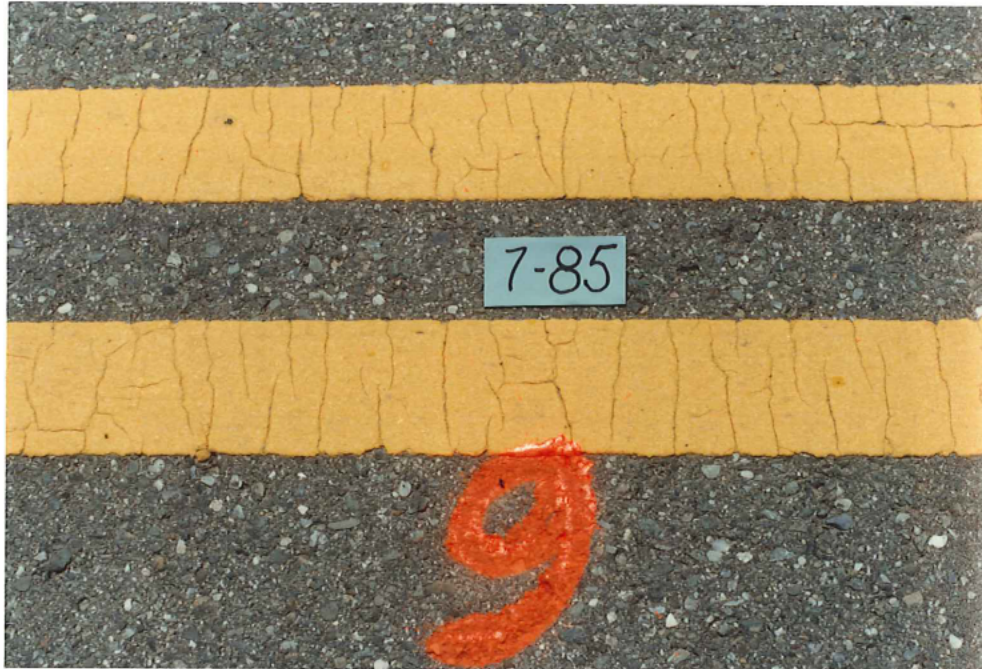
Cracks In The Thermoplastic - Occasional fine transverse cracks were noted in the material at the five month inspection.

The number of cracks increased soon after and were joined on occasion by random or longitudinal cracks. As the length of exposure increased there was some erosion of the material at the top interfaces of the cracks but loss of line due to the cracks has been limited to occasional small chips missing along the edges at the intersection of cracks.

Note cracks in thermoplastic lines @ 23 months of service

Cracks which developed in the material did not affect overall performance.

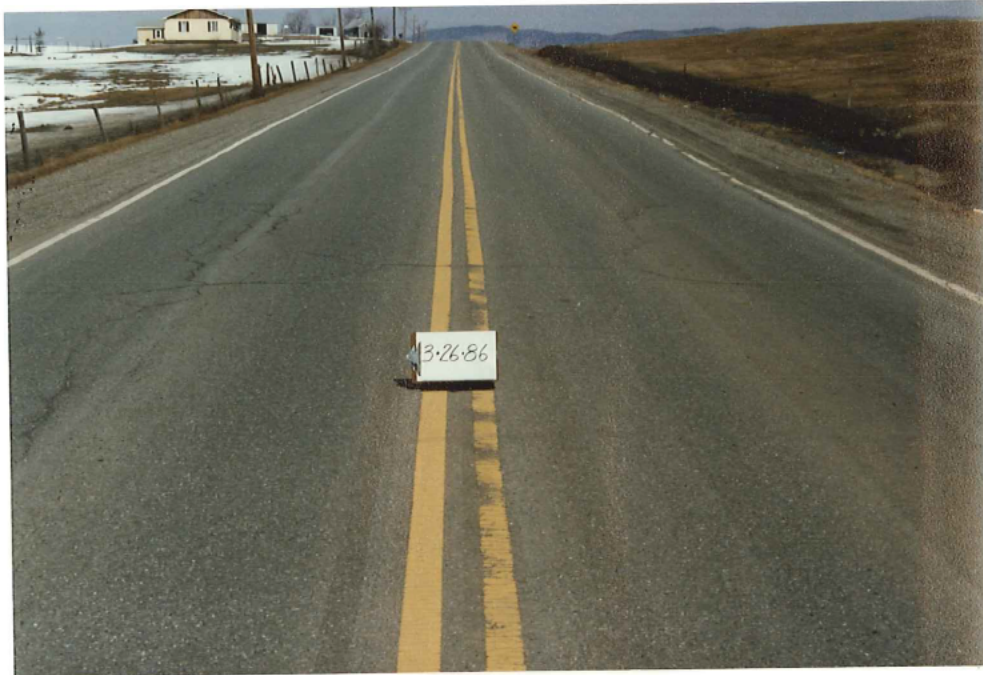
averaged only two percent. A very small part of the loss appeared due to snowplows shaving the line where the pavement surface was uneven. At 31 months, wear loss had increased to 15 percent on the remainder of the easterly side of the double line on Route 100. The loss at 40 months was estimated at 20 percent with about 3 percent loss on the westerly line.

Wear loss estimated @ 15% on easterly side, Route 100 @ 31 months

The reason for the significant difference in performance between the two parallel lines on Route 100 is not known. It is suspected that some increase in wear may be due to the fact that northbound vehicles are climbing upgrade along the easterly line and the traffic is crowding the centerline due to the narrow unpaved shoulders with severe tire abrasion the end result. Overall, wear loss was much greater on Route 100 than on Route 15 even though traffic volumes are three times as great on Route 15. The wide paved shoulders on Route 15 are credited with extending the life of the markings due to less encroachment of traffic on the centerline.

WEAR: Estimate 15 % loss of the east side of the double line on
Rte 100.

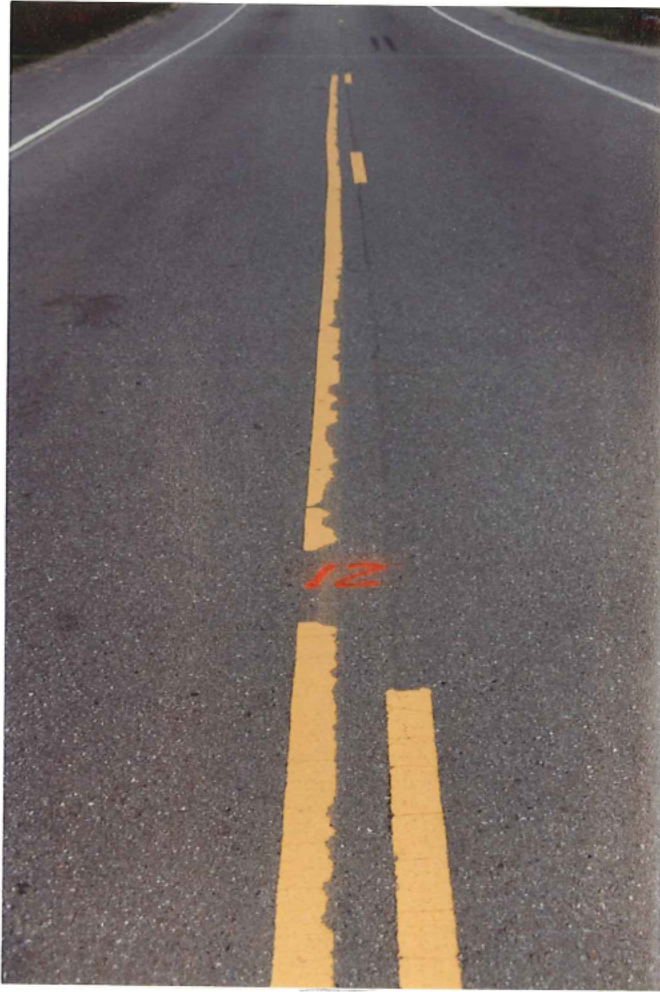
Loss Of Line - The loss of line other than that caused by traffic wear was the result of snowplow damage or lack of bond to the pavement. Initially, the loss was limited to an inch or so of the leading edge of 10 foot strips. Within 16 months, one third of the stripes had lost an average of six inches of line. The loss of line due to snow plow damage was confined almost exclusively to Route 15. The difference may be due to the type of snowplow blades used on the two routes. District 8 which maintains the Route 100 portion of the project uses carbide blades backed by a 3/4 inch thick steel blade. District 6 which maintains the Route 15 portion uses steel blades only.

Through the 40 month period the majority of the loss occurred on a quarter mile portion of the 2.1 mile Route 15 project between MM 0010 and 0035. Within that area, the loss included edge scalloping and gradual complete loss of skip lines. The loss cannot be related to any specific item such as pavement condition or the amount of traffic paint present prior to application. A large number of pits or craters were noted in the thermoplastic in the area where losses occurred. They may suggest that moisture was present in the pavement at the time of application or that the material temperature was outside the normal range.

Bond loss/edge scalloping @ MM0030± on Route 15
Photo taken on 7/19/84 after 11 months of exposure

COMMENTS: Weak bond noted between thermoplastic and pavement where edge scalloping has occurred at MM 0040 ±. Able to lift material with fingernail.
The centerline needs repainting off the ends of the project.

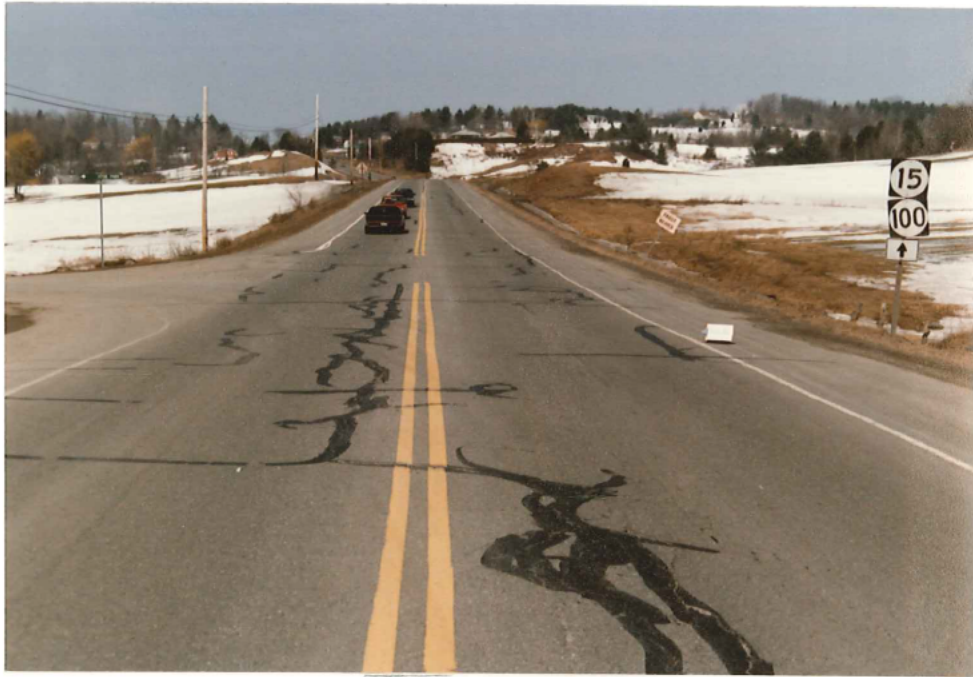
Thermoplastic lines on Route 15 after 31 months of service
