EXPERIMENTAL USE
HEADLIGHT GLARE SCREEN
IN WATERBURY & BOLTON, VERMONT

FINAL REPORT 88 - 1

REPORTING ON WORK PLAN 82-R-17

STATE OF VERMONT
AGENCY OF TRANSPORTATION
MATERIALS & RESEARCH DIVISION

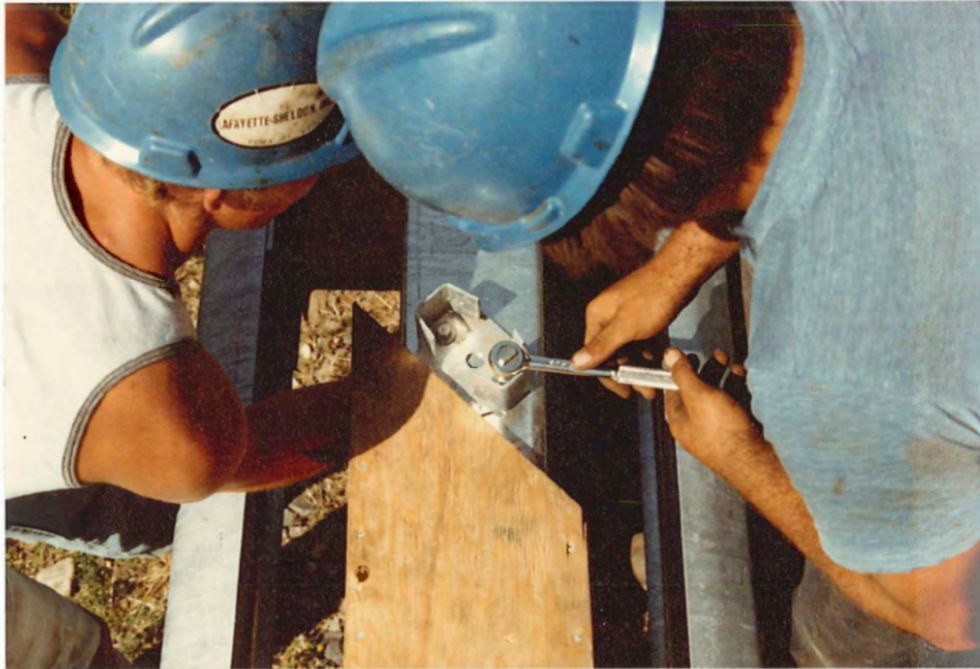
Installing Glarefoil Brackets

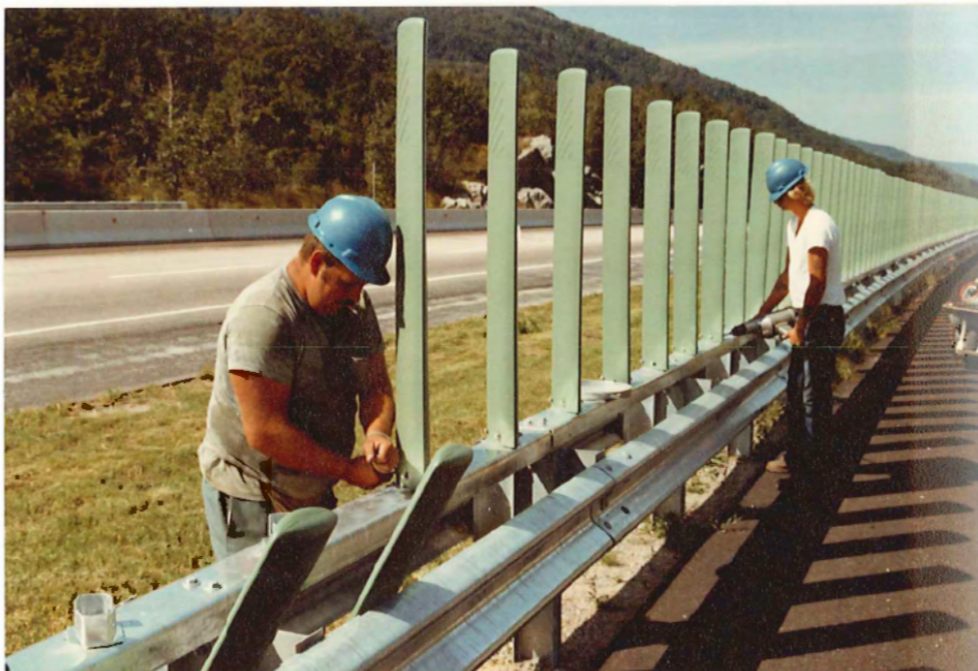
Installing Glarefoils

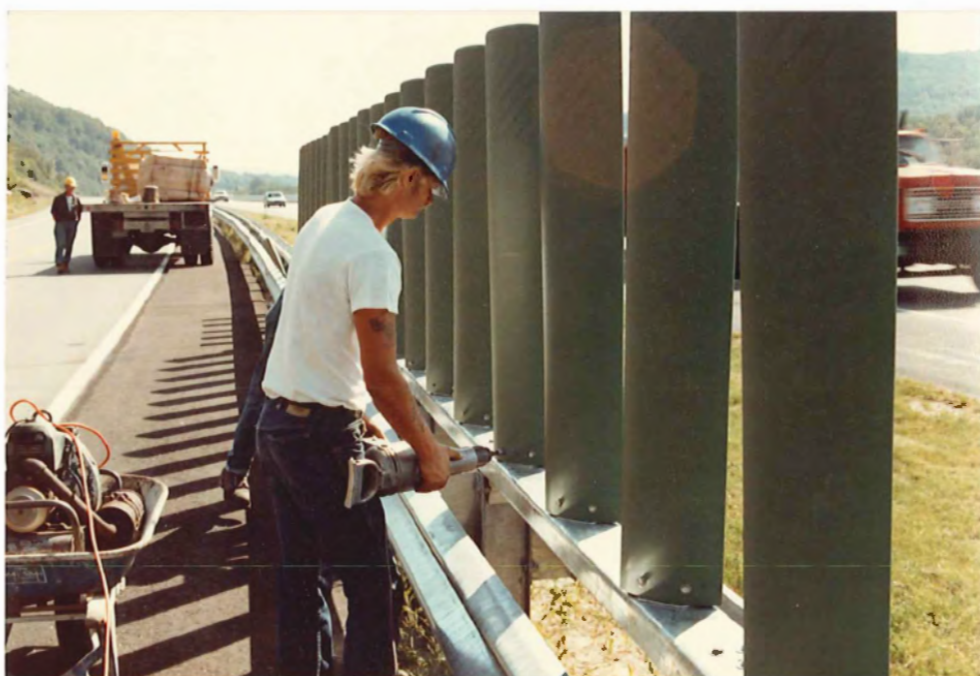
The last step was the installation of the glare screen blades. The first blades installed were four feet in length. Each blade has four connector bolts at the base which are fastened to the base plate bracket. The photograph below shows a worker using a large industrial size drill to tighten the bolts. As a result, many bolts were over tightened causing deformation and weakening of the plastic blade material. In some cases the bolts were believed to have been stripped and this condition became more apparent over time.

The workers commented that "it was difficult to tell when the bolt was sufficiently tightened". The condition was most likely due to the oversize drill used for the job.

Perhaps torque requirements, or use of lock washers should be specified to avoid problems as discussed earlier in this report. Careful monitoring of bolt installation is highly recommended for future installations.

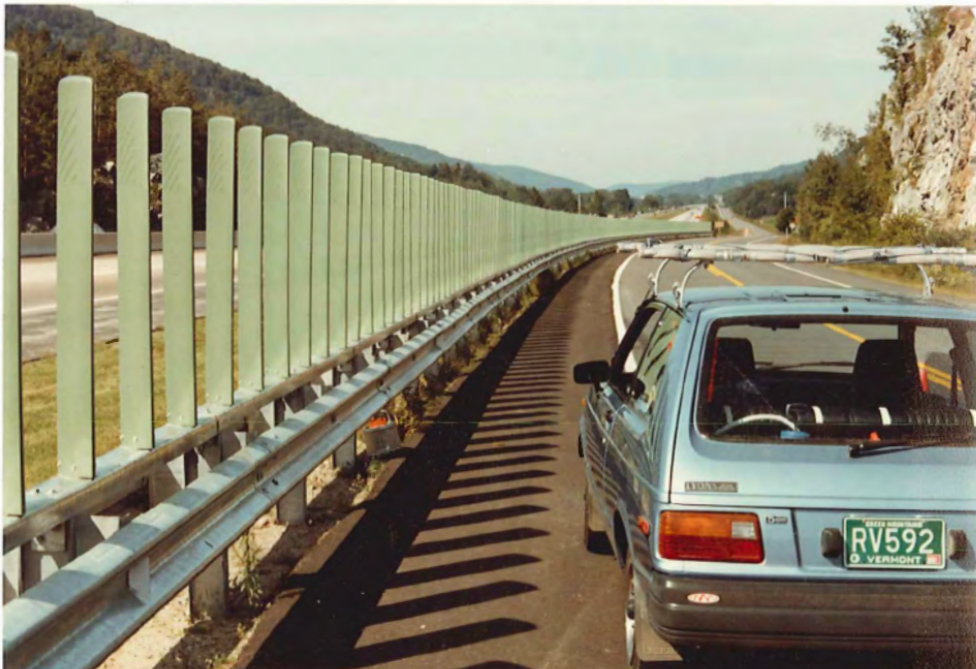
It was noted that the predrilled holes in the blades and base plate bracket did not align perfectly. Therefore workers found it necessary to use extra force by either pulling or pushing the blade itself or using a hammer to bend the base plate bracket. This condition was apparently due to poor quality control during manufacturing. Such factors resulted in imperfections in vertical alignment which decreased the quality of the glare screens appearance in general.

The view from Route 2 looking north westerly.

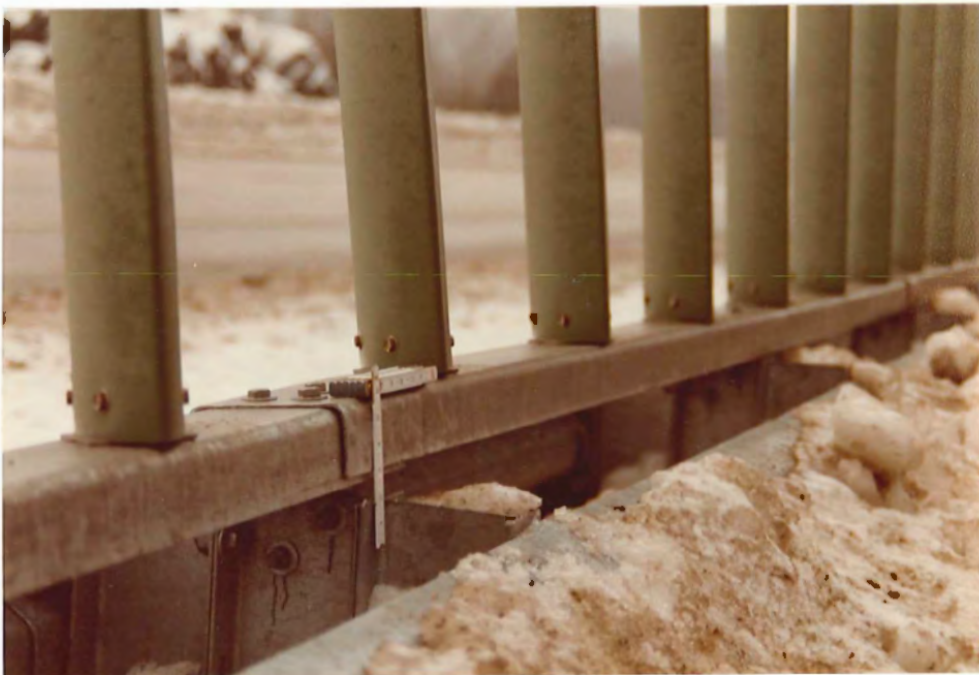
Of particular concern were the mounting plate connector brackets and bolts which serve as the structural connection of the glare screen system to the guard rail. Apparently bolts were not originally torqued tight enough causing the mounting plate to lift up and lean away from plowing operations on U. S. Route 2.

Tilted mounting plate bracket.

This condition was present on approximately 30 -40% of the mounting plate sections suggesting that snow loading from plowing operations pushed on the blades and caused an upward force on the bracket, which enabled the bolts and/or mounting plate brackets to slip. Once this condition occurred all of the blades on the plate would lean off their vertical axis causing increased stress on the mounting brackets used to fasten each individual blade. In some cases this stress bent the mounting bracket and the blade leaned even farther from the vertical axis.

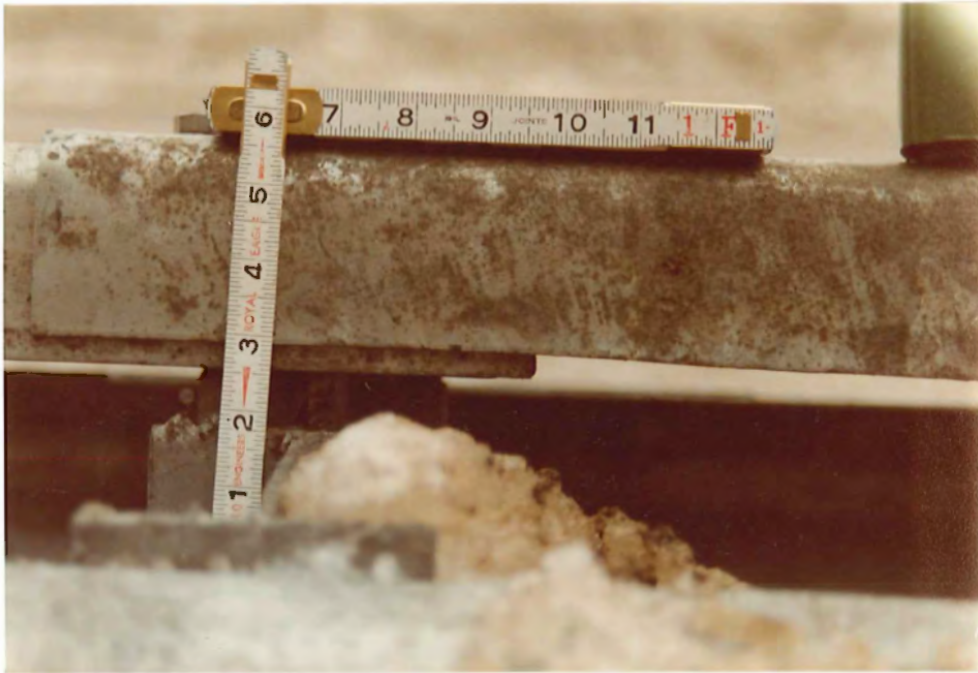
Tilted mounting plate bracket.

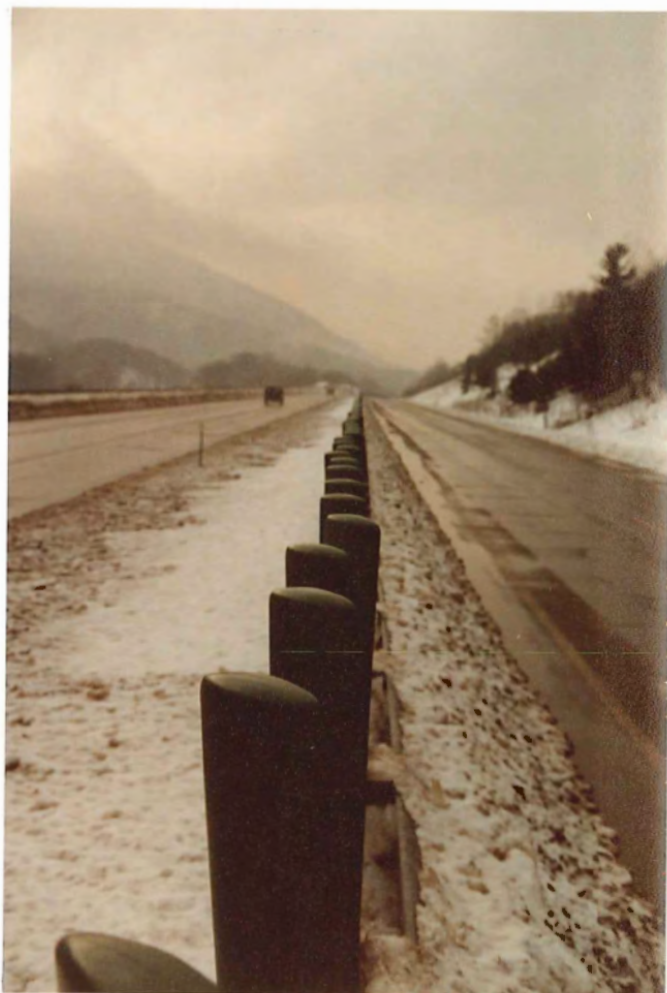
The photograph below shows the variation in the vertical alignment of the four foot blades.

Blade lengths should be limited to three feet where impact from plowed snow is anticipated.

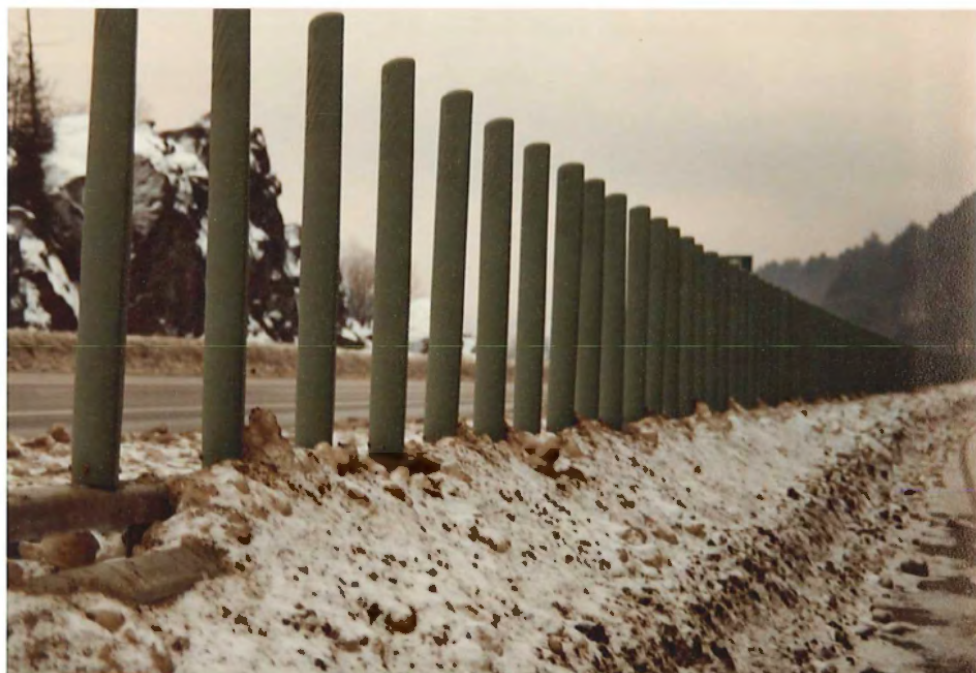
With the new location of guardrail closer to U. S. Route 2, plow drivers commented on the increased difficulty of snow removal. The combination of a narrow four foot shoulder and the glare screen acting as a wall left little room for dispersion of the plowed snow. As mentioned earlier in this report, plowing speeds were slowed by as much as 20 miles per hour further emphasizing the problem. As snow accumulations increased there was less space available for stockpiling as can be seen in the photograph below.

Future installations should be designed to allow for wider shoulders and medians to accommodate snow plowing operations. The base plates used to connect the blade to the mounting plate should also be modified as follows:

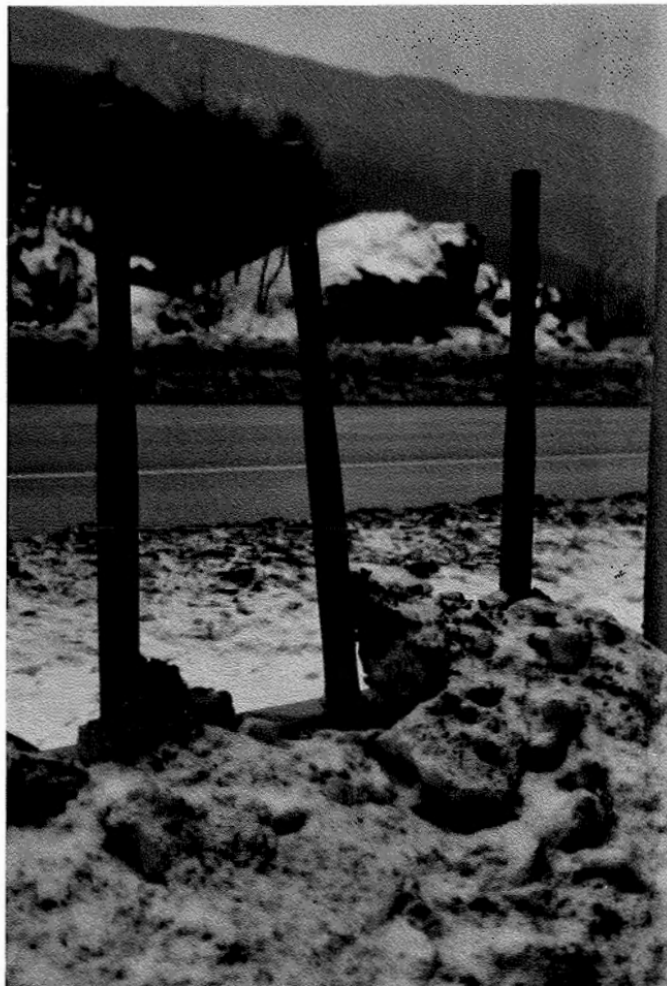
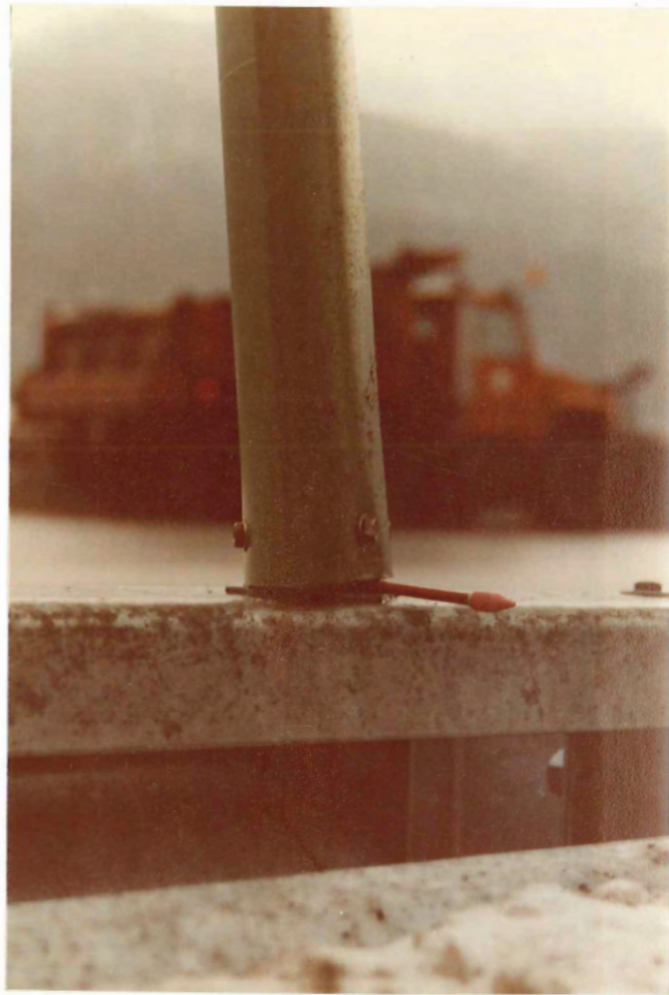
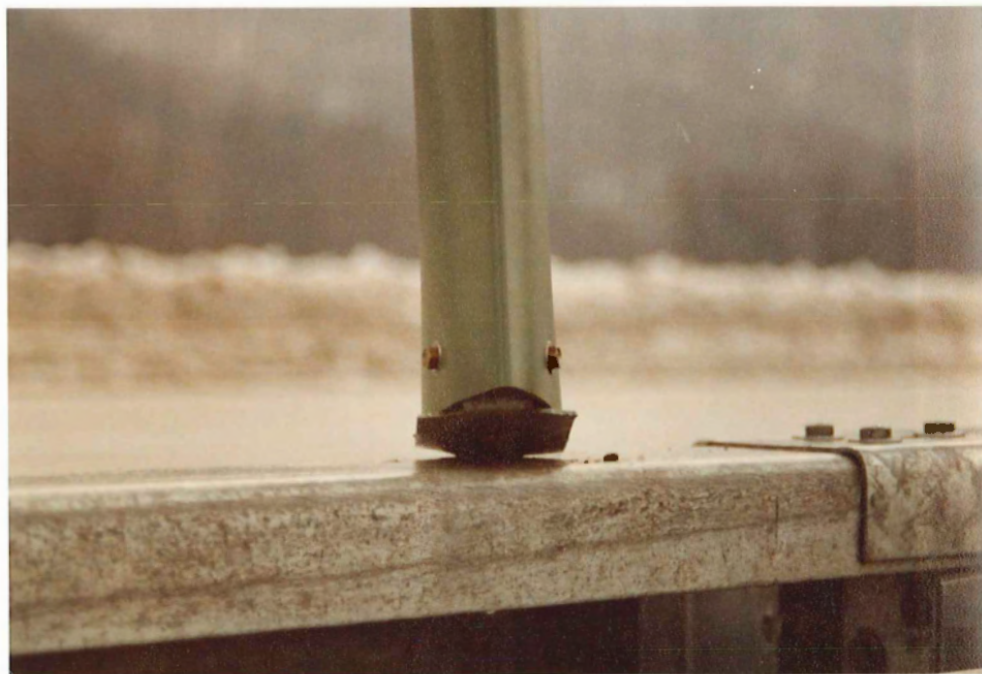
Eventually the plowed snow was piled high enough that the only place for the snow to go was over the top of the pile and/or through the glare screen. District forces had to revise their plowing techniques to accomodate this problem. The District 5 maintenance crew used a grader and front-end loader to remove the excess snow and place it on the opposite side of U. S. 2. District 6 workers plowed snow from the eastbound lane while plowing the westbound lane. This procedure was done with caution due to the possibility of encounter with eastbound vehicles. This procedure was therefore limited to periods of low traffic during the day and at night. In some cases large frozen chunks of ice and snow would be pushed up against the blades, again putting severe stress on the base plate bracket, occasionally shearing it. This condition and its effects can be seen in the following photographs.

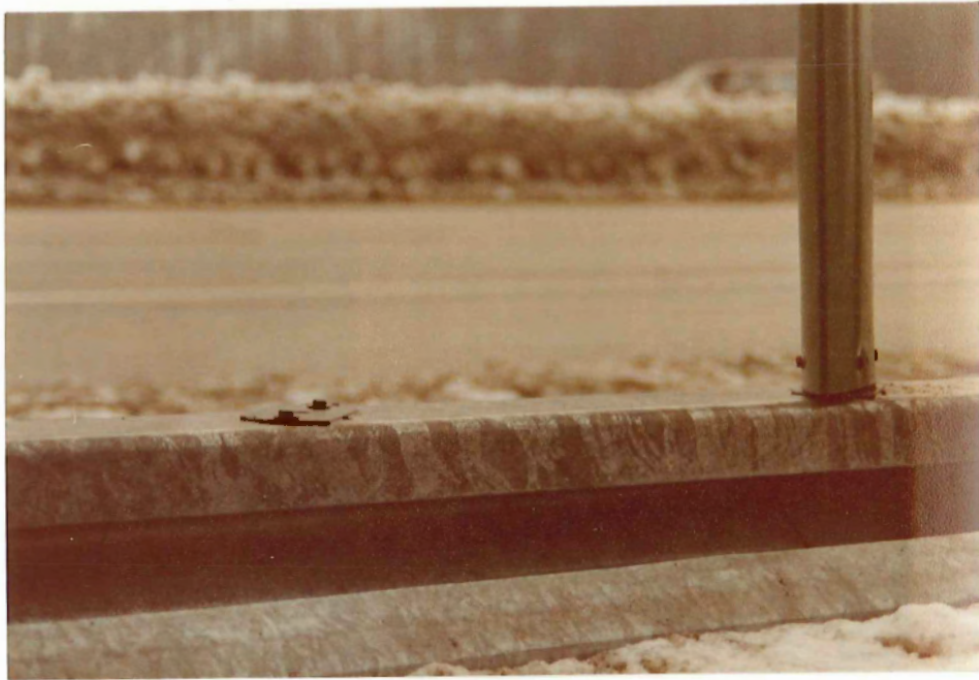
Vertical portion of bracket broken off

- 1) Increase the height of the bracket
- 2) Add more bolts to fasten the bracket down
- 3) Strengthen materials used
- 4) Use larger washers on the bolts which connect the blade to the bracket

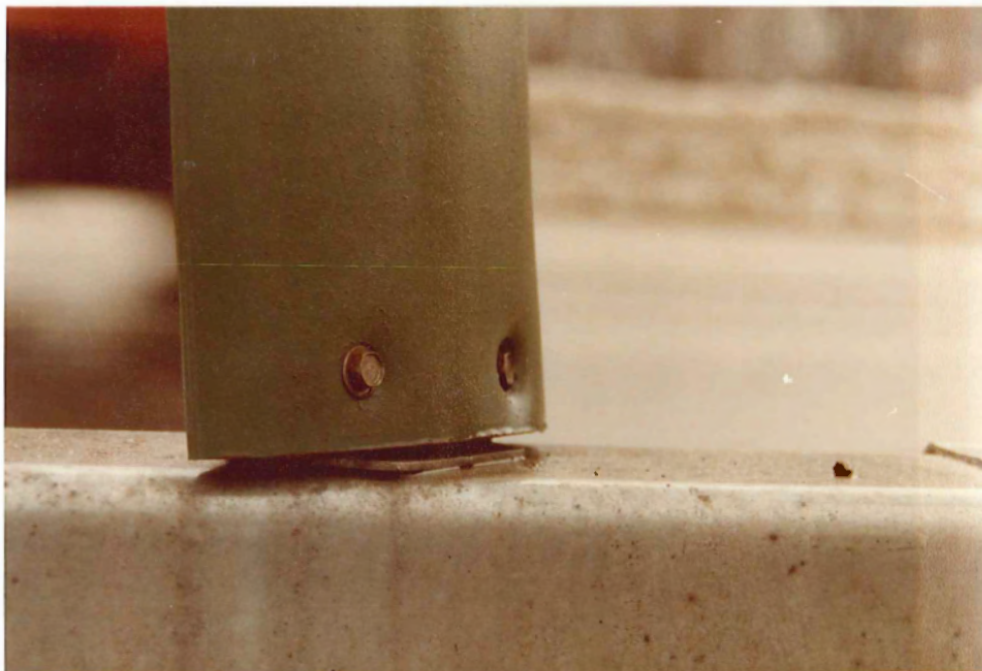
Note how bolt was overtightened on Glarefoil

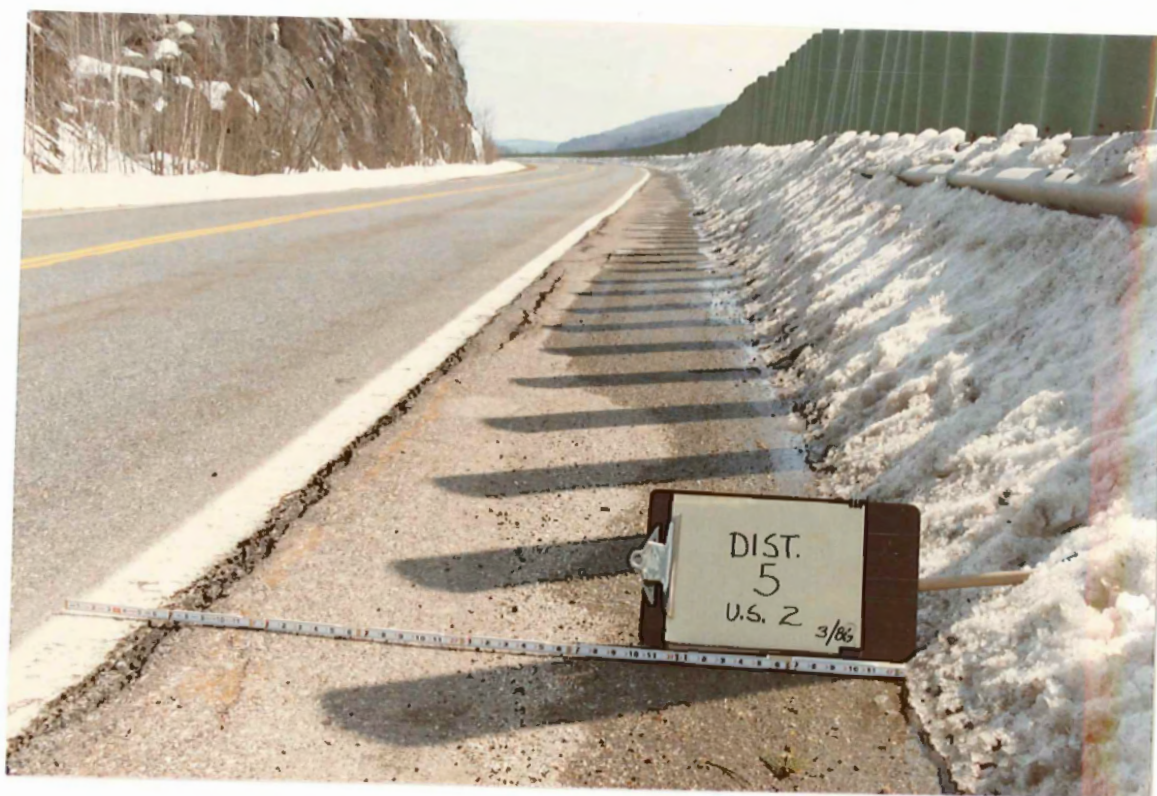
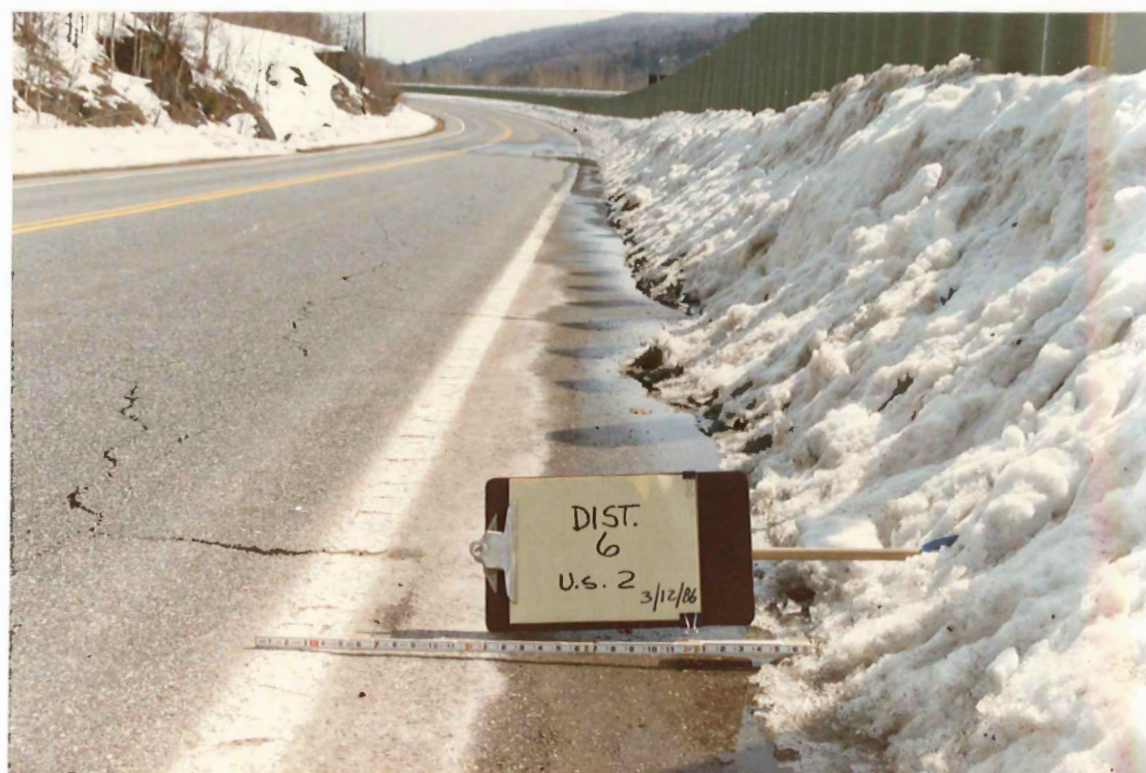
Follow up surveys after the second winter of exposure (1985-1986) have shown that these conditions have continued to be a problem but only in the District 5 area in the Town of Bolton. The plowing operators of District 5 are running the plows closer to the guard rail than in District 6. A total of 18 blades were found to be missing or knocked down in the District 5 section. The following photographs show the difference in the plowing operations. This difference is clearly shown by location of plowed snow and its distance from the shoulder line.
