FIELD COMPARISON OF
INFRARED THERMOGRAPHY AND
MANUAL SURVEY RESULTS

Report 88-3
September, 1988

STATE OF VERMONT
AGENCY OF TRANSPORTATION
MATERIALS & RESEARCH DIVISION

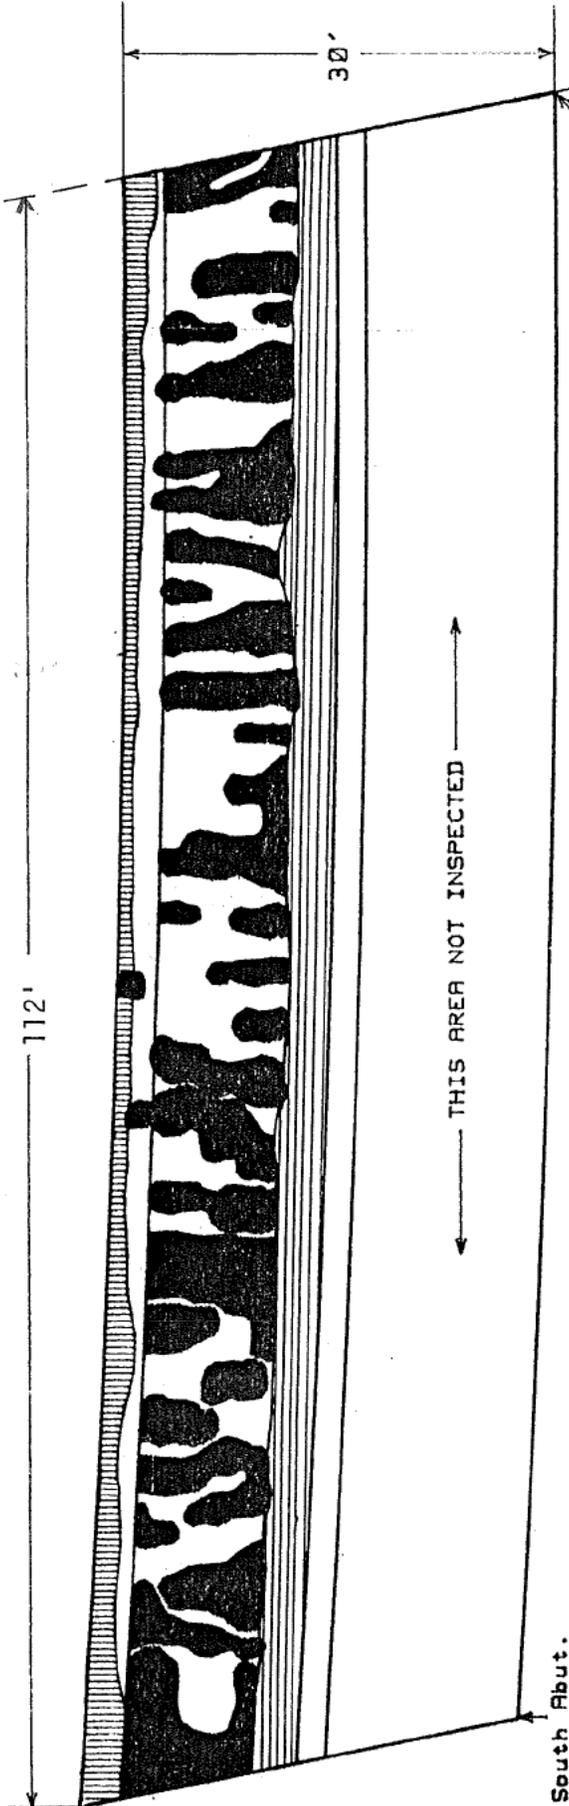
BRIDGE 28S

Upon removal of the pavement, in April of 1988, numerous spalls, cracks, rust stains, and areas of severe scaling were visible on the surface of the deck. A detailed chain drag and hammer survey was conducted on a 1283 square foot area covering the travel lane from the southerly abutment to a point 95' north. A total of 37 delaminated areas were identified, totaling approximately 34 square feet or 3% of the area evaluated.

A corrosion survey done on a 5' grid was used to plot contours representing areas of high corrosion potential ($\geq -0.40V$). From this plot 53% or 686 SF of the area surveyed displayed a high potential for delamination.

Donohue's findings for this area were 24 areas of delamination totaling 520 square feet.

Nine cores were taken by A.O.T. personnel in areas where Donohue had identified delaminations. Each was taken in an area where corrosion readings were ≥ -0.40 volts but no delamination had been identified by sounding. Six (67%) of the cores revealed evidence of delamination at the 2" depth of the reinforcing steel. The other three cores, although not showing visual evidence of delamination, such as rust stains or fine cracks, broke off with only moderate

pressure, suggesting the locations were in the early stages of fracture plane development.

An overlay of the delaminated areas, areas of high corrosion potential, greater than $\geq -0.40V$, and core locations was made. This was then used to overlay a reduced copy of Donohue's plot and a visual comparison was made. Approximately 85% of the area identified as delaminated by IRT was considered to be confirmed by the overlay procedure. (See Figure 2 Page 8)

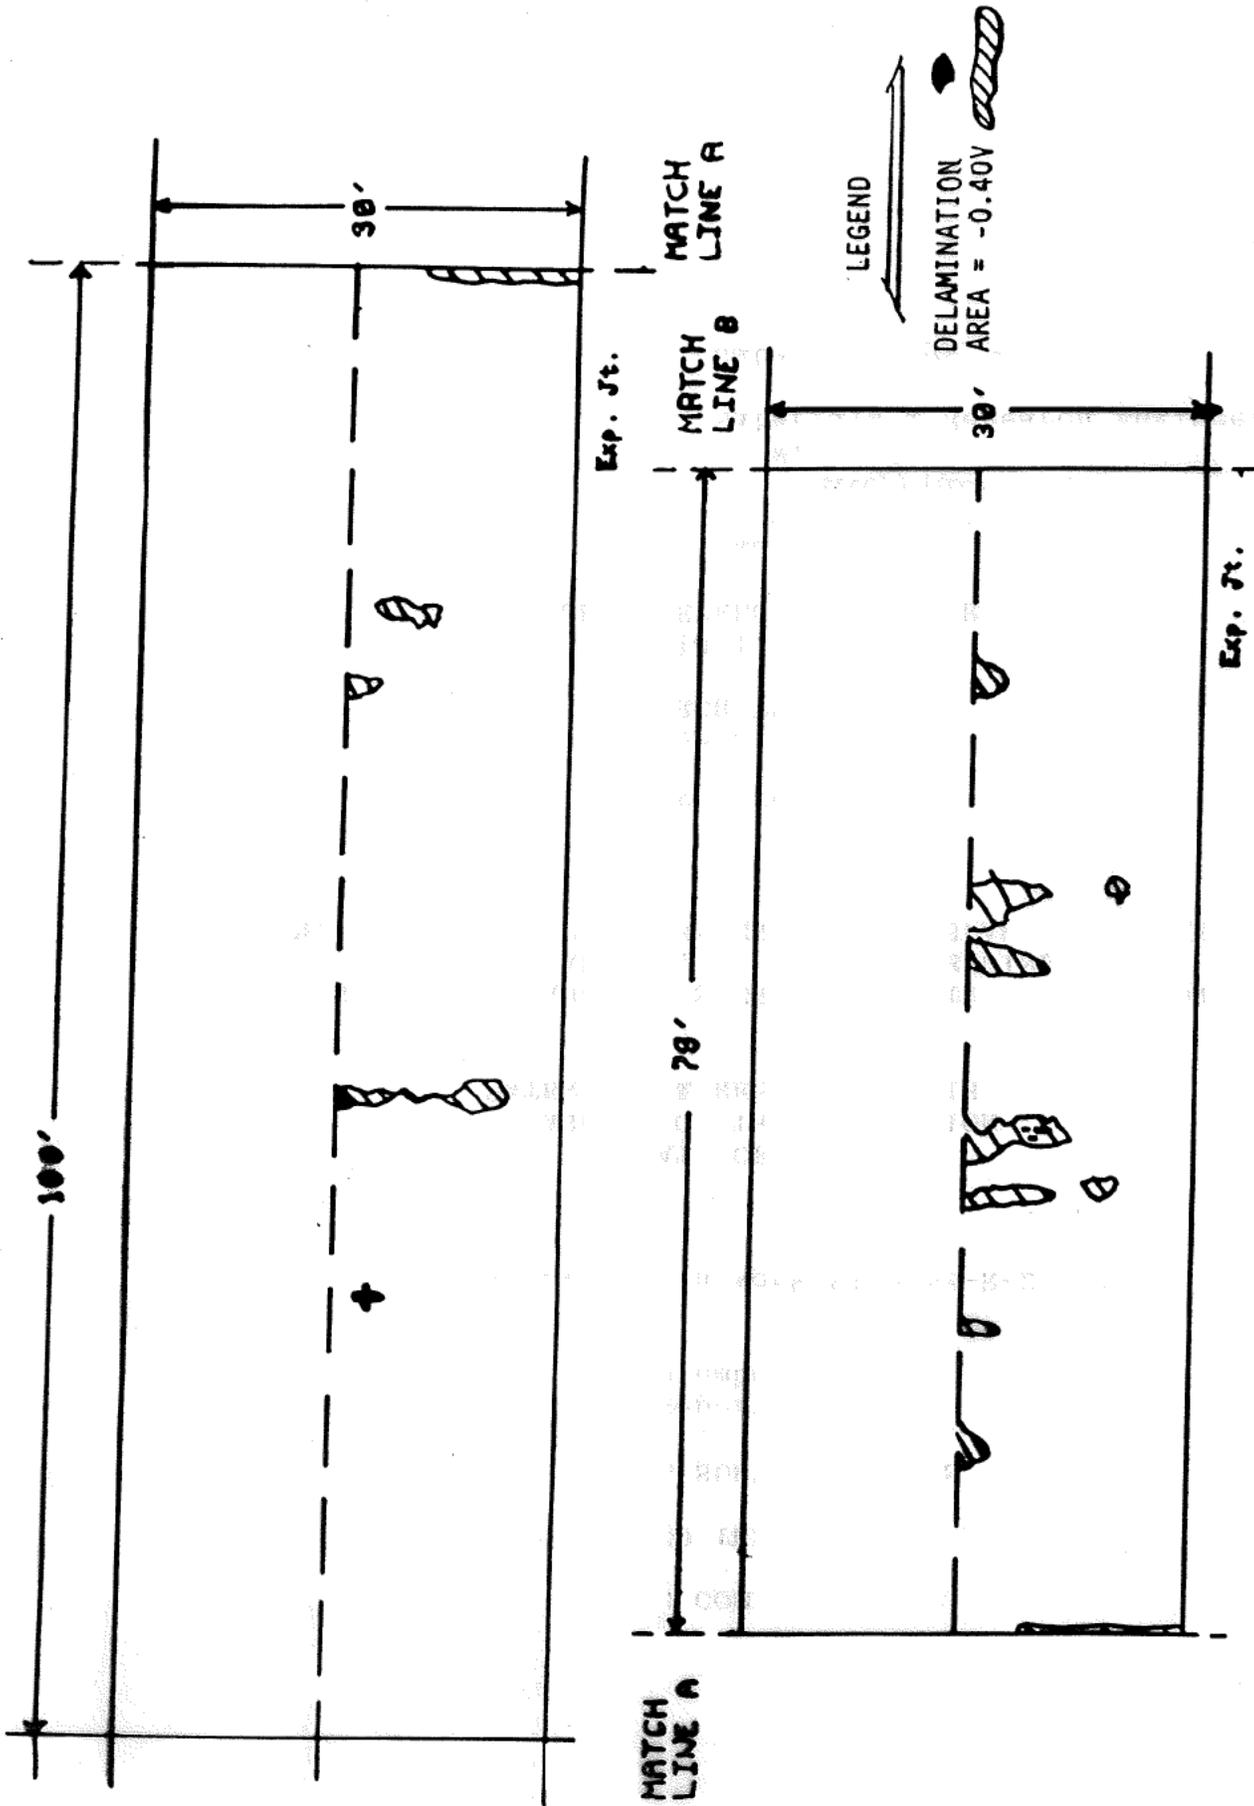
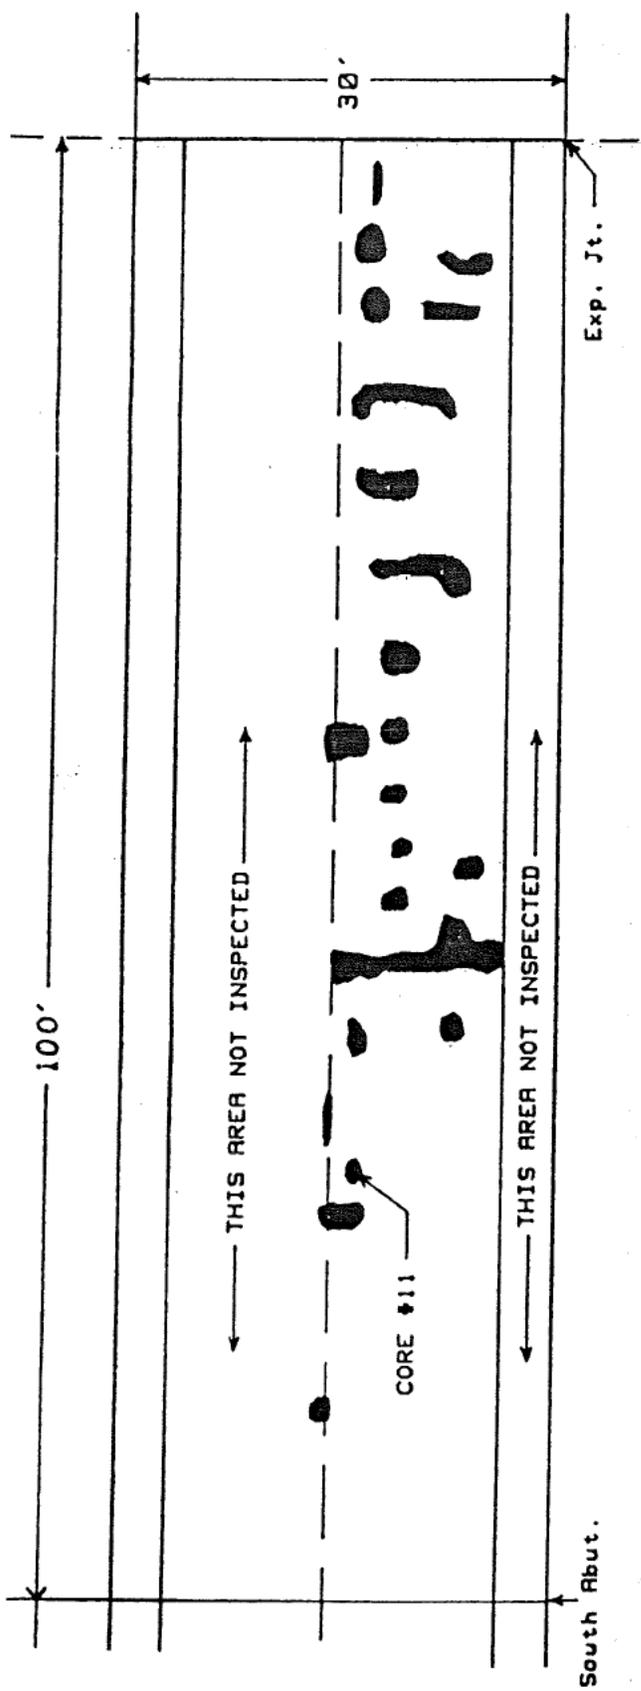
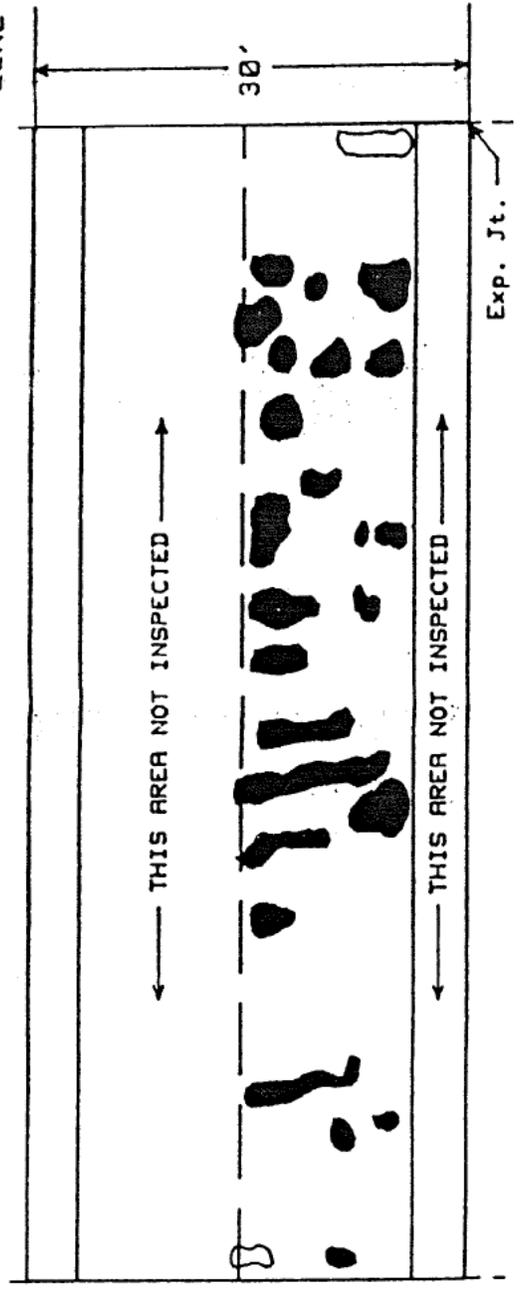
FIGURE 3 Sheet 1 of 2.

Upon removal of the pavement in April of 1988, no spalls, rust stains, or areas of severe scaling were visible on the surface of the deck. There were some transverse cracks. A detailed chain drag and hammer survey was conducted on a 4656 SF area covering the travel lane on four sections of the deck from the south abutment to a point 389' north. A total of 8 delaminated areas were identified, totaling approximately 15 square feet. A corrosion survey conducted over the same area identified 40 areas representing 380 square feet or 7% of the deck with potentials of $\geq -0.40V$. Five cores were taken in areas of high corrosion readings and all revealed delamination which had not been evident by sounding.

Later, while marking the deck for removal of delaminated concrete, the resident engineer identified 21 more areas of high potential which agreed with Donohue's identification.

DONOHUE'S findings for the area were 115 areas of delamination totaling 819 square feet or 18% of the area evaluated.

Since standard methods confirmed only 58%+ of the delaminations identified by IRT, further study was undertaken. Eighteen locations were selected for confirmation by coring at locations where Donohue's plot showed delamination but where no delamination had been identified by sounding or corrosion survey.

Upon field inspection, it was found that five of the 18 locations had already been identified and removed by the Resident Engineer. Transverse cracks, which had not been observed in the earlier surveys, were visible on the surface at ten of the locations. Three 2" diameter cores were taken which confirmed delaminations in locations where cracks were present. All ten of the selected areas which had cracks were thus considered to be delaminated.

Three other cores were taken where there were no visible cracks. All three broke off easily at the 1-7/8" to 2-3/8" rebar level, indicating a weakness or delamination. The determination that these three were also delaminated raised the confirmations to 70%. Because the 20 check cores on the two decks confirmed the accuracy of the IRT survey, no attempt was made to check the 34 remaining unconfirmed delaminations on Bridge 33N. (See Figure 3 page 9 and Table 1. Page 11)
