FIELD EVALUATION OF A
CORROSION INHIBITING DEICER
INITIAL REPORT 90 - 1
JANUARY 1990

Reporting On Work Plan 88-R-10

STATE OF VERMONT
AGENCY OF TRANSPORTATION

Prepared By
Ronald I. Frascoia
Research and Development Supervisor

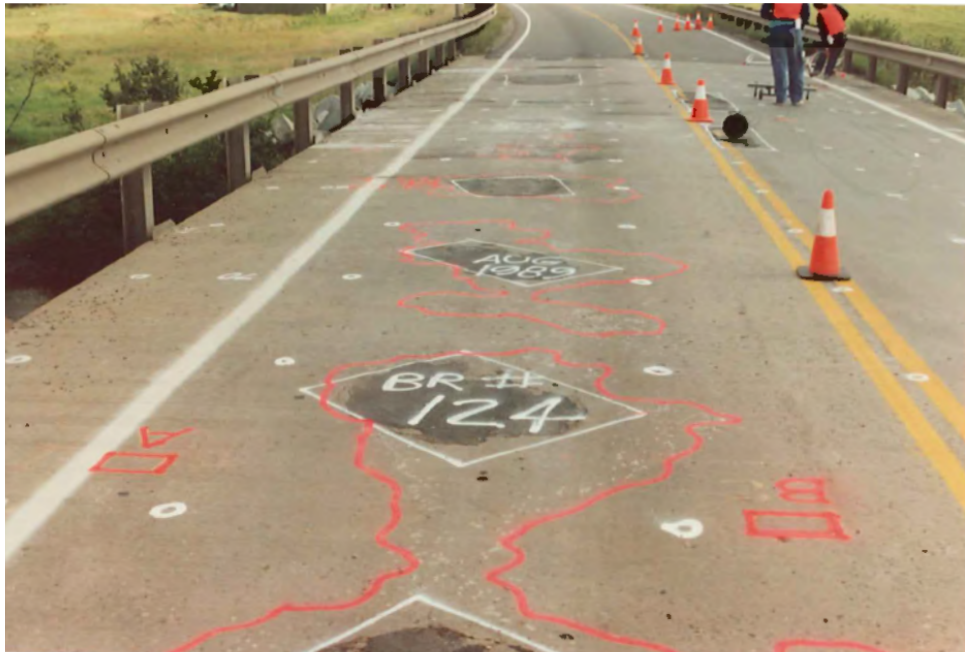
Differences in the physical condition of the northbound (NB) and southbound (SB) lanes were visually apparent and also documented by the corrosion rate and corrosion potential testing. The August 24th testing series revealed the NB lane was 98% active with an average value of -0.51 volts while the SB lane was 73% active with an average value of -0.44 volts.

A number of different factors may have caused the difference in the extent of deterioration of the two lanes. Since the deck was reconstructed one lane at a time to allow maintenance of one-way traffic, differences in the water - cement ratio and the resulting concrete permeability and resistivity would have resulted in different chloride penetration rates on the two lanes. The difference in concrete cover over the top mat of reinforcing steel is a major factor. Cover on the SB lane averages approximately 2 1/2 inches while the NB lane is in the range of 1 3/4 inches.

Condition of NB lane on August 24, 1989. Red lines indicate the perimeter of concrete delaminations. White rectangles outline areas to be saw cut and patched.

Following the August 24 test series, maintenance personnel squared up the potholed areas and patched them with bituminous mix. Thirteen patches were made ranging from 1 to 34 square feet in area with an average size of 11 square feet. Seventy-seven percent of the patched area was in the NB lane. The majority of the patched area on the SB lane occurred along the centerline adjacent to the longitudinal construction joint.
