TIRE CHIPS IN THE BASE COURSE OF A LOCAL ROAD

REPORT 94-2

MARCH 1994

STATE OF VERMONT
AGENCY OF TRANSPORTATION
MATERIALS AND RESEARCH DIVISION

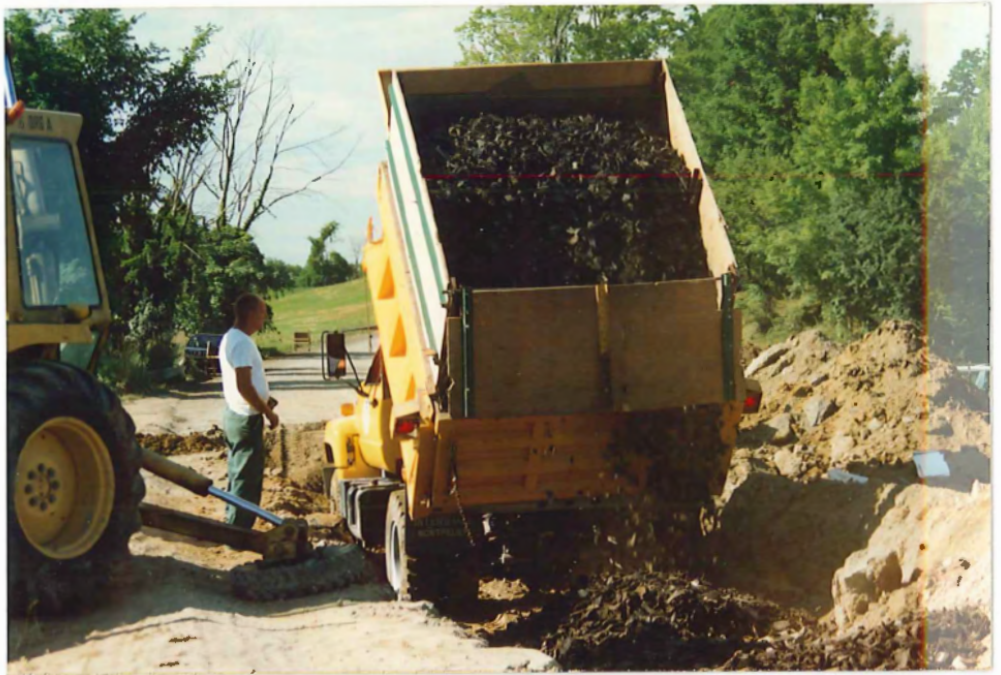
Backfilling the 24" to 30"
excavation with a 16 c.y.
load of tire chips.

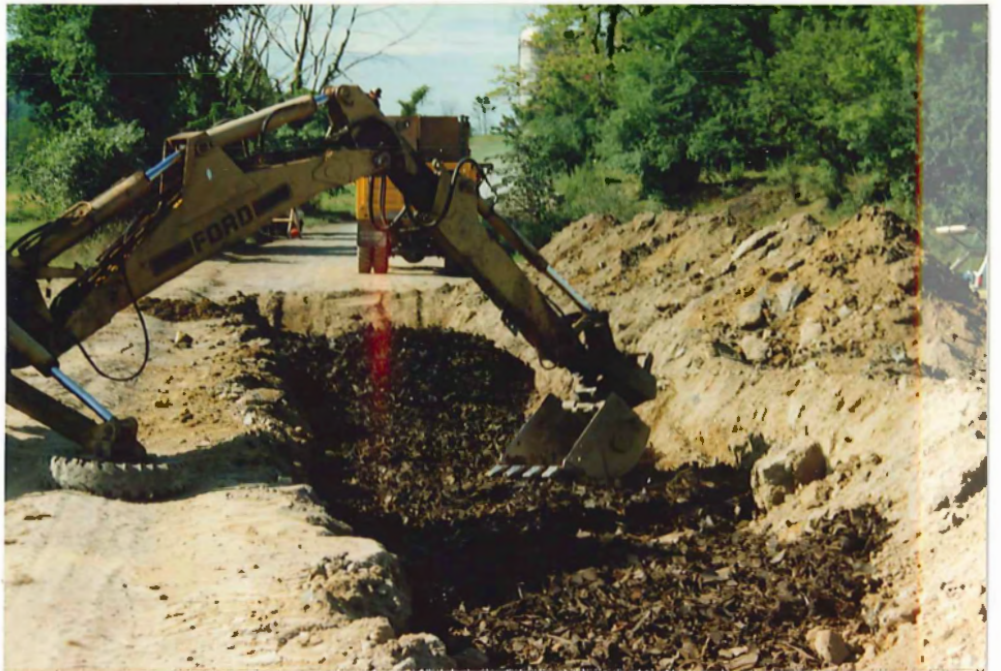
Leveling the tire chips
with a backhoe to obtain
a 9" to 12" layer.

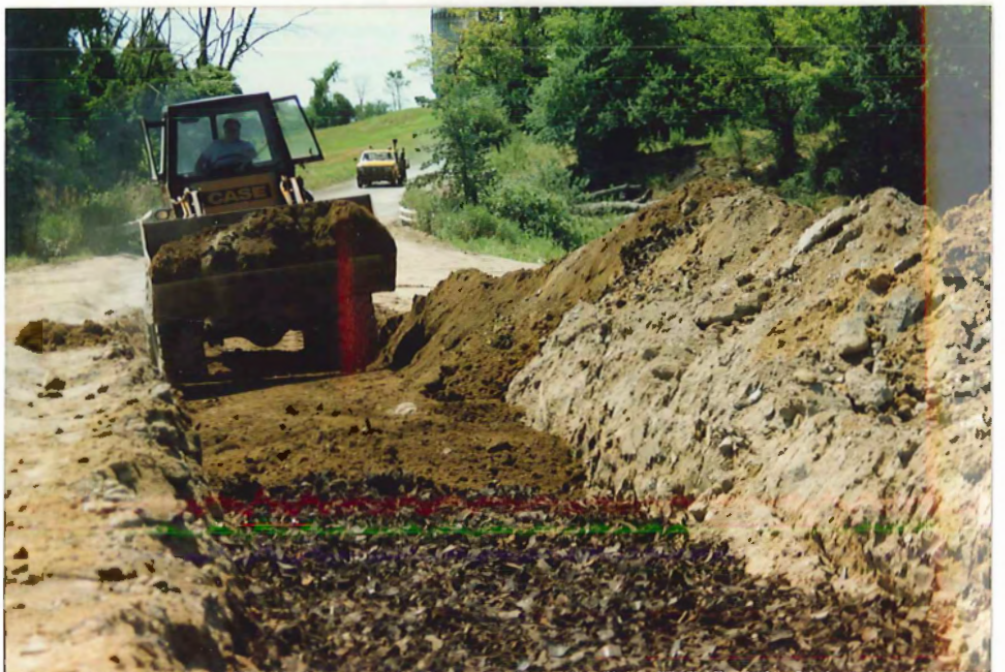
Backfilling the trench
with the original gravel.

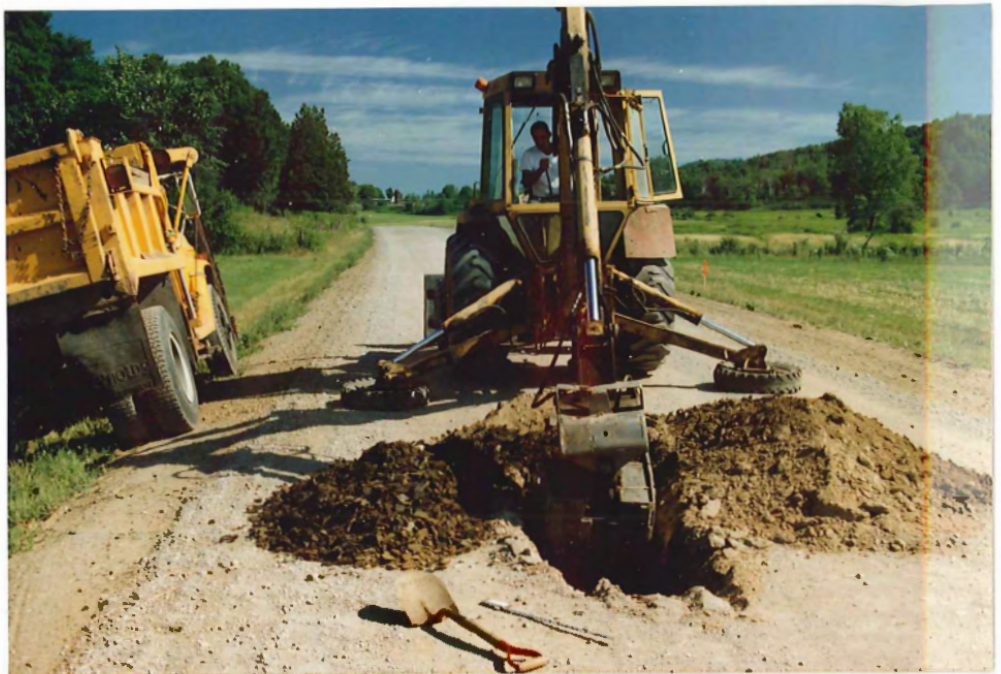
The 2 x 6 foot test pit was dug in the left wheelpath of the southbound lane, 25 feet north of the southerly well point placed in 1990. The pit revealed 21 inches of gravel over 8 to 9 inches of tightly compacted tire chips. The top six inches of gravel contained 8% minus no. 200 sieve material, while the remainder averaged 15% minus no. 200 material. A trace of moisture was noted on the top side of the chips while the bottom side was dry. The silty sand beneath the chips contained enough moisture to ball together when squeezed. No attempt was made to locate the water table elevation.

Excavating a test pit
in the 1990 construction
project.

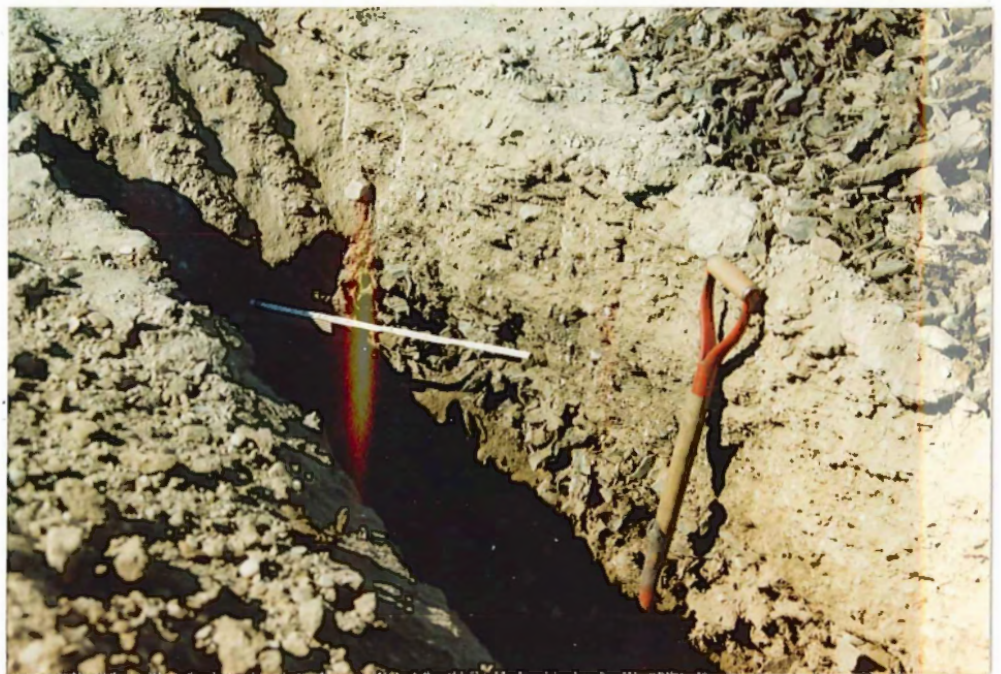
The base consisted of 21"
of dirty gravel over 9" \pm
of compacted tire chips.
The gravel was dry, while
the silty sand subgrade
contained enough moisture
to hold the material to-
gether when squeezed.

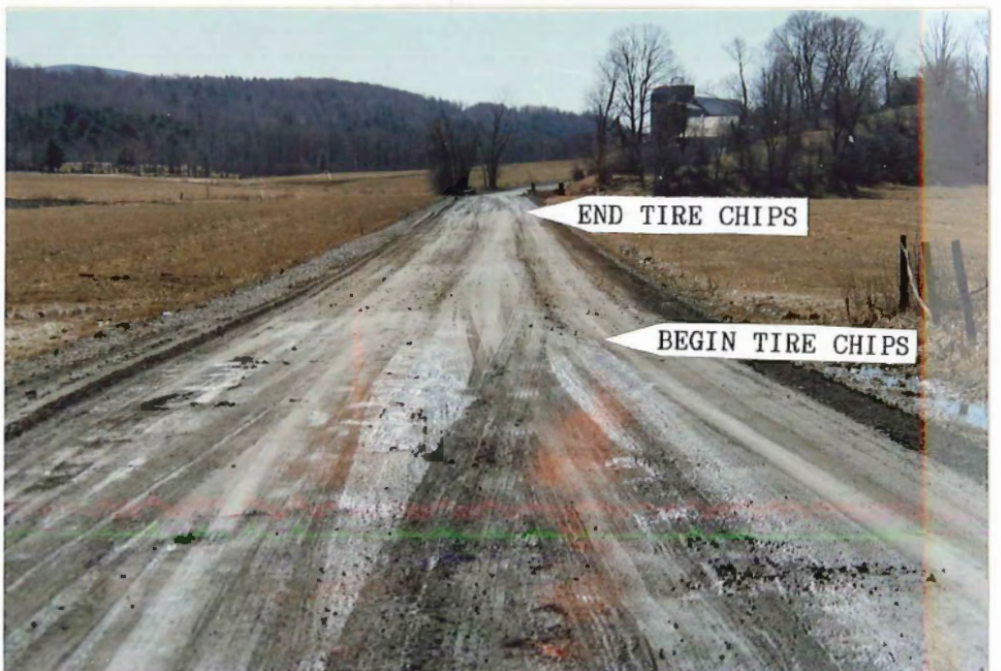
On April 3, 1991, the roadway was inspected, photos were taken, and the water table elevation was measured. The roadway surface within the test section was visibly dry and free of any rutting. A few fine longitudinal and transverse cracks were visible on the northerly half of the test section, with most noted in the southbound lane. The water table averaged 12 inches below the ground surface or 6 inches below the estimated bottom of the tire chips. The water table elevation was 5 1/2 inches higher than that recorded the previous November.

In comparison, the untreated roadway north and south of the tire chip section was in poor condition. The surfaces were visibly wet and revealed numerous ruts, cracks, and boils. The poor areas were soft to walk on and water could be drawn to the surface with a tamping action. In general, TH No. 4 was in better overall shape than in other years, due to a milder winter with below-average snowfall and a dry spring season.

Overview of the tire chip
section on April 3, 1991.

Note surface moisture on
the adjacent untreated
sections.
