RECLAIMED BASE COURSE

STABILIZED WITH CALCIUM CHLORIDE

REPORT 94-5

STATE OF VERMONT AGENCY OF TRANSPORTATION MATERIAL AND RESEARCH DIVISION

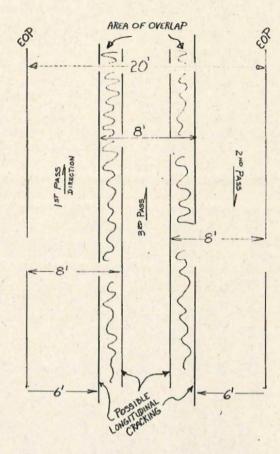
SKETCH SHOWING AREA OF OVERLAP DURING RECLAIMING PROCESS

During grinding, and because of the characteristic width of the BOMAG equipment, the area beginning 1.8 m (6 ft) inboard from either edge of the street and extending 0.6 m (2 ft) toward the center line was pulverized twice as often as the remaining roadway. The pavement may develop longitudinal cracks along planes created where repetitions of the reclaimer occurred.

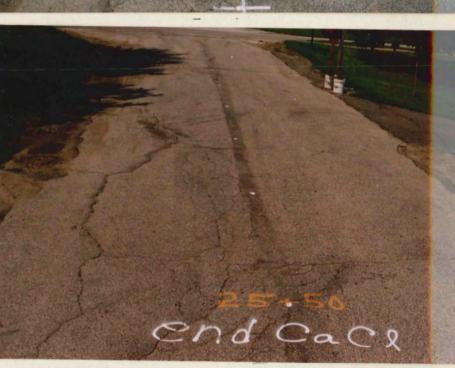
Control Test Section 7

Pavement and subbase reclaimed 10 inches deep

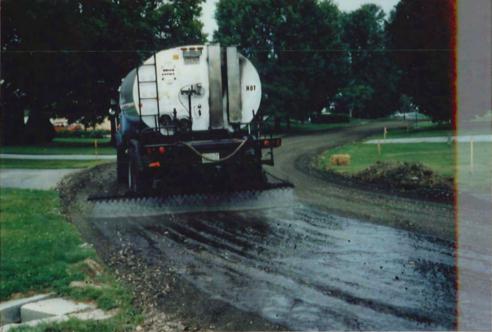
Applying the Calcium Chloride Solution

During the application of the CaCl₂ it was obvious that all of the solution was not absorbed into the base because run-off was observed collecting along either side of the road.
