**Waterborne Paint with Rohm and Haas
Rhoplex® HD-21 Binder**

Interstates I-89 and I-91, Vermont

**June 2002
Reporting on Work Plan 2000-R-7
Final Report**

State of Vermont
Agency of Transportation
Materials and Research

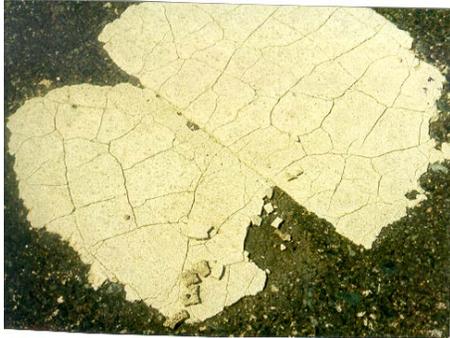
Figure 1. St. Johnsbury – Deteriorated Thermoplastic (9 months old).
(Photo taken July 13, 2000)

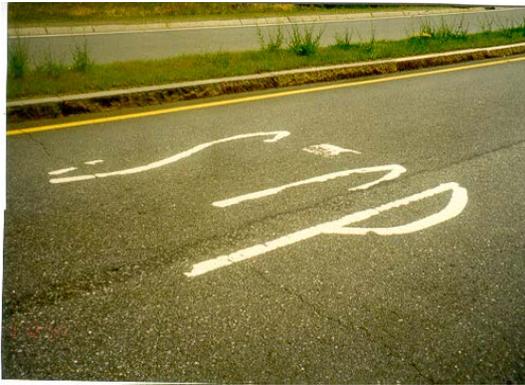
Figure 2A. Pre-Construction
(Photo taken July 12, 2000)

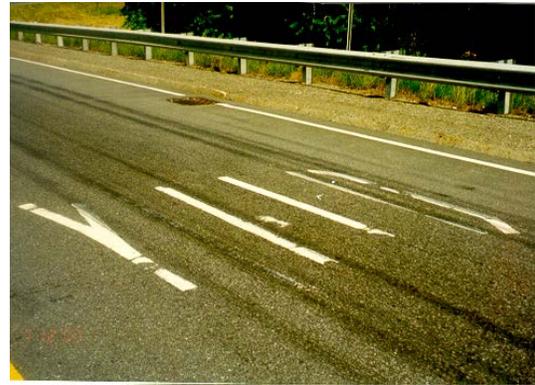
Figure 3A. Pre-Construction
(Photo taken July 12, 2000)

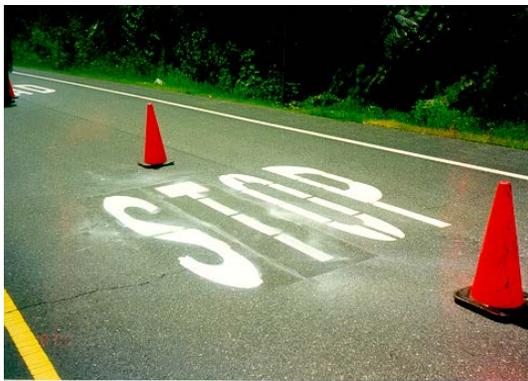
Figure 2B. Post-Construction
(Photo taken July 18, 2000)

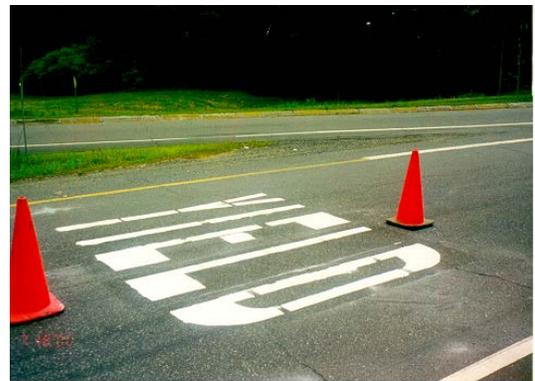
Figure 3B. Post-Construction
(Photo taken July 18, 2000)

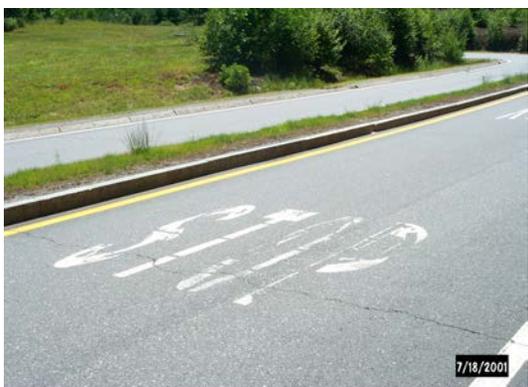
Figure 2C. One-Year of Service
(Photo taken July 18, 2001)

The majority of the rehabilitated markings on these interstate highway ramps receive some of Vermont's highest traffic volumes. In 2000, the annual average daily traffic (AADT) along the interstate in these areas ranged from 32,900 in Williston (I-89), 29,600 in Colchester (I-89), 23,400 in Brattleboro (I-91), to 6,300 in St. Johnsbury (I-91). As a result of the pavement markings transverse placement to traffic flow, loss of the marking material due to vehicular wear is inevitable, particularly in the wheel path areas in the high traffic volume areas. This is exhibited by comparing the markings in St. Johnsbury (Figures 5A-C), a low volume interchange, to those in Williston (Figures 7A-C) and in Brattleboro at Exit 3 (Figures 3A-C), both high volume interchanges.

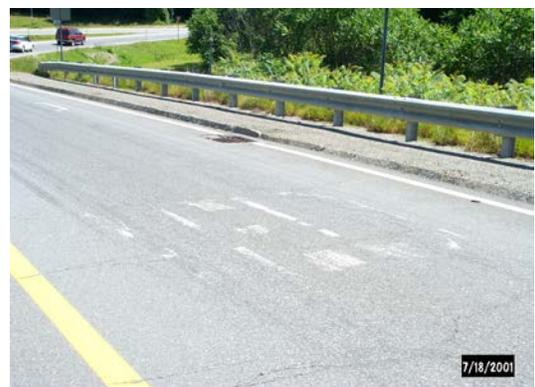
Figure 3C. One-Year of Service
(Photo taken July 18, 2001)

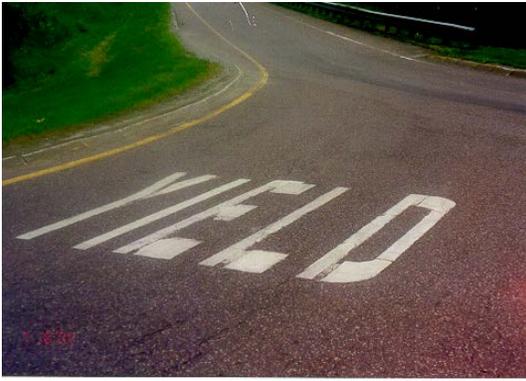
Figure 4A. Pre-Construction
(Photo taken July 6, 2000)

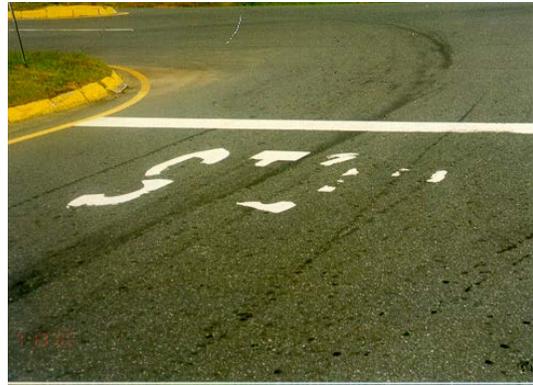
Figure 5A. Pre-Construction
(Photo taken July 13, 2000)

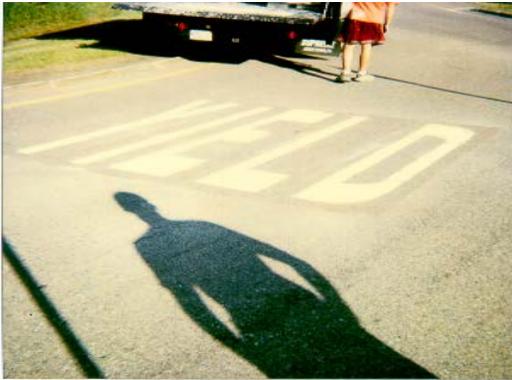
Figure 4B. Post-Construction
(Photo taken July 19, 2000)

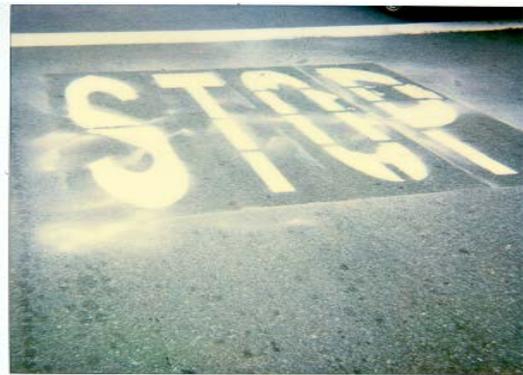
Figure 5B. Post-Construction
(Photo taken July 19, 2000)

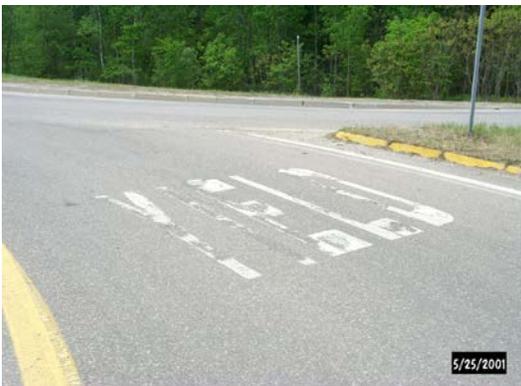
Figure 4C. Ten-Months of Service
(Photo taken May 25, 2001)

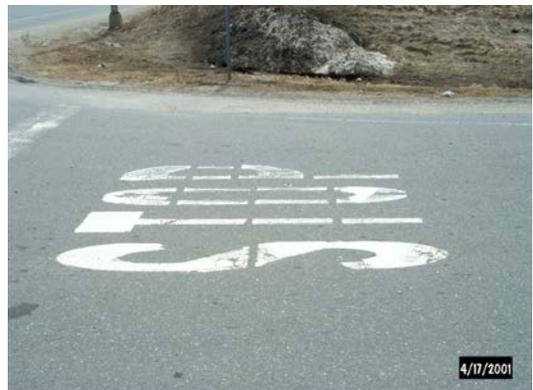
Figure 5C. Nine-Months of Service
(Photo taken April 17, 2001)

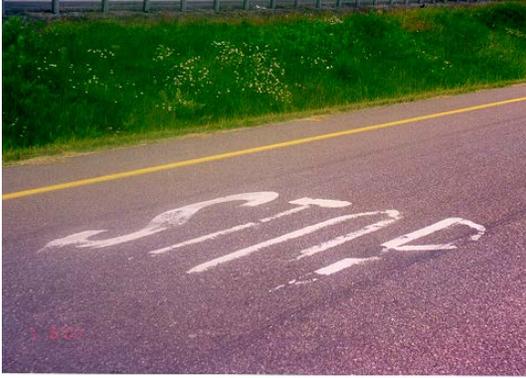
Figure 6A. Pre-Construction
(Photo taken July 6, 2000)

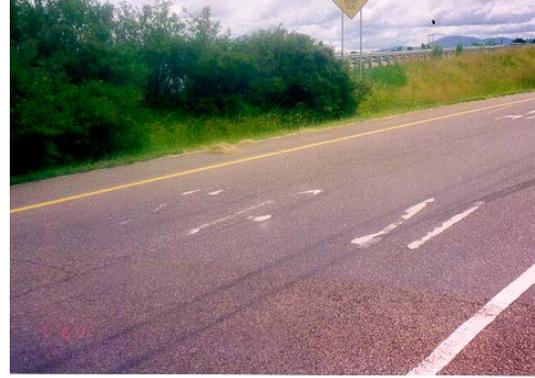
Figure 7A. Pre-Construction
(Photo taken July 6, 2000)

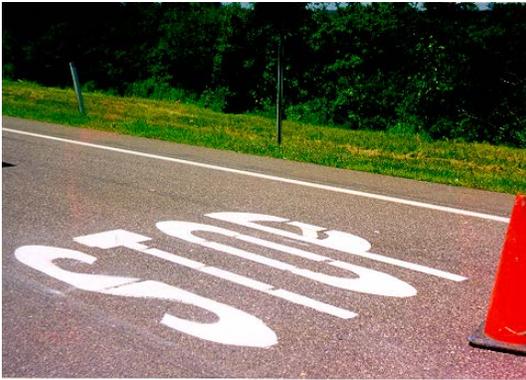
Figure 6B. Post-Construction
(Photo taken July 20, 2000)

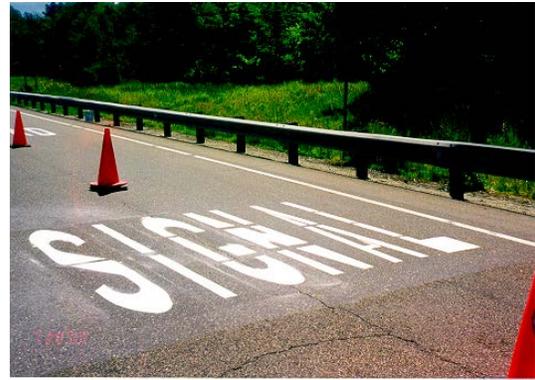
Figure 7B. Post-Construction
(Photo taken July 20, 2000)

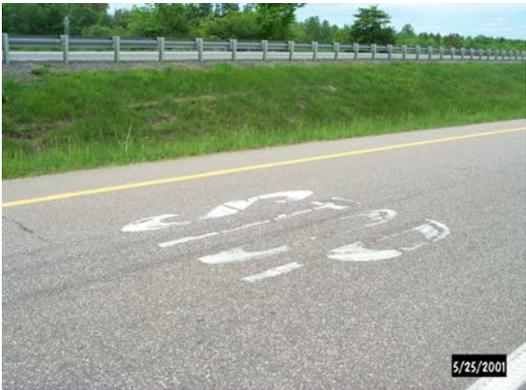
Figure 6C. Ten-Months of Service
(Photo taken May 25, 2001)

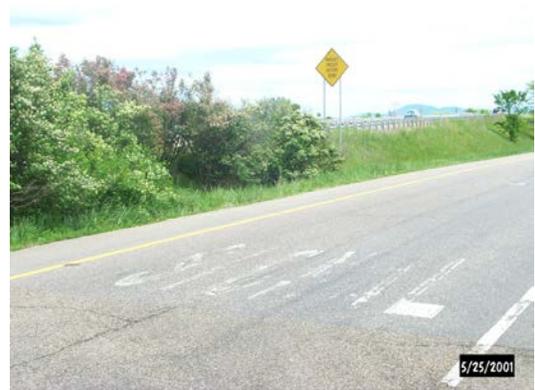
Figure 7C. Ten-Months of Service
(Photo taken May 25, 2001)

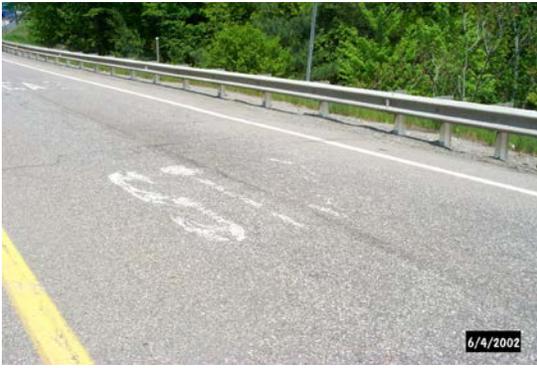
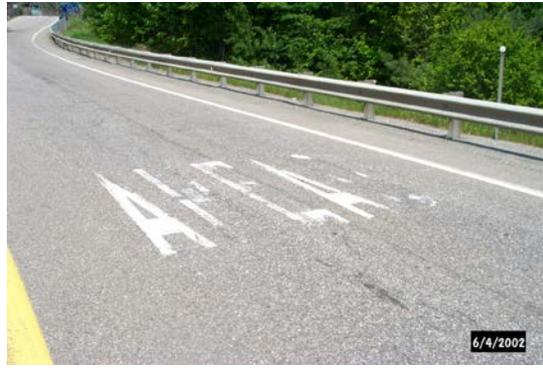
In 2002, the remaining legend marks were, in large part, the underlying thermoplastic material with little or no evidence of any paint remaining. Some of the waterborne paint with HD-21 binder is present on the asphalt bituminous pavement but is worn beyond any effective daytime recognition and provides no nighttime benefits. Photographs of some of the sites are presented in Figures 8-10. A few legends remaining are likely the result of several material applications over the years as seen in Figure 10 and not the remnants of the waterborne paint with HD-21 binder.

Figure 8. Waterbury (I-89, Exit 10, NB off ramp) after two years of service.
(Photos taken June 4, 2002)

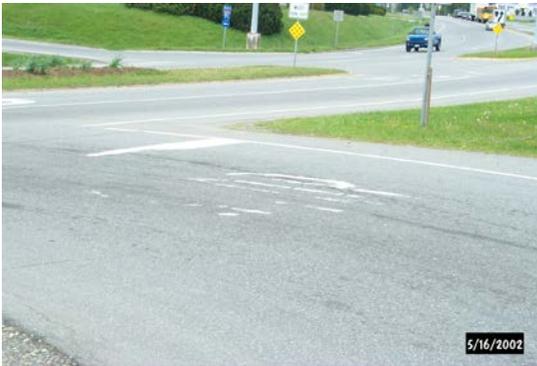
Figure 9. White River Junction
(I-91, Exit 11, NB off ramp)
after two years of service.
(Photo taken May 16, 2002)

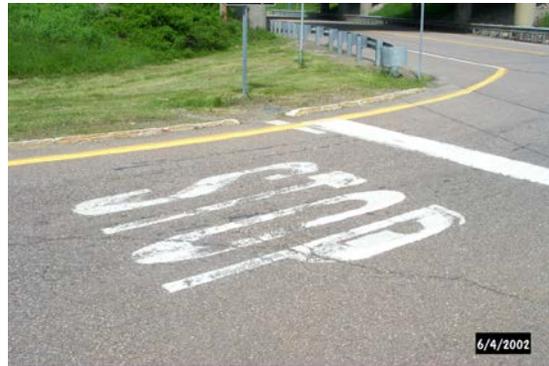
Figure 10. Middlesex
(I-89, Exit 9, SB off ramp)
after two years of service.
(Photo taken June 4, 2002)
