An Investigation into
the Physical Condition of the
I-89 Concrete Median Barrier Rail
In the Towns of Bolton
& Waterbury

Vermont Agency of Transportation
Materials and Research Section

Date: December 11, 2003

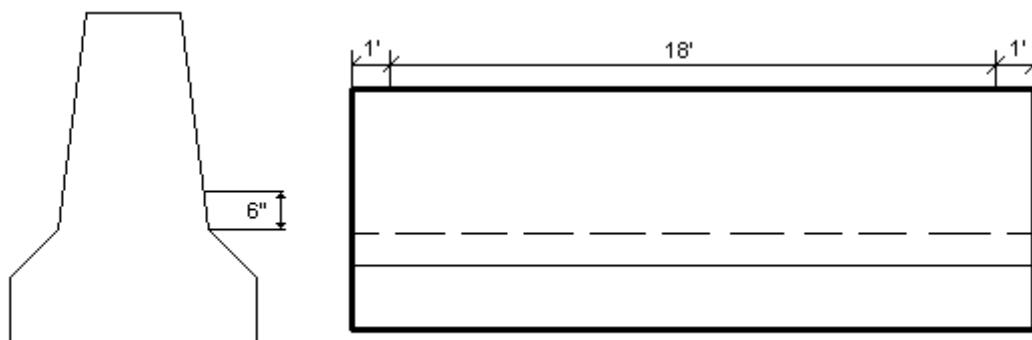
Figure 1- Cross section of Jersey Barrier Figure 2- Horizontal View of Barrier

3) Sample/Test Locations- All samples will be centered and tests performed within the 6" vertical distance shown in Figure 1 and the 18' section shown in Figure 2 (Note- Not to scale).
