**Westfall Fiberglass Bridge Drain Pipe System
South Burlington, Vermont
Initial Report**

June 2007

**Report 2007 - 7
Reporting on Work Plan 2000-R-2**

State of Vermont
Agency of Transportation
Materials and Research Section

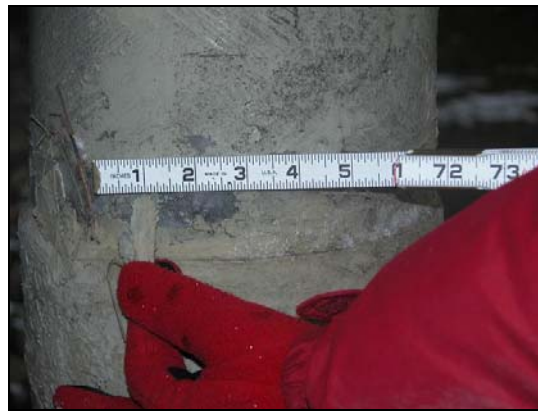
Pipe fittings were also examined. While found to be in good condition, external flaking of the resin adhesive, used to bond and seal the elbow pieces to the straight pipe section, was observed as shown in Figure 3. This raised concerns regarding the potential for water infiltration between the connections potentially resulting in freeze thaw damage during winter months. Immediately following the site inspection, the Westfall Company

was contacted to discuss this phenomenon. They explained that the resin adhesive will not adhere to the glazed finish on the exterior of the pipe. Furthermore, the resin is only needed for the bond between fittings and is not intended to be applied beyond the joint.

Figure 3 – Flaking of Adhesive

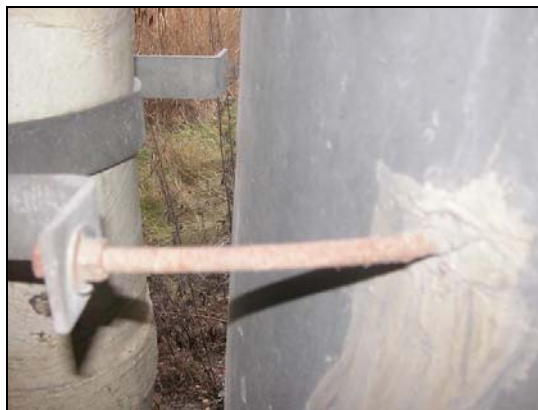
All lower supports were examined during the site visit and found to display signs of distress. As shown in Figure 4, the bolts that secure the drainage system to the pier were slightly deformed. This is most likely caused by shear forces generated from wind currents and bridge vibration. Section loss resulting from rust was also observed. Both will likely contribute to some form of stem or shear failure. When assessed by Peter Bergerson, he stated that the bolts were too small in diameter to withstand shear and vibratory forces.

Figure 4 – Bolt Deformation

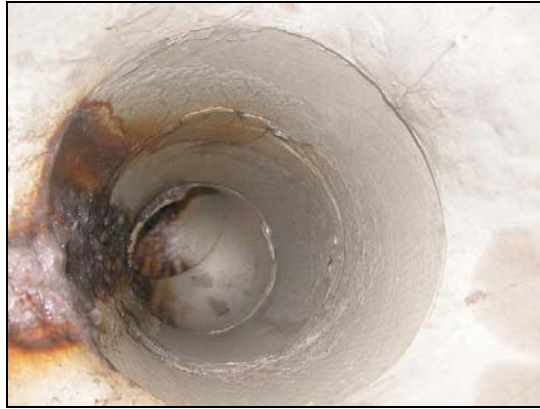
Following an exterior examination, the interior of each catch basin and associated trough was assessed. Some iron-oxide discoloration, shown in Figure 5, was noted on the inside of the catch basin and drainage pipe most likely resulting from a discharge of runoff containing rust subsequently washed from the bridge deck into the trough and drain pipe. This may also indicate that there was some plugging and the water pooled in the catch-basin causing the orange colored ring around the top. Peter also noticed what he referred to as “fissure cracking” within some of the fiberglass structure, a term referring to the miniscule cracks in the fiberglass caused by fatigue, movement and expansion stressing.

Figure 5 – Iron-Oxide Discoloration

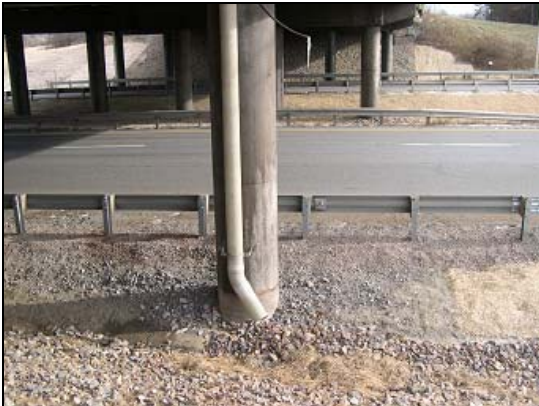
During the inspection, runoff from the downspout was pooling around the bottom of the pier columns rather than draining away. This indicates that the stone fill drainage has failed. Figure 6 and 7 provide a comparison between the condition of the drainage system at the base of the piers at the time of installation and during the site visit conducted in December 2006. According to the Portland Cement Association, concrete absorbs water, which expands when it undergoes a freeze-thaw cycle and builds pressure. This internal pressure can cause damage to the concrete such as scaling and spalling. The infiltration of water also provides a mechanism for the penetration of destructive materials such as chloride and sulfate ions increasing the likelihood for concrete delamination and corrosion of reinforcing steel. Maintenance of the drainage system on at least an annual basis is recommended at this time.

Figure 6 – Drainage on Dec. 2, 2003

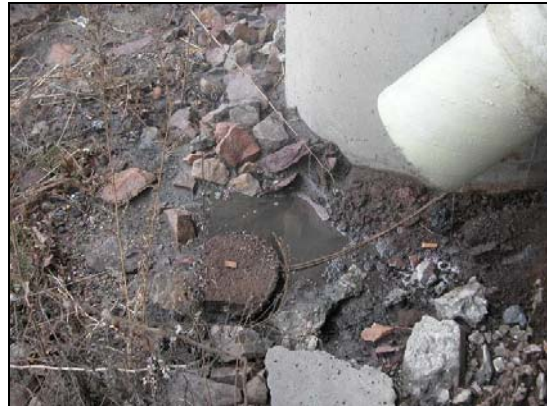
Figure 7 – Drainage on Dec. 19, 2006

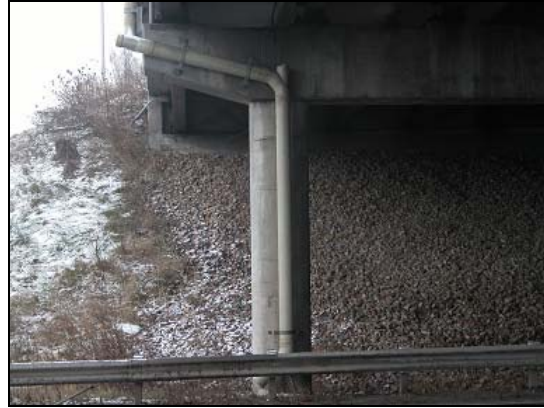
The intent of this investigation was to assess the durability of a material that is reportedly inert to oil, gas and deicing salts known as fiberglass. Installed in 2003, the six fiberglass drainage systems were found to be performing well four years following installation. Minor fisher cracking typically caused by fatigue, movement and expansion stressing was observed inside a few catch basins located at the outlet of the trough. Iron-oxide staining was also visible inside the catch basin most likely resulting from runoff containing rust. Although there were concerns raised regarding flaking of the resin adhesive found at joint connections, the Westfall Company assured that this is common when adhered to the glaze finish of the fiberglass. The bolts connecting the supporting system for the drainage pipe to the pier column were deformed as a result of wind and vibratory forces. This along with apparent section loss will most likely result in some type of shear or stem failure in the future. As a final aside, inadequate drainage was noted below the fiberglass drainage system indicating that the stone fill basin has failed generating a ponding effect around the adjacent concrete piers. This will cause premature concrete spalling and corrosion of reinforcing steel if left unaddressed. Maintenance is recommended at this time. This could be accomplished by cleaning the stone fill or by extending the discharge drainage pipe away from the column. With regards to cost, fiberglass is certainly cost effective when compared to other typically utilized materials. Overall, preliminary results are favorable. Figure 8 and 9 display the drainage system immediately following installation and three years following installation.

Figure 9 – On Dec. 19, 2006
