**Insituform Pipe Lining Process  
Richmond, Bridport, and Addison, VT  
Final Report**

**November 2007**

**Report 2007 - 15  
Reporting on Work Plans 91-R-9 and 92-R-15**

State of Vermont  
Agency of Transportation  
Materials and Research Section

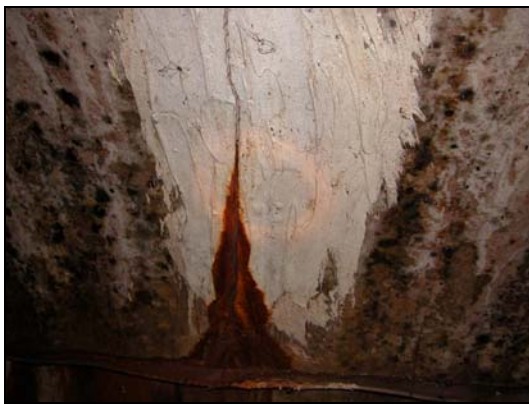
According to the initial inspection report, U96-1, “Insituform Pipe Lining Process,” the culvert at Richmond appeared satisfactory except for a narrow band of irregular texture approximately 49 feet downstream of the inlet of the culvert. This area was described as “scab-like” in addition to a crack, displayed in Figure 1, originating at the fault area and down the left side of the culvert for a distance of approximately two feet. Please note that this crack did not extend the full thickness of the liner or compromise structural integrity. However, it does appear that this area was patched as shown in Figure 2. Some discoloration, wrinkling and blistering was noted along the top of the culverts located in Bridport and Addison. Overall, all liners appeared to be in good condition.

Figure 1 – Cracked in Richmond, 08/26/03

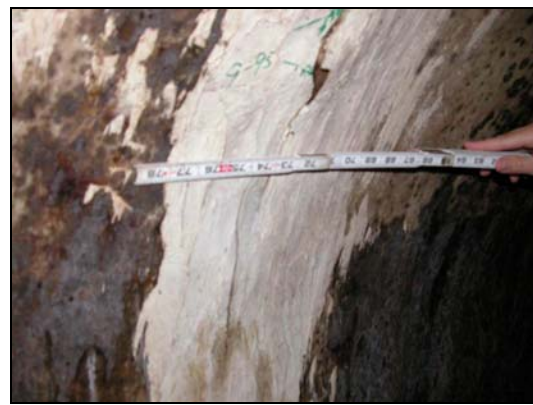
Figure 2 – Patching in Richmond, 7/2/07

monitoring period. A crack was also noted around the fault area in Richmond. This area was patched between 1992 and 1993 and remains unchanged. No debris was noted inside the pipes during any of the inspections however significant debris was observed at the inlet of the culverts in Addison and Bridport. Removal is recommended for optimum performance. The culvert liners appear to be in good condition.

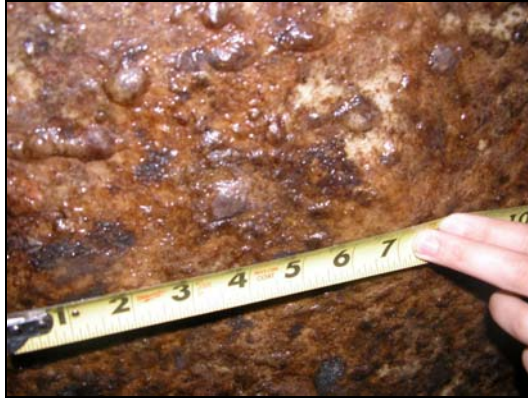
Observation recorded from subsequent visits reported similar conditions at all three culvert locations. Annual dimension measurements collected from the inlet and outlet of the culvert in Bridport were consistent throughout the 15 year monitoring period, indicating sufficient structural support from the liner, eliminating the need for complete replacement. A significant centerline crack along the overlaying pavement roughly 2.5” deep, 3” wide and 16” long was observed during an inspection in 2006 and 2007. This could have been caused by erosion or piping around the culvert, however it is suspected to be due to lateral movement of the subgrade or subbase. In either case, the liner was found to be intact. Finally, blistering was noted along the upper surface on the inside face of all three culvert liners as shown in Figure 3. It is important to note that this phenomenon was found towards the center of each culvert and is most likely due to minimal air circulation in this area allowing condensation to accumulate. However, this blistering does not appear to compromise the integrity of the CIPPs.

Figure 3 – Blistering in Addison, 6/20/06

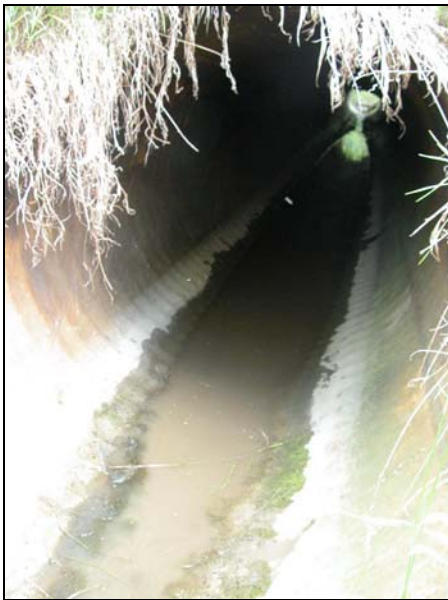
Little to no debris inside the culverts was noted during annual inspections. This is somewhat intuitive as the liner provides a lower friction value as compared to a corrugated metal pipe which allows debris to move more freely throughout the culverts. However, significant vegetative growth and tree branches were evident at the inlet of the culverts in Bridport and Addison. Removal is recommended for optimum flow. Sediment was noted along the bottom of the culverts in Bridport and Addison during the inspections conducted in 2006 and 2007 as shown in Figures 4 and 5. This is most likely attributed to the low flow characteristics of the incoming flow in association with adjacent land uses.

Figure 4 – Low flow in Addison, 7/2/07

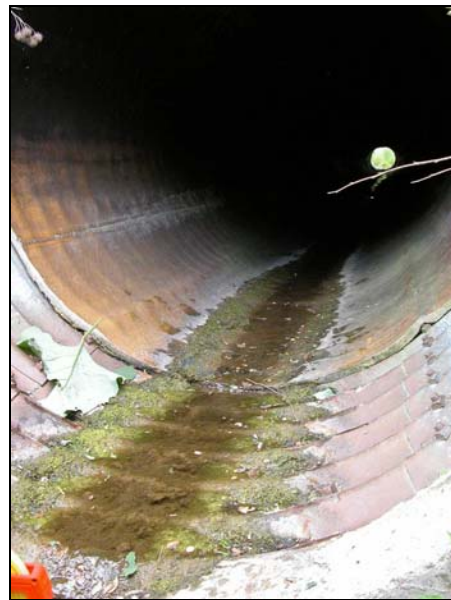
Figure 5 – Low flow in Bridport, 7/2/07
