**PavePrep Crack Reduction Interlayer
Lowell, Highgate and Hartford, Vermont
Final Report**

May 2008

**Report 2008 - 3
Reporting on Work Plan 94-R-19**

State of Vermont
Agency of Transportation
Materials and Research Section

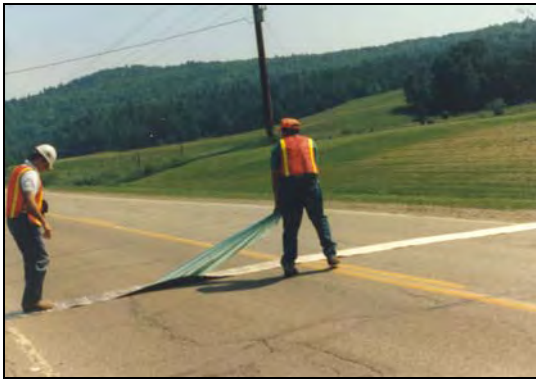
Figure 6 – Lowell MM 6.13 Installation

In the summer of 1994, PavPrep Crack Reduction Interlayer was installed in four locations in conjunction with three separate projects. The first installation occurred on June 15, 1994 on the Lowell-Westfield project. A 20" wide by 22' long section of PavPrep SA was applied to a transverse shoulder to shoulder crack in two locations, at MM 3.26 and MM 6.13 in the town of Lowell on VT Route 100. The installation is shown in Figures 6 and 7 below. The roadway was paved on June 21, 1994, 6 days following application, with a 1.5" wearing course of standard Type III Marshall overlay at MM 3.26 and a 1.5" ARHM overlay at MM 6.13. Emulsified asphalt was applied prior to placement of the overlay.

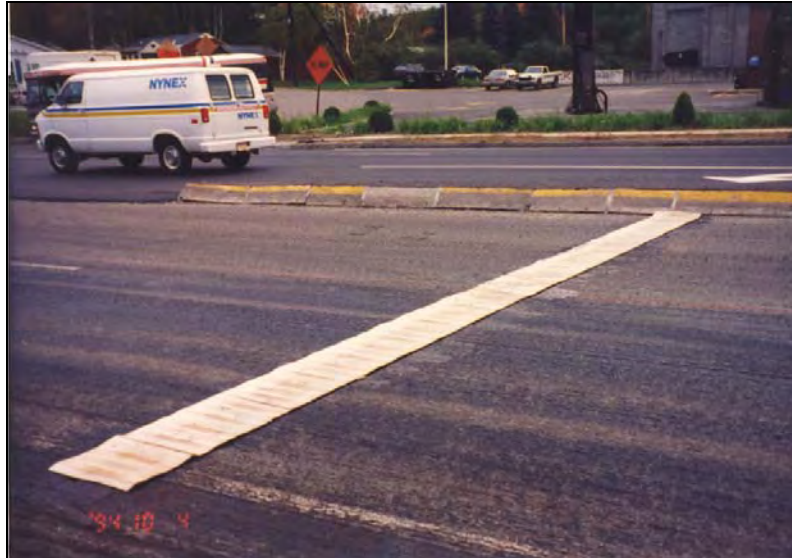
Figure 8 – Hartford PavePrep Installation

The final PavPrep installation began on September 28, 1994 on the Hartford project. A 20" wide by 24' long section of PavPrep SA was applied to a transverse shoulder to shoulder crack at the intersection of US Route 5 and Sykes Avenue on a milled surface. The following day, the material was found to have detached itself from the road surface, most likely caused by the rough textured pavement surface and further aggravated by rain

showers following installation. On October 4, 1994 a new 20” wide by 24’ long strip of PavePrep SA was placed at MM 3.13 on US Route 5, as shown in Figure 8. Emulsified asphalt was applied to the milled surface prior to the PavePrep SA installation, as recommended by the manufacturer. The first lane was then paved within ten minutes following installation. During paving operations, the PavePrep fabric was picked up by the shoes on the paver’s automatic grading and slope equipment. This problem was corrected by lifting up each pad as it passed over the PavePrep material, as shown in Figure 9. The roadway was paved with a 2.5” wearing course consisting of two 1.25” lifts of a standard Type III bituminous concrete overlay as shown in Figure 10.

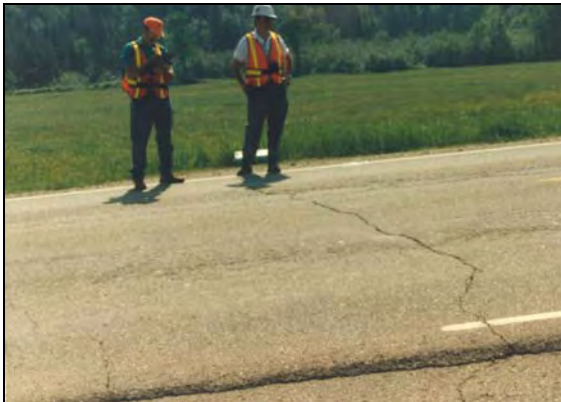
Figure 11 – Lowell MM 3.26 Preconstruction

At the initial site visit in 1995, one year following application, there were no signs of reflective cracking in either of the PavePrep test locations or the control sections. In general the pavement appeared to be performing well in the test section and adjacent areas. In the summer of 1996, three small reflective cracks totaling 10 feet developed at the test location at MM 3.26, with seven feet located in the northbound lane and three feet in the southbound lane. It was later determined that portions of the crack were located outside of the PavePrep area, as the crack diverges away from the interlayer towards a southerly direction beginning nine feet from the shoulder extending towards the centerline. Several reflective cracks were also found in the control section, with a maximum length of 11 feet. The test section at MM 6.13, within the experimental AHRM section, was still found to be free of cracking. In 1997, the previously noted reflective crack at MM 3.26 had increased in length from 10 feet to 14 feet, with 10 feet in the northbound lane and four feet in the southbound lane. Figures 11-14 show the test sites prior to the PavePrep installation in 1994, and again four years after installation in 1998.

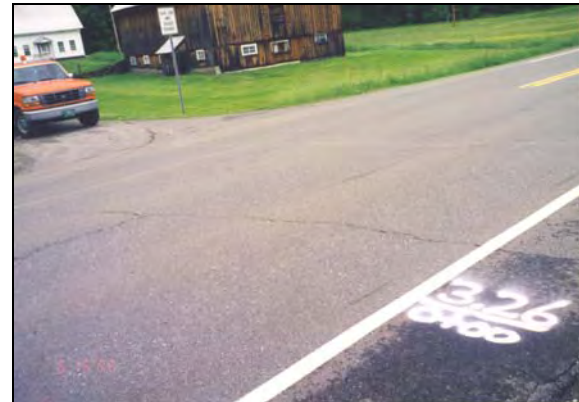
Figure 12 – Lowell MM 3.26 in 1998

The locations were again inspected in June 1998. Notes from the site visit indicate that no further cracking had developed at MM 3.26 and no reflective cracking was observed at MM 6.13. However, upon comparison of photos from preconstruction in 1995 and the 1998 site visit, it appears that the transverse crack had reflected at MM 6.13. A transverse crack that was noted as being three feet south of the PavePrep material was determined to actually be at the location of the PavePrep. This was verified by comparing the shape and characteristics of the reflected crack with the preconstruction crack. Upon further investigation, pavement life surveys for the test site indicated that the reflected crack was originally observed in 1996 along with several other transverse cracks in the area. In 1996 the crack extended within two feet of the entire roadway width and in 2005 the crack reflected the final two feet across the roadway. In the 1998 photographs, the reflected crack appeared to be much less severe than the preconstruction crack. This indicates that although the PavePrep had not prevented the crack from reflecting, it had minimized the severity of the crack.

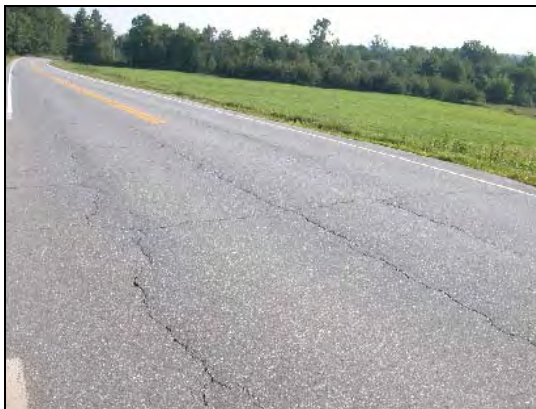
Figure 15 – Lowell MM 3.26 in 2007

In July 1999 it was found that the reflective crack at MM 3.26 had extended across the entire width of the northbound lane, to a length of 12 feet in the northbound lane and 4 feet in the southbound lane. This crack had increased to a length of 18 feet in October 2000, although still only nine feet of the crack length was located within the PavePrep test area. Also in 2000, hairline cracking was noticed at the test section at MM 6.13. These cracks were longitudinal in nature and not transverse or reflective, which indicates that they were caused either by fatigue or environmental factors. In July 2001, the hairline longitudinal cracks at MM 6.13 had expanded in width to nearly 1" in certain locations. The cracking at MM 3.26 remained unchanged from the previous inspection. At a final site visit in July 2007, the crack at MM 3.26, shown below in Figure 15, had extended across the entire roadway and was interconnected with other longitudinal cracks in the pavement, which had led to alligator cracking in one area. At MM 6.13, shown in Figure 16 below, the transverse reflective crack spanned the entire roadway and had a width of up to 2 cm. This crack was interconnected with several longitudinal cracks, but did not display the severity of alligator cracking.

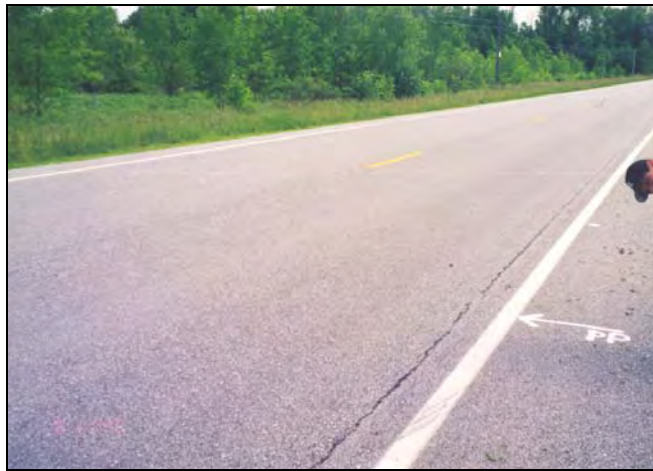
Figure 17 – Highgate in 1998

At the initial site visit in 1995, one year following application, there were no signs of reflective cracking in either the PavePrep test location or the control section. In general the pavement appeared to be performing well in the test section and adjacent areas. Figure 17 shows the condition of the pavement during the 1998 site visit. No cracking had developed in either the experimental or control sections until June 2000, when full length transverse cracking was observed both 15.5 feet and 36.5 feet south of the PavePrep material. Longitudinal cracking was noted 10" off the center of the white edge line in the northbound lane and 16" off the center of the white edge line in the southbound lane in both the experimental and control areas, as shown in Figure 18 below. These cracks were typical of the roadway in the immediate area and most likely are located at the paving joints. Signs of longitudinal cracking at the centerline were observed beginning slightly south of the PavePrep location and continuing southerly. No reflective cracking was observed in the experimental PavePrep area.

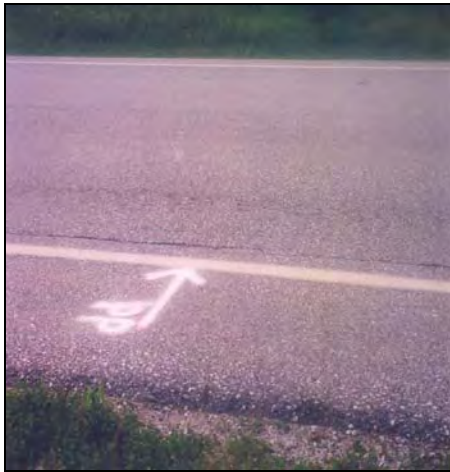
Figure 18 – Highgate in 2000

In July 2001, the longitudinal cracking had become more evident throughout the site. During this site visit a centerline longitudinal crack extending through the PavePrep test location with an average width of 0.5 cm was recorded. However field notes and photographs from the August 2002 site visit indicated that this is not the case. The paving joint was visible but there were no signs of reflective cracking in the PavePrep area, though there were some reflective centerline cracks in the control area. No reflective transverse cracking was noticed at the PavePrep location, but full length transverse cracks were observed at 40 foot intervals throughout the control section. These cracks are most likely caused by the joints of the underlying Portland cement concrete reflecting through the overlay, but could also be caused by construction practices during the installation of the new overlay, with each crack representing a new truck load of asphalt during application. At a final site visit in July 2007, shown in Figure 19 below, cracking had begun to develop on both the transverse and centerline PavePrep locations. The transverse crack spanned the entire roadway, but was only 5 mm wide. The centerline longitudinal crack was also only 5 mm wide and did not extend

through the entire length of the test site. Longitudinal cracking had developed next to the centerline paving joint.

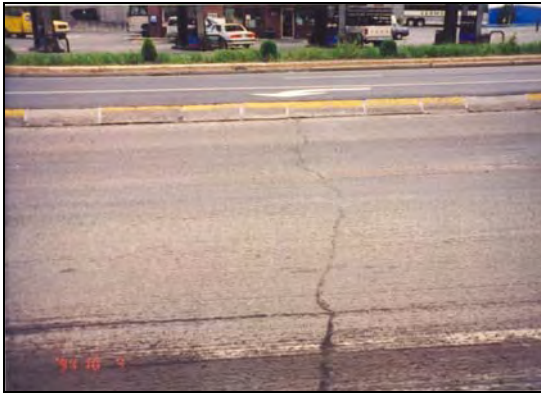
Figure 20 – Hartford in 1994

At the initial site visit in 1995, one year following application, there were no signs of reflective cracking in either the PavePrep test location or control section. In general the pavement appeared to be performing well in the test section and adjacent areas. No cracking was observed through 1997, and no site visit was conducted in 1998. In July 1999, two transverse reflective cracks were observed at the test site along the PavePrep location. One crack measured nine feet in length, spanning from the shoulder edge towards the centerline, while the other crack measured 23 feet in length and spanned from the island median towards the centerline. The cracks overlap slightly at the centerline, and combined they span the entire roadway width. The crack had been filled with crack sealer prior to the 1999 site visit. No additional cracking was observed until July 2001 when polygon cracks began to develop off both sides of the sealed cracks. This trend was also observed during an August 2002 site visit, and a centerline longitudinal crack had also developed and been filled with crack sealer. At the final site visit in July 2007, additional cracking had developed off of the original transverse cracks, as well as additional longitudinal cracking along the centerline and shoulder edge of the roadway. However, it is important to consider problems associated with construction as described previously making it difficult to draw any conclusions regarding performance at this particular test site. Figures 20-22 below show the condition of the PavePrep area prior to construction in 1994 and post construction in 2000 and 2007.
