INVESTIGATION OF ALKALI-SILICA-REACTIVITY IN PORTLAND CEMENT CONCRETE

PHASE II – SELECT VERMONT STRUCTURES

**Vermont Agency of
Transportation
Research, Development and
Technology Transfer Project**

DECEMBER 2008

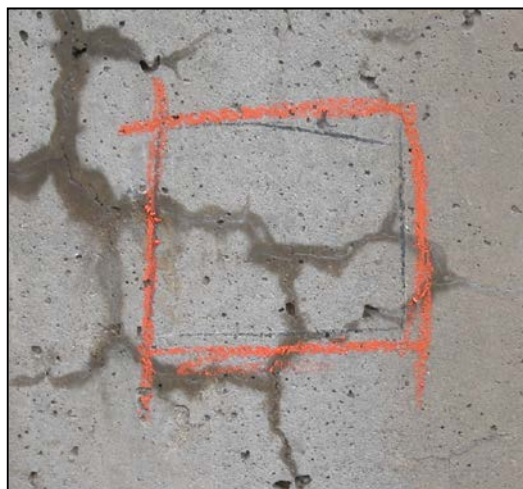
Figure 1 Crack with white precipitate.

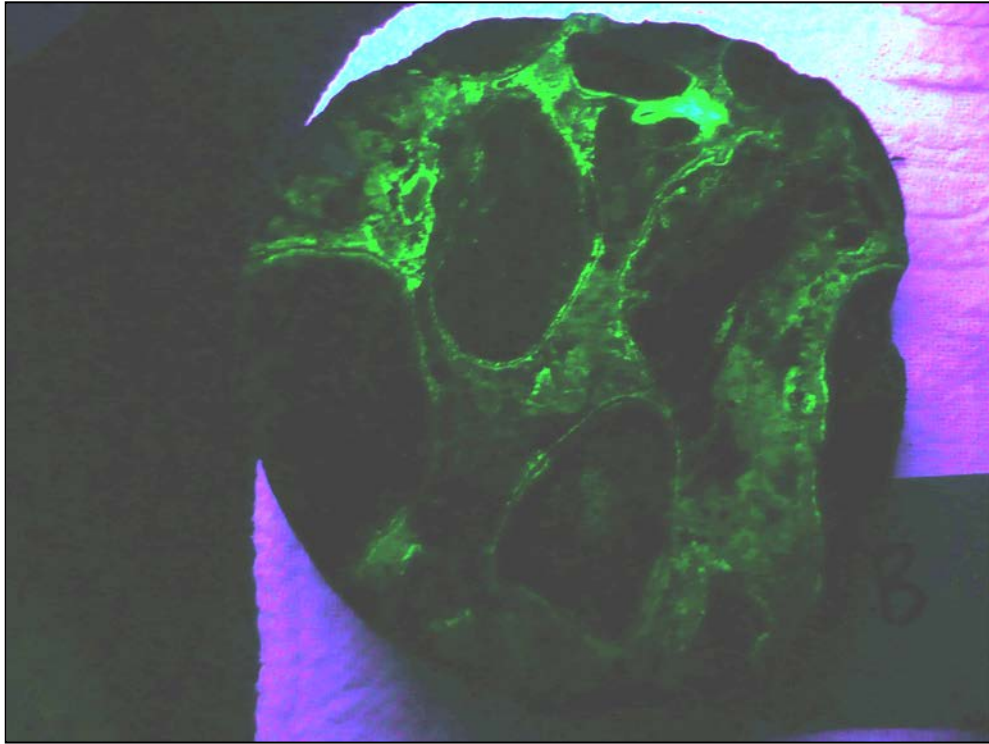
Figure 5 Photograph of core sample under Ultra Violet light showing ASR development.

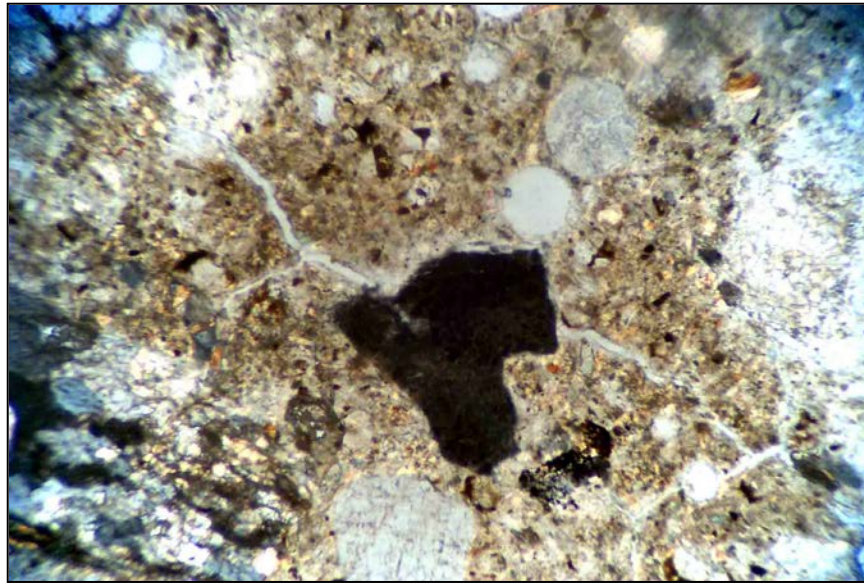
Figure 6 Photomicrograph showing ASR distress in the form of micro cracking.

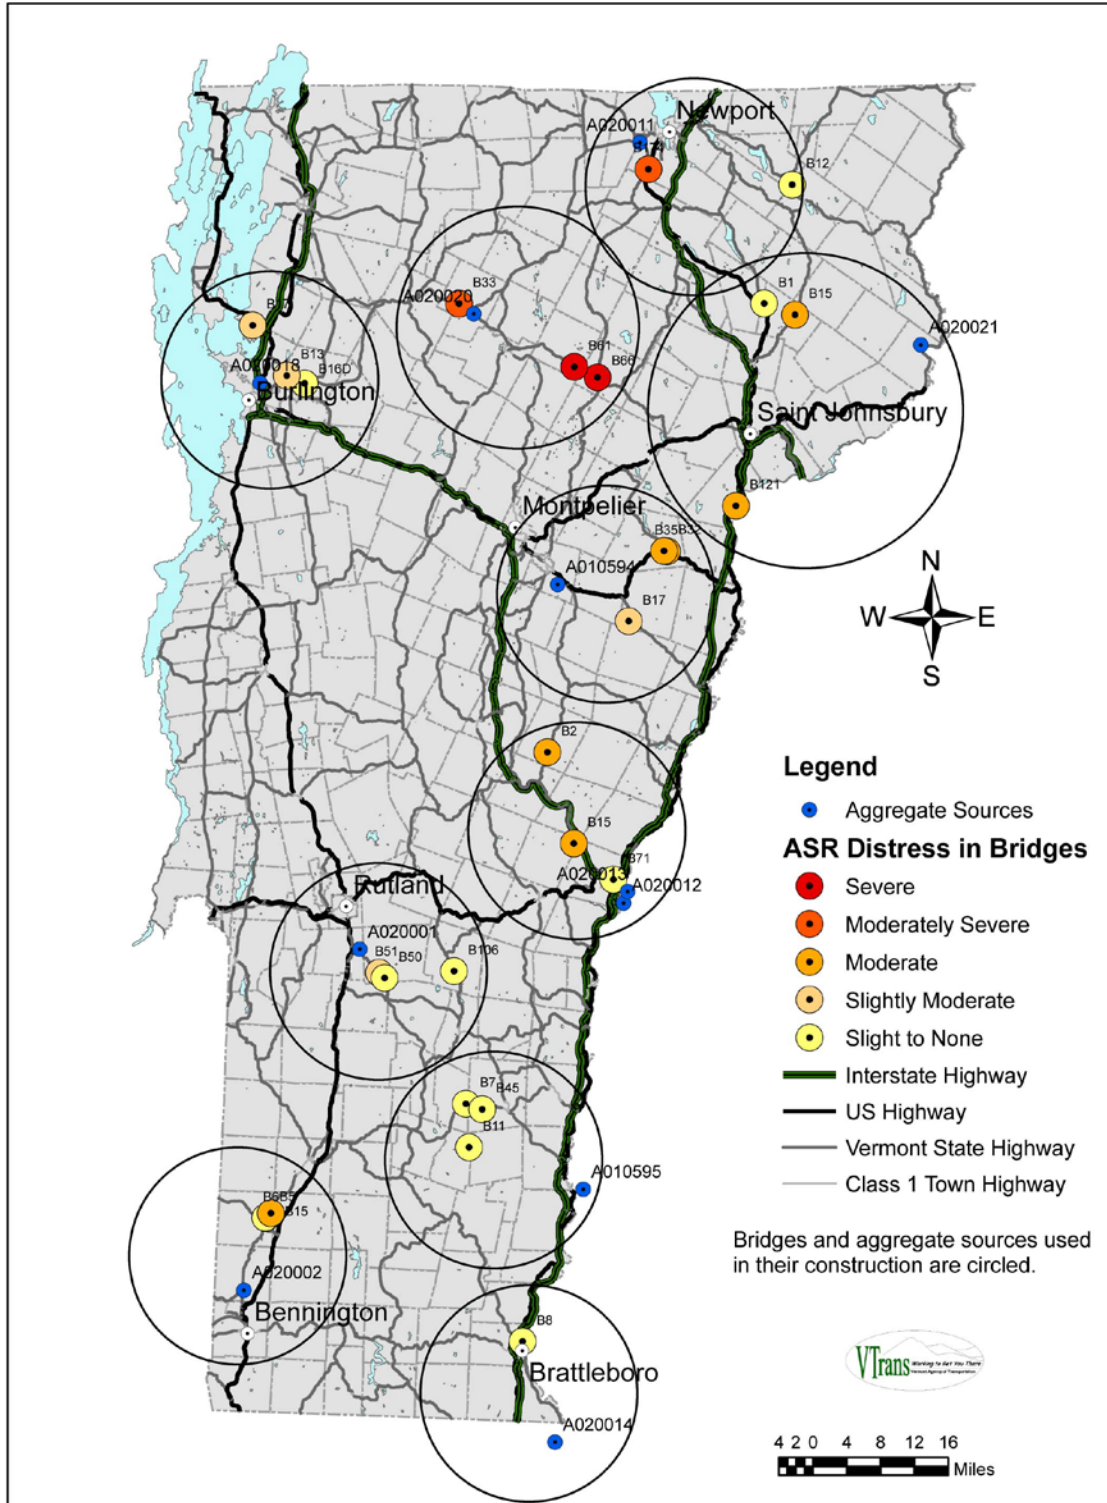
moderately severe ASR distress centered in the north-central portion of the state. Moderate ASR distress of bridges was noted in the upper Connecticut River Valley while slightly moderate to no ASR distress were observed in bridges in the Champlain Valley, Vermont Valley and southern portions of the state.

Figure 7 Map showing ASR distress in the bridges investigated during this study.
