Vermont Agency of Transportation
Program Development Division
Materials and Research Section
Phone (802)828-2561 Fax (802)828-2792

DATE: December 16, 2009
TO: Richard Tetreault, P.E., Program Development Director
FROM: Jason Tremblay, M.S., E.I., Research Engineer
Jennifer Fitch, P.E., Research Administrator
via Bill Ahearn, P.E., Materials and Research Engineer
SUBJECT: Insituform CIPP on I-91 in Barnet Assessment

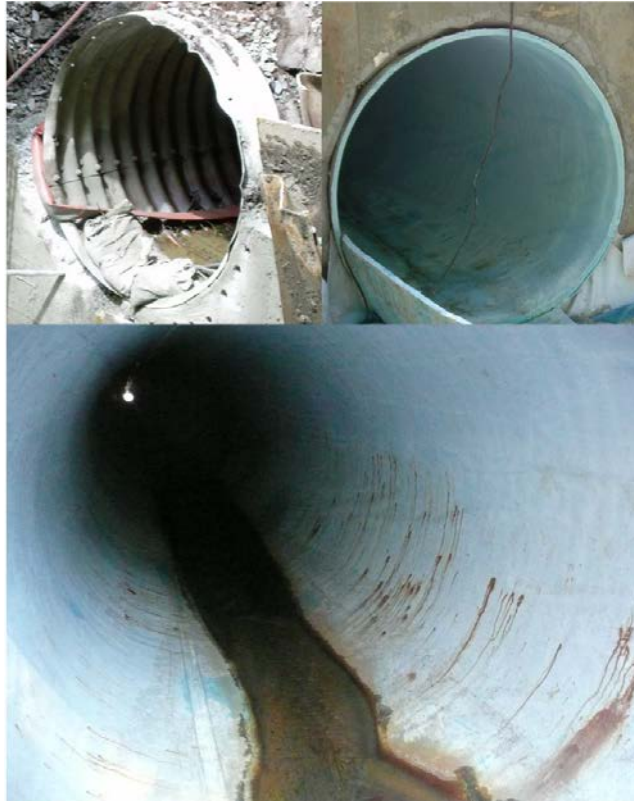
Once onsite, the inlet and outlet of the 54” culvert liner was visually inspected. Photographs were also collected and used later to compare the current condition of the inlet and outlet to the asbuilt condition. As stated in the “Culvert Overview” section, the outlet of the culvert liner is in much worse condition than the inlet, displaying considerable (suspected) corrosion staining. The inlet of the culvert liner also demonstrates staining as the outlet to a much lesser extent. The staining in question comes from the so-called slimy material that appears to be seeping through the liner. The material was brown in color and resembled a dirt substance, a product of metal corrosion, or both. The material has stained, as it has run down the curvature of the culvert liner due to gravity, and into the water present in the culvert. Photographs of the pre and post installation conditions, as well as current, are provided in Figures 1 and 2 below. There is no

Figure 1. Condition of the inlet of the culvert (clockwise from top left), preconstruction, post-construction, and present.

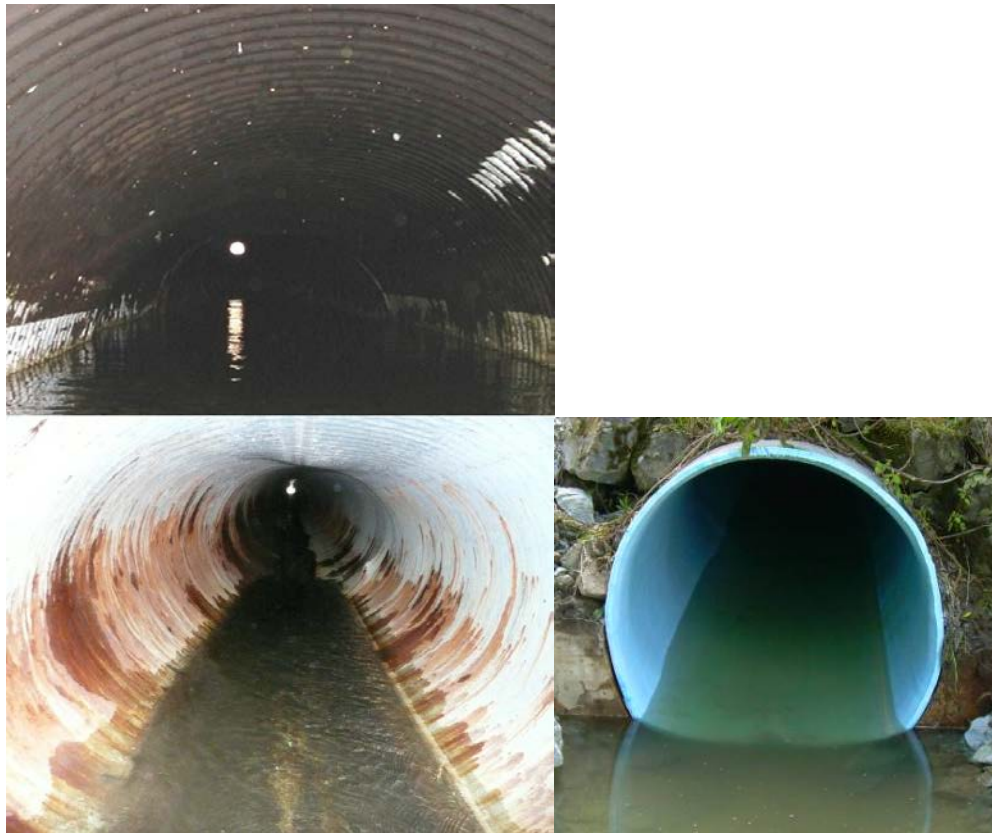
photograph of the outlet of the culvert liner immediately following construction for comparison. The staining pattern is shown below.

Figure 2. Condition of the outlet of the culvert at preconstruction (top), post-construction (bottom right), and present (bottom left).

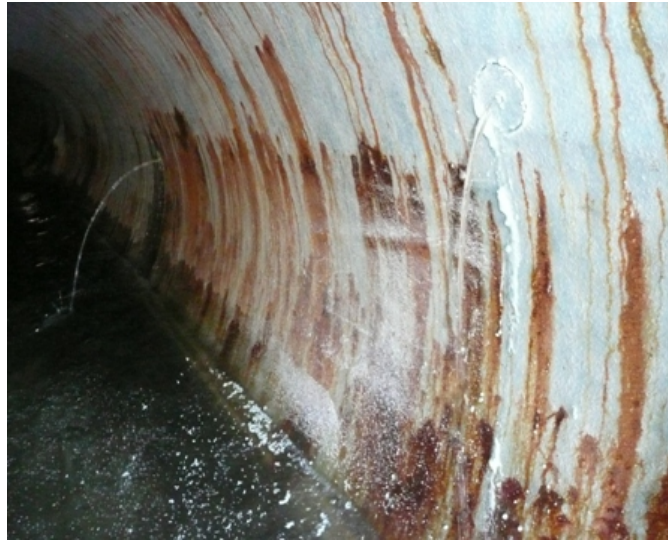
Upon removal of samples 1, 2, and 4, a steady stream of water poured through the liner from an outside source. Conversely, following the removal of sample 3, no excess water flowed through the liner. While the source was not identified, it is interesting to consider extraction height of the samples with respect to observed water infiltration. Samples 1, 2, and 4 were extracted at a maximum distance of 25 inches from the bottom of the culvert while sample 3 was collected from a distance of 38 inches from the bottom of the culvert. This could indicate that some

source of water creates a water table around the bottom of the pipe. Figures 3 and 4 below show the water ingress into the culvert at the three locations. Water at location 4 drained heavily into the culvert for a short time and subsequently stopped within an hour. Upon extraction, sample 2 was in two pieces with the outermost $\frac{1}{4}$ of an inch delaminated (separated) from the rest of the sample as shown in Figure 5.

Figure 3. Water flowing into the culvert at sample 2 (far) and sample 4 (near).

Repair of the core holes was performed using a product called Tiger Hair manufactured by Evercoat. It is a long strand fiberglass reinforced body filler, and claims to have high strength and high build, as well as being waterproof and stress crack resistant. The main drawback of this repair material (and almost any other) is that the repair area must be dry in order for the material to cure properly. Holes at test sample location 3 and 4 were easily repaired as water did not infiltrate sample location 3 and water only infiltrated through sample location 4 for a short duration. Unfortunately locations 1 and 2 were not able to be repaired on the day of sampling as water continuously flowed through them for the entire duration of the site visit. Repair will be attempted on a future date, when no water is present or when another method is proposed. However the presence of these small holes does not reduce the structural integrity of the liner.

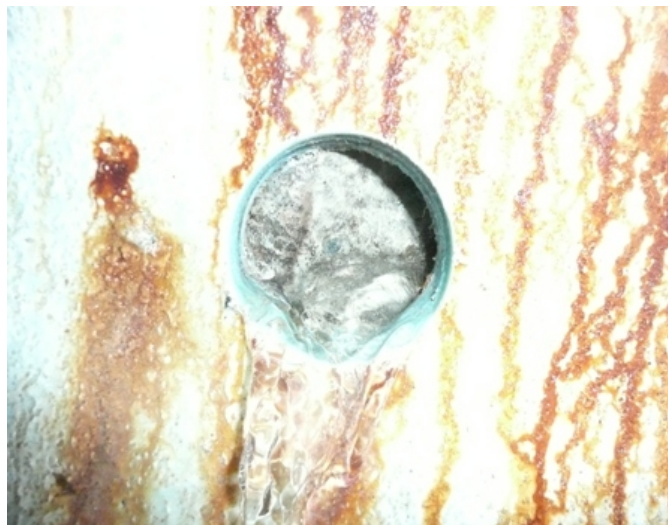
Figure 4. Water flowing into the culvert at sample 1

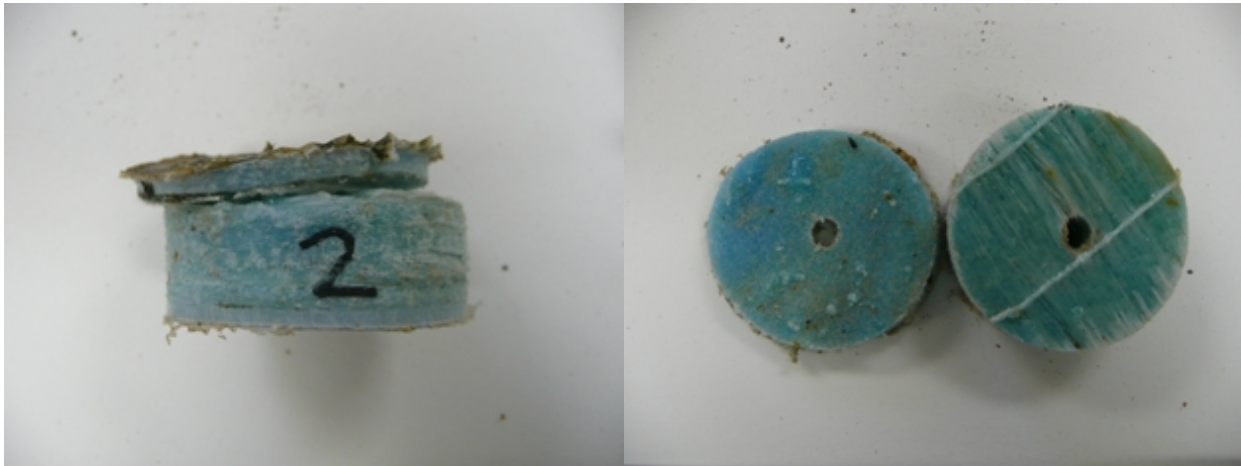
Figure 5. Photographs of sample 2, showing separated layers.

The left hand image in Figure 5 shows the cross section of sample 2, with the outermost layer (the layer closest to the original culvert) delaminated from the remainder of the sample. These two pieces have separated from one another; they appear to have not bonded during the curing process. The right hand image shows the difference in the appearance and structure of the different layers; one layer (right) being very fibrous, while the other (left) much smoother and homogenous.

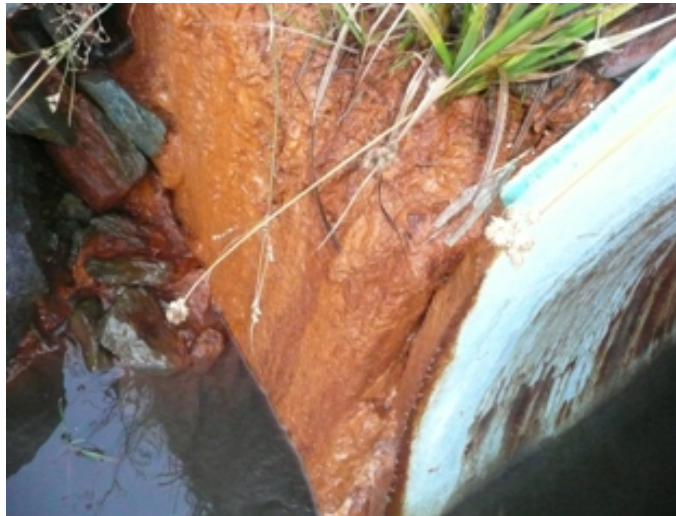
Figure 6. Photograph of the slimy material present on the outlet headwall.

Personnel in DEC looked at the two samples sent to the Lab on 11/24/09. The findings were the same for both samples and are described below. Both the samples contained the same Fe bacterium.

The sample brought down earlier today was examined under high power using a compound microscope. The sample composition was primarily iron particulates attached to detritus. Detritus is the general debris of living and nonliving particulate material found in our samples. Colonies of iron bacterium were also observed. We do not have a key to speciate iron bacteria, but it is a very common type according to Hynes's "The Biology of Polluted water is Leptothrix ochracea. It looked very similar to this species by using pictures provided in Ward and Wipple's 2nd Edition of "Freshwater Biology".

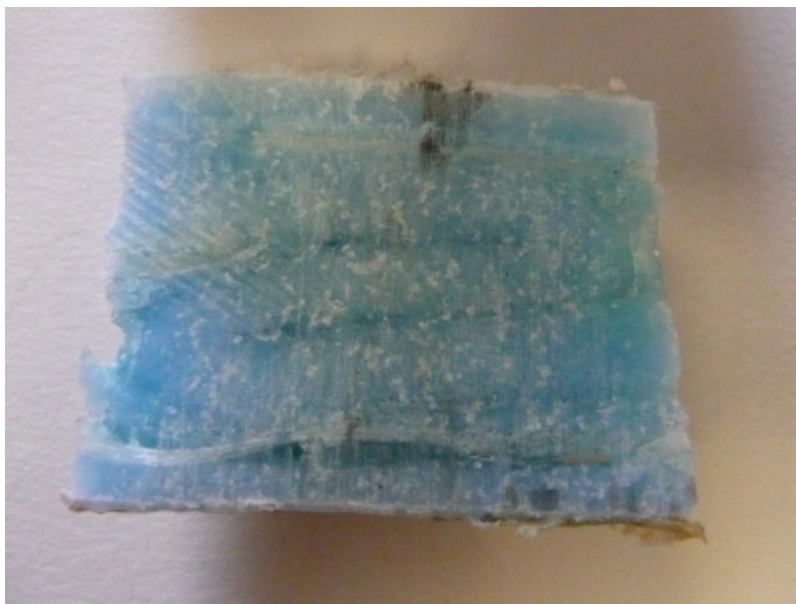
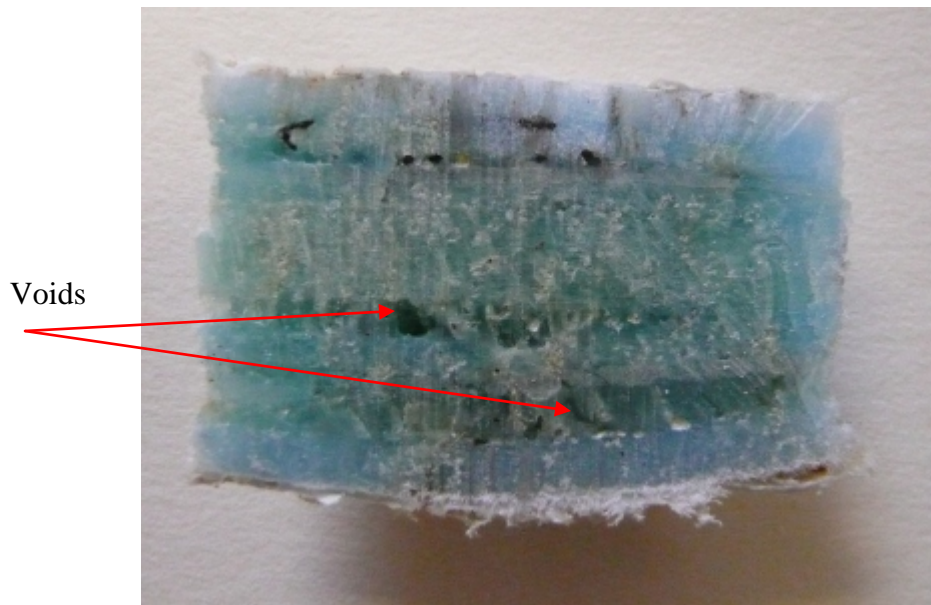
Figure 7. Cross sections of a 'good' sample (top) and 'bad' (bottom).

Figure 7 shows a distinct difference between a sample from a “good” location with no visible rust colored stains and a “poor” location with visible staining. The top image is very solid with few voids present, while the bottom shows large areas of voids and lines of corrosion migrating into the liner. Also present, at the location of the large areas of voids, is a seeming separation of layers of the liner, as was most likely the reason for the separating, or delamination, of the second ‘bad’ sample. This delamination appears to have occurred due to the polymer pulling apart before it hardened. This appears consistent with the possibility that the defects might have been caused by a reduction of steam pressure during the curing process. Sample 2, as mentioned earlier, was separated into two pieces when extracted, with an outer layer delaminating from the remaining liner.

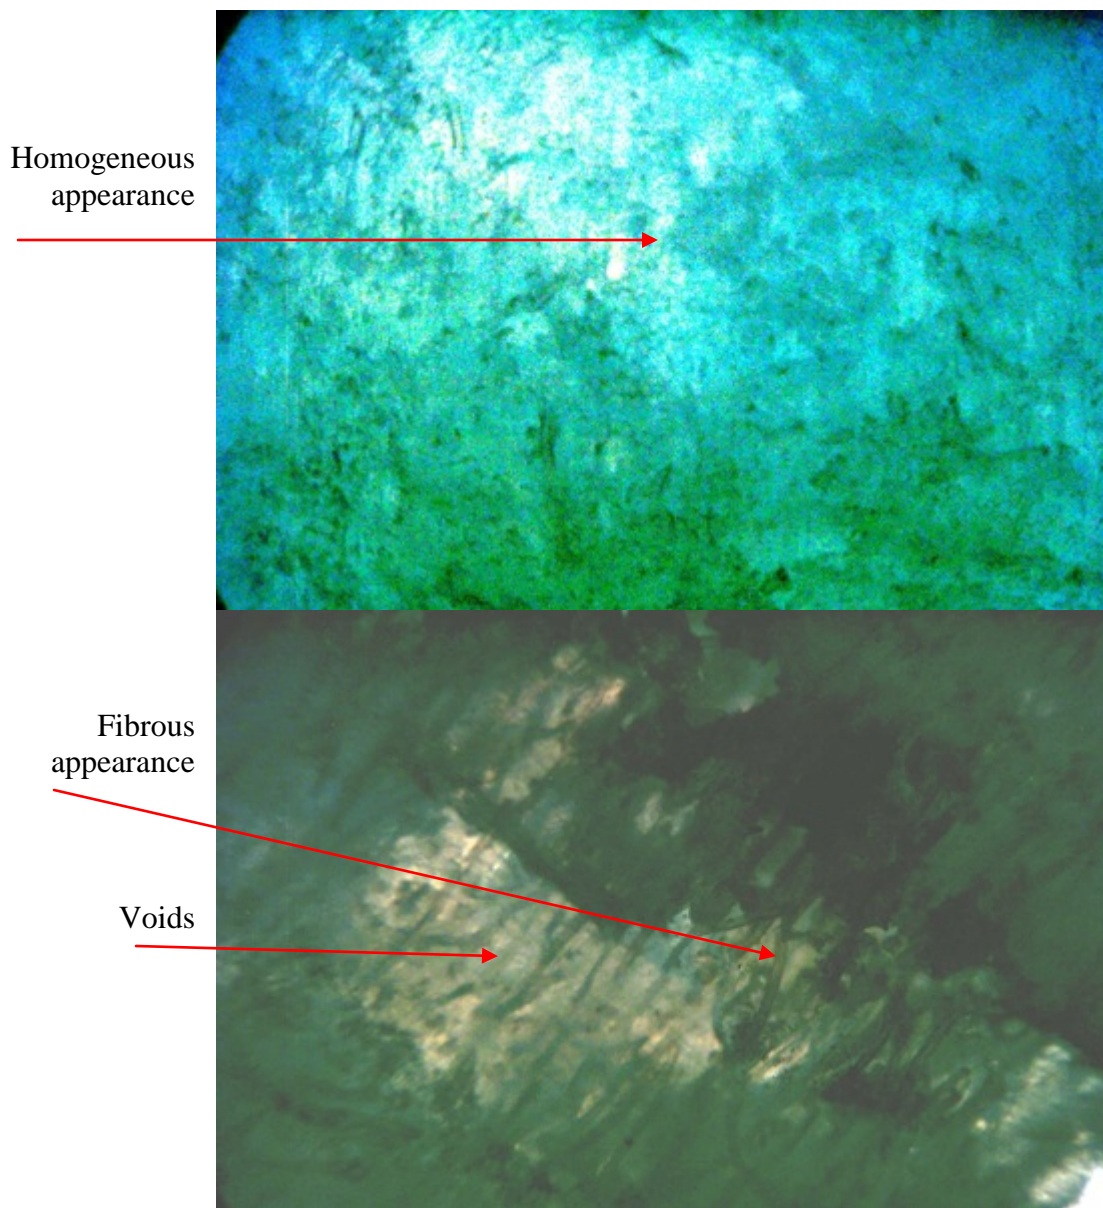
Figure 8. Microscopic images of cross sections of a 'good' sample (top) and a 'bad' sample (bottom) at 40x.

Figure 8, under 40x, also shows that the defective areas are much more porous and permeable than the intact liner, as rust colored stains could be seen throughout the cores, which indicates that the liner is somewhat permeable. The intact areas seem much more amorphous, indicating homogeneity, than the defective areas, which have a more fibrous appearance. Small fibers are contained inside most voids. This fibrous appearance could possibly be due to the stretching of the partially cured polymer during inflation of the liner and also during deflation if steam pressure was lost.
