**WESTFALL FIBERGLASS BRIDGE DRAIN SYSTEM**

Report 2013 – 03

March 12, 2013

Follow Up to Initial Report 2007 – 07

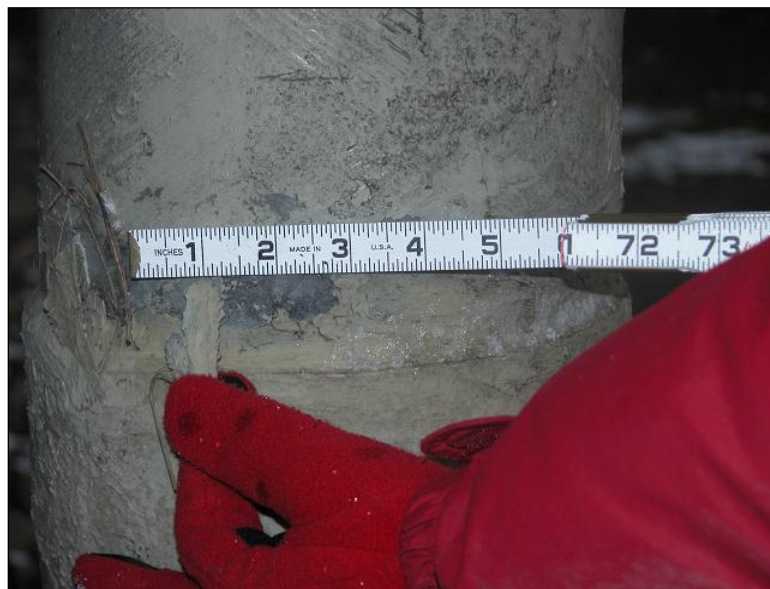
**Figure 1 – Flaking of Adhesive**

The group also examined the pipefittings. While found to be in good condition, external flaking of the resin adhesive, used to bond and seal the elbow pieces to the straight pipe section, was observed as shown in Figure 1. This raised concerns regarding the potential for water infiltration between the connections potentially resulting in freeze thaw damage during winter months. Immediately following the site inspection, the Westfall Company was contacted to discuss this phenomenon. The company explained that the resin adhesive would not adhere to the glazed finish on the exterior of the pipe. The company further stated, the bond between fittings is the only place requiring the resin and that it is not required beyond the joint.

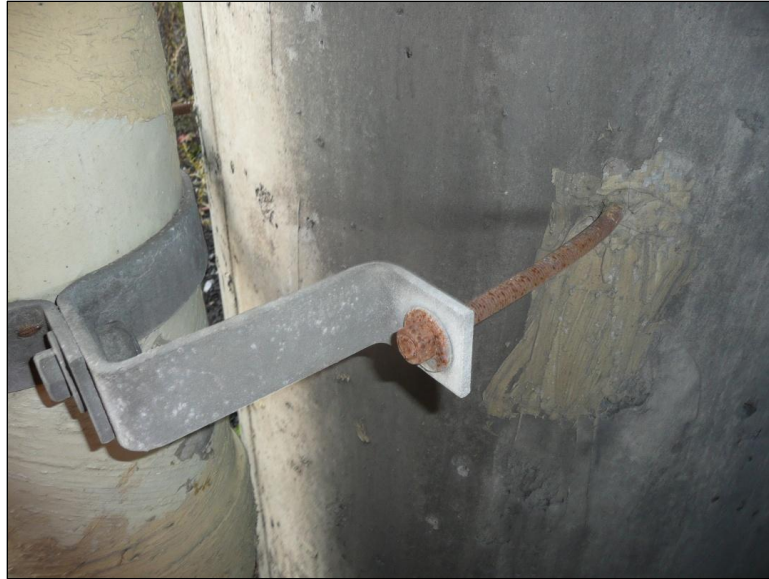
**Figure 2 - Deformed Bolt**

The group examined all lower supports during the site visit and found that they displayed signs of distress. As shown in Figure 2, the bolts that secure the drainage system to the pier were slightly deformed. This is most likely caused by shear forces generated from wind currents and bridge vibration. Section loss resulting from rust was also observed. Both will likely contribute to some form of stem or shear failure. When assessed by Peter Bergeron, he stated that the bolts were too small in diameter to withstand shear and vibratory forces.

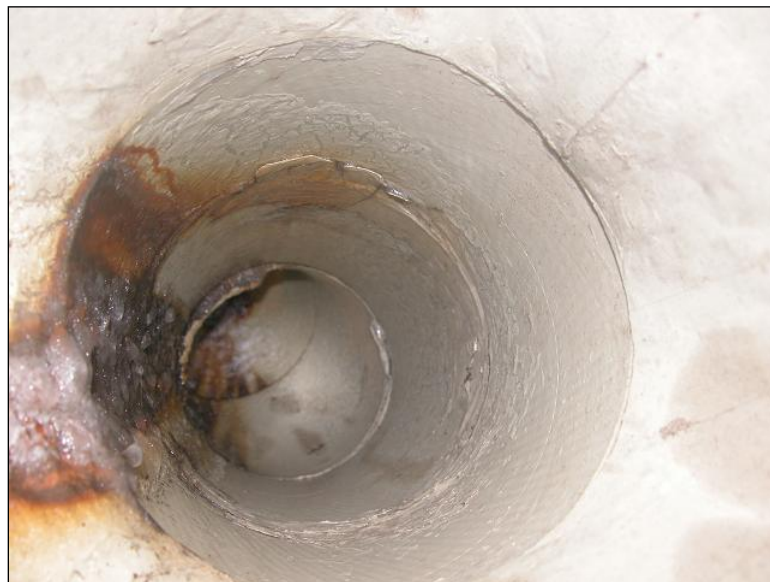
**Figure 3 - Iron-Oxide Discoloration 2006**

The group inspected the interior of each catch basin and associated trough, revealing iron-oxide discoloration as seen in Figure 3 and in Figure 4. The discoloration is likely resulting from bridge deck runoff containing rust. The inspection also indicated that there was some plugging resulting with water pooling in the catch basin, thereby forming an orange colored ring around the top. Peter pointed out what he referred to as “fissure cracking” within some of the fiberglass structure, a term referring to the miniscule cracks in the fiberglass caused by fatigue, movement and expansion stressing.
