AN EVALUATION OF TYFO-S FIBRWRAP

Report 2013 – 05

May 9, 2013

In June 1994, Bridge #60 in Williston underwent rehabilitation to repair damage from salt intrusion in the columns and piers. Rather than employ a standard concrete encasement, the Agency evaluated a fiber reinforced polymeric (FRP) encasement that has tensile strengths fifty times greater than concrete. TYFO S Fibrwrap was applied to the columns of Pier #1 of Bridge #60. The columns are located close to the travel lanes and become coated with salt impregnated slush cast by high-speed traffic. The TYFO S Fibrwrap was selected in order to prevent further contamination from the salt spray, along with providing structural reinforcement for the patched concrete members. (2)

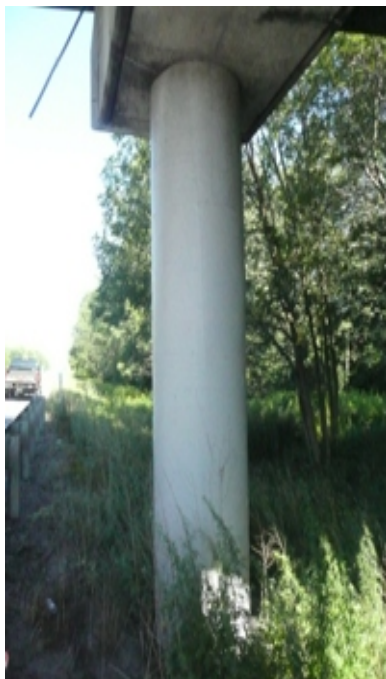
Upon the inspections in July of 2010 and in May of 2013, no further imperfections were noted. The Fibrwrap material seems to be performing at a very satisfying level. The concrete columns beneath the surface have shown no signs of distress or decay, and even though there is some surface rust leaching from the core holes, it is not considered to have any structural consequence. The untreated concrete columns under have exhibited further cracking and

spalling. The control columns are overall in worse condition than the experimental columns. At this point, nearly nineteen years after installation, the TYFO S Fibrwrap material remains aesthetically pleasing as well as structurally sound. A comparison of a wrapped and unwrapped column is shown in Figure 10 and Figure 11.

Figure 10: Column #3 under pier #1, 2010 treated with TYFO S Fibrwrap

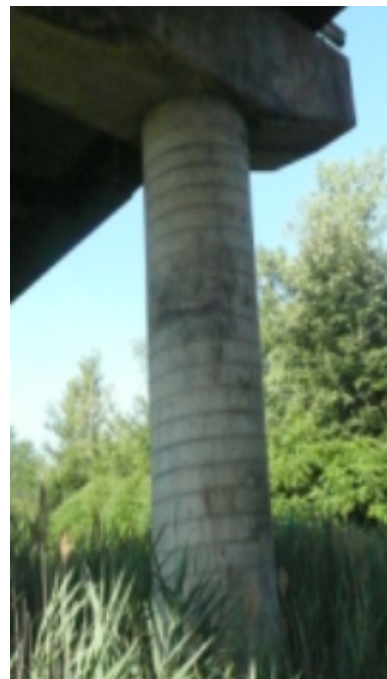
Figure 11: Column #3 under pier #2, 2010 not treated with TYFO S Fibrwrap
