VERMONT AGENCY OF TRANSPORTATION

ENNIS PAINT, INC. TYREGRIp HIGH FRICTION SURFACE SYSTEM

Report 2014 – 02

March 2014

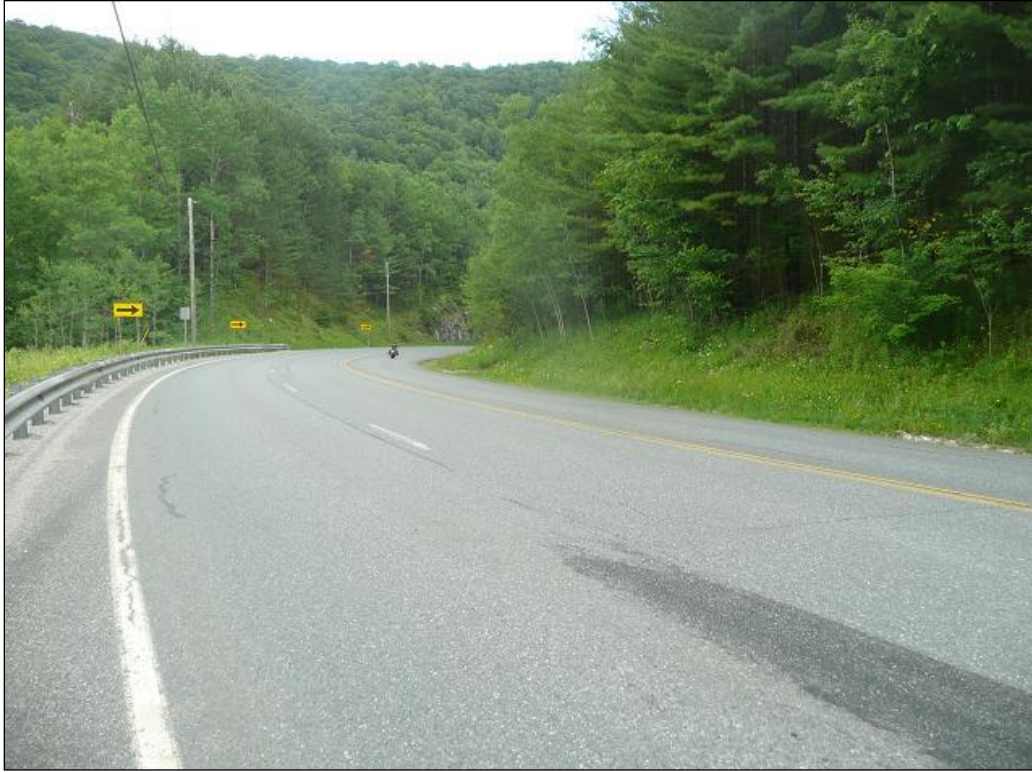
Figure 1 Overview of the site pre-construction

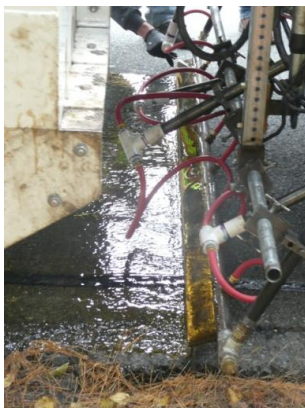
The application process shown in Figure 2 and Figure 3 began at 10:49 am at which time, the pavement temperature was 51°F and the air temperature was 52°F. The operation was halted by the contractor after laying 60 feet down. The epoxy did not appear to be curing correctly and the truck did not appear to be moving smoothly and at the necessary slow speed required for the application, presumably due to the steep grade of the hill. At this time, the contractor cleaned and changed several distribution hoses to meet proper application requirements. After several attempts, the contractor told Research personnel that they would not be able to correct the problems and decided to apply the overlay by hand.

Figure 2: Epoxy truck application

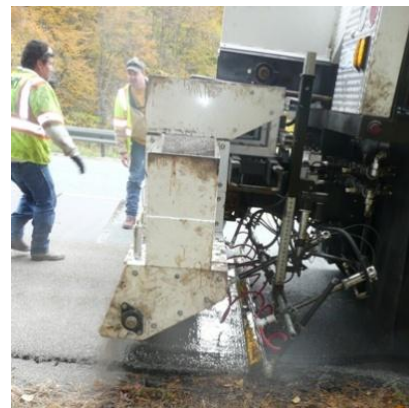
Figure 3: Truck application

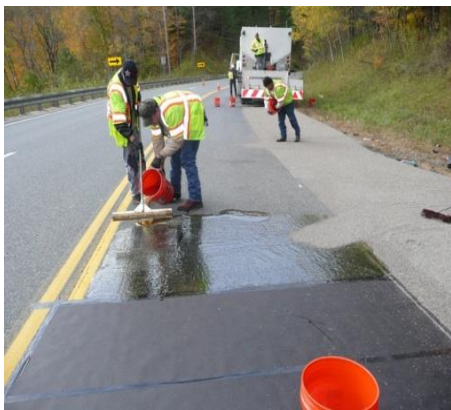
Figure 4: Hand application

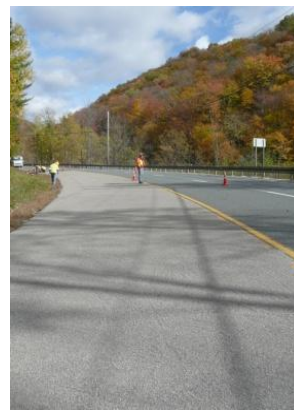
Figure 5: Completed application

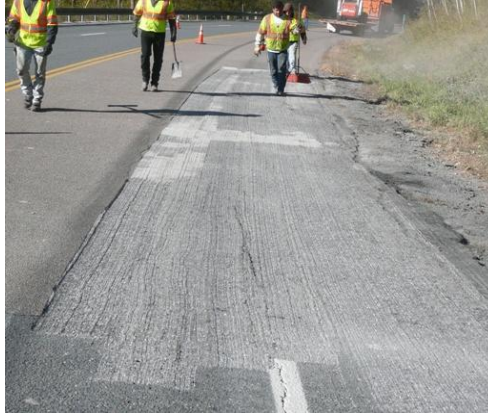
At the conclusion of the day, the contractor decided that the 60 feet of mechanical applied material previously placed was not curing properly due to improper mixing ratios of the two-part epoxy and needed to be removed and replaced. They proceeded to scrape the material off the roadway. Some of the material remained on the roadway surface. To rectify the issue, the contractor returned on Monday, October 12 to repair this section.

Figure 6: Repair area, after grinding and sweeping

On October 12, 2009, THM, District 1, and Research personnel were once again, onsite to complete the removal of the improperly placed overlay and the subsequent replacement of new overlay within the 60-foot by 8.5-foot section. The operation began at approximately 9:20 AM at which time the pavement temperature was 31°F and the air temperature was 43°F. The errant material was removed by grinding the existing surface and a minor portion of the underlying bituminous pavement. Loose materials remaining on the surface were removed with a sweeper shown in Figure 6.

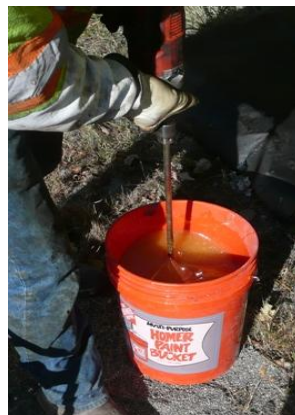
Figure 7: Mixing the epoxy

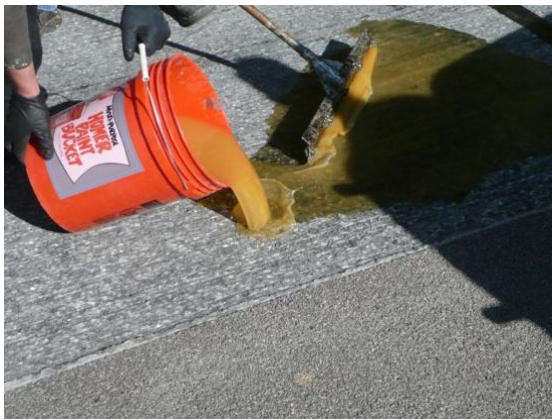
Figure 8: Pouring the epoxy

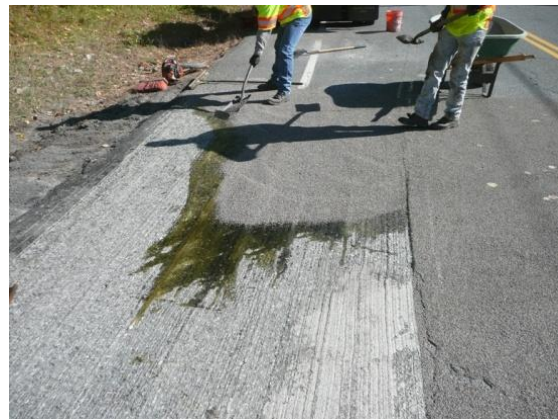
Figure 9: Spreading the aggregate

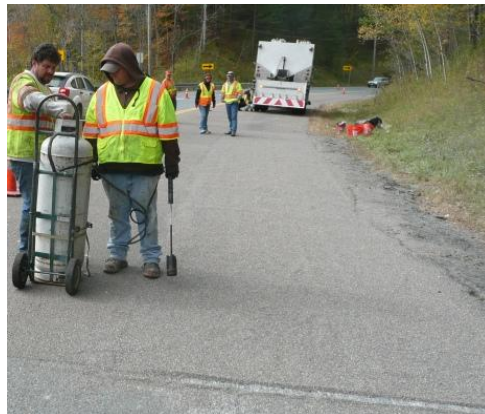
Figure 10: Completed repair

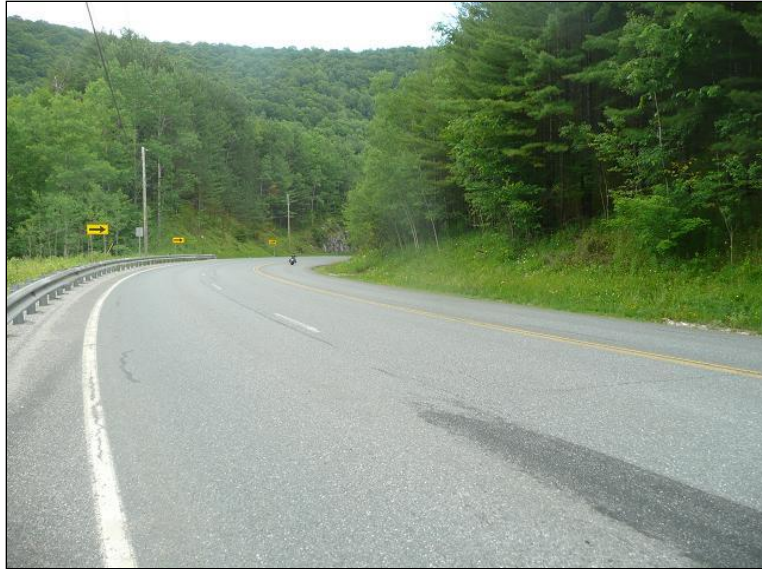
Figure 11: Overview of site
