**ASSESSMENT OF JAHN PERMEABLE MORTAR SYSTEM IN A
HISTORIC BRIDGE ABUTMENT APPLICATION**

Report 2015 – 10

June 2015

Reporting on Work Plan 2011-R-05

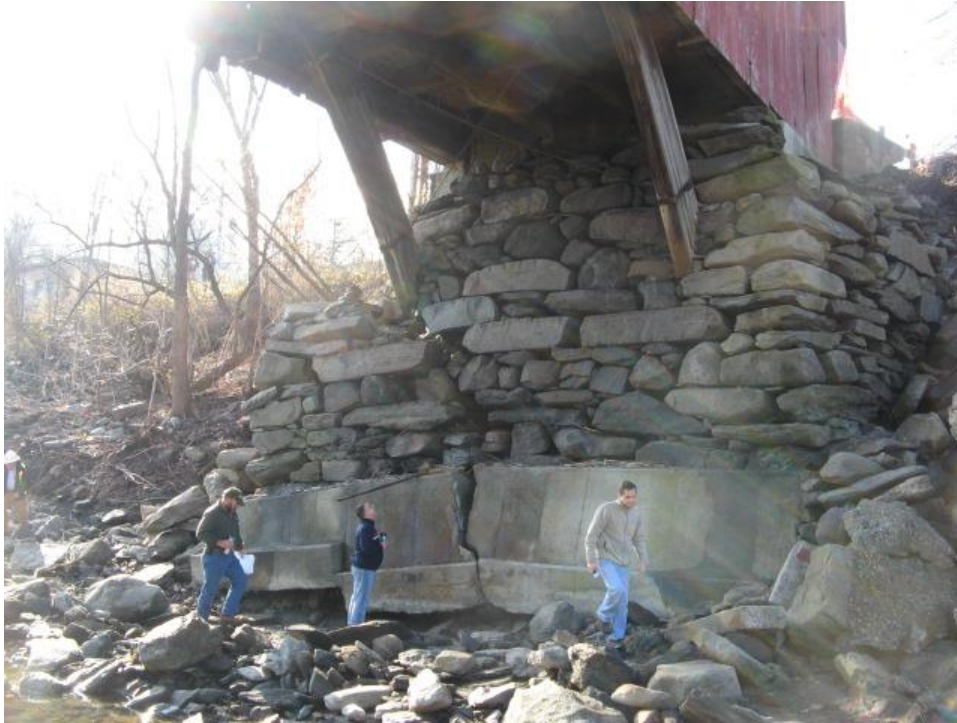
Figure 8 Westerly abutment partially collapsed (VTrans 2011)

The tropical storm eventually undermined the westerly abutment at the downstream end. The abutment fractured (Figure 8) resulting in the downstream westerly arch to pull out of the stone socket securing it in place. (Figure 10) In turn, the westerly span twisted, causing damage at connections throughout both spans. The covered bridge was scheduled for a nearly \$3 million National Covered Bridge rehabilitation project that was scheduled to begin in September 2012. Much of the work that was planned for that project was incorporated in the project resulting from the storm activities.

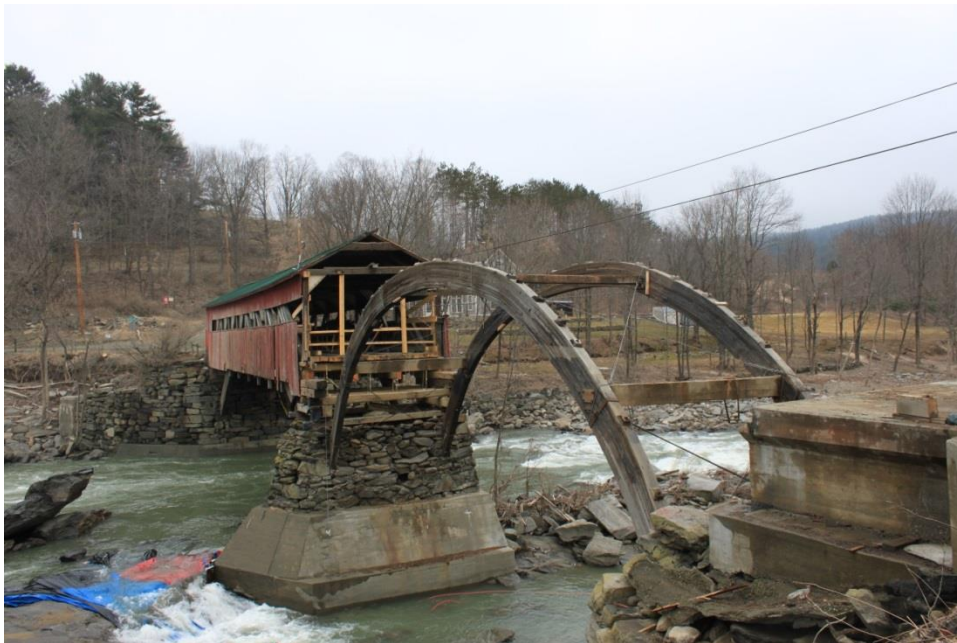
Figure 9 Westerly span dismantled leaving only the arches (VTrans, 2011)

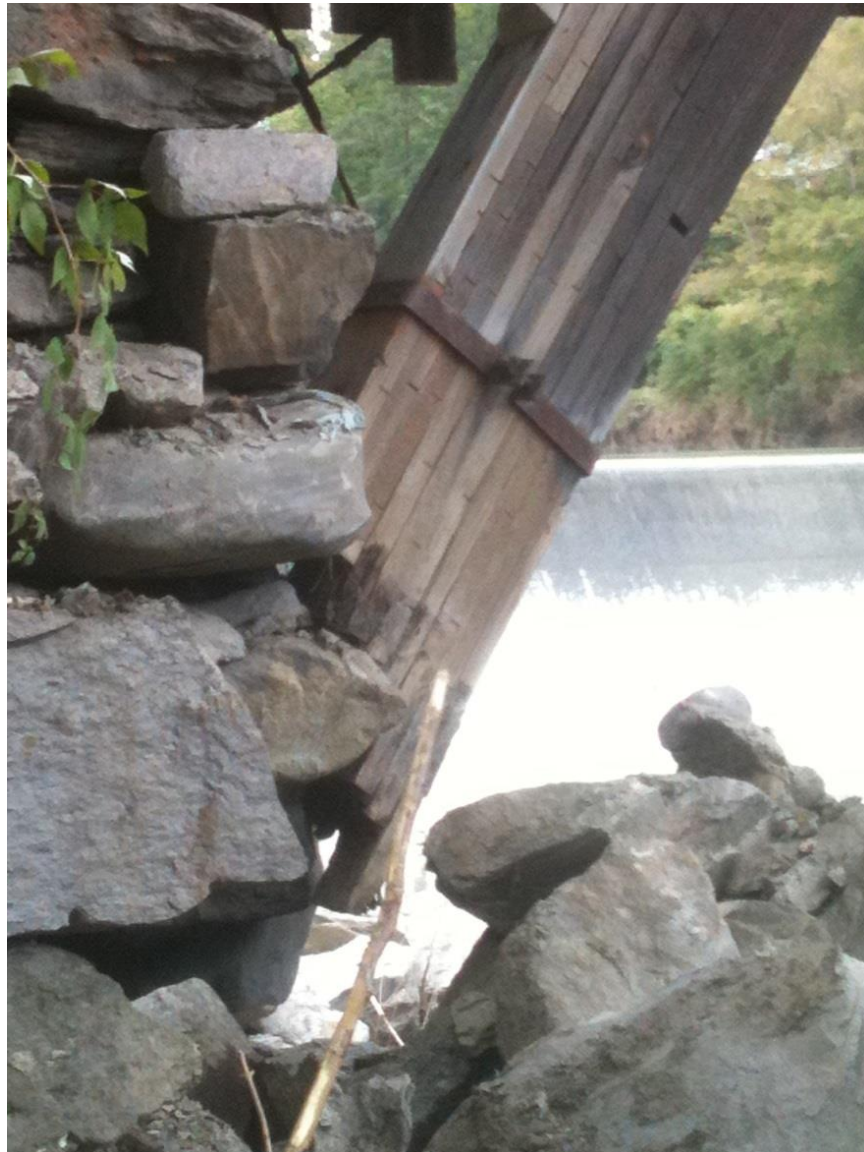
Figure 10 Downstream westerly arch dislodged from abutment (VTrans 2011)

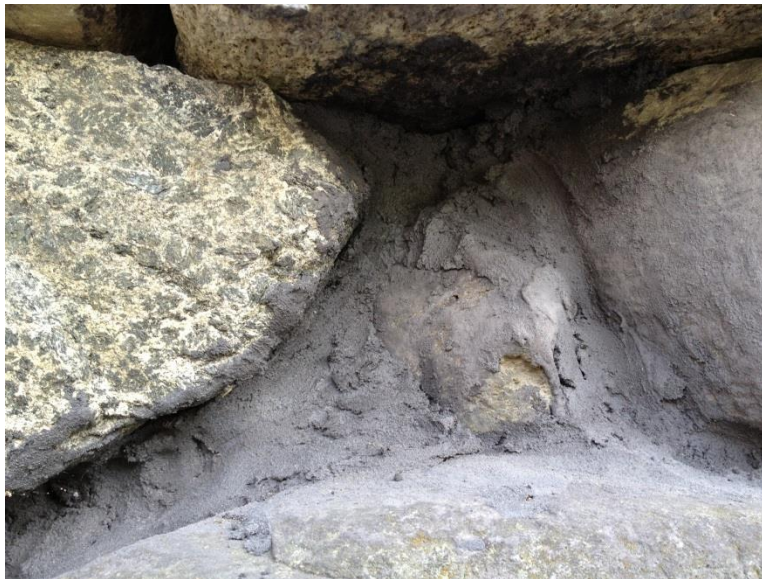
The stonemason used a narrow pointed mason's trowel to pry out small loose stones and debris from the dry-laid stone joints. Using a brush or their hands, the stonemason would remove dust and dirt from within the joints. The crew had access to an air compressor, which they used to clean fines out of the joints. It was determined that a power washer would be the best option to conduct the final cleaning of the stones. Where there were gaps, the stonemason would size up a stone provided on the rigging, and fit it into the opening, carefully matching the shape of the stone to the shape of the gap. In places, several stones were required. Smaller stones were worked deep into the larger gaps (Figure 14 and Figure 15). The stones for this work came from the collapsed westerly abutment that was being excavated. The larger stones were broken apart to make smaller stones for chinking.

Figure 14 Up-close view of stone pointing and mortar work (VTrans 2013)

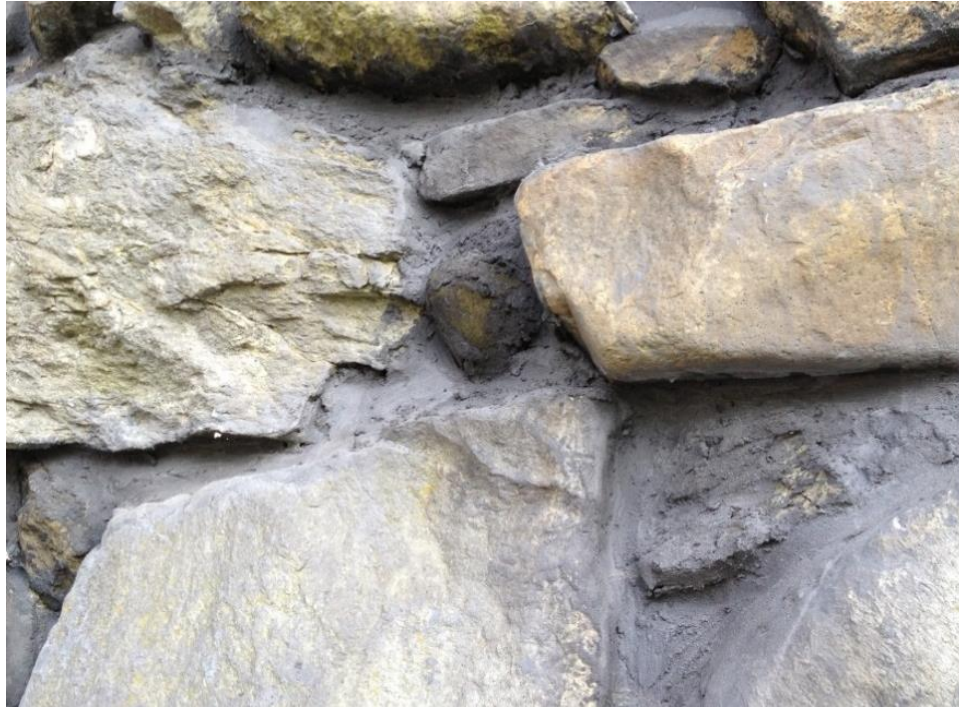
Figure 15 Completed mortar work (VTrans 2013)

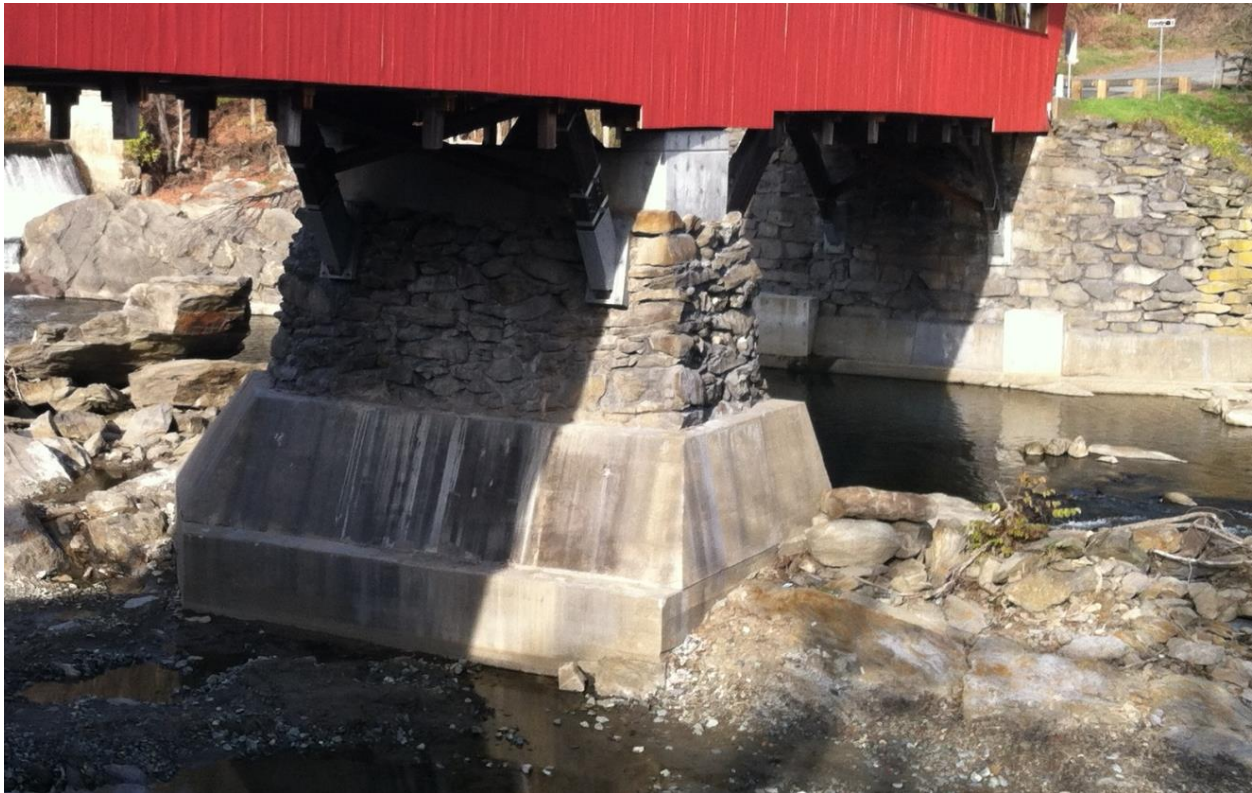
The final work on the pier was placing a new 3-foot high reinforced concrete cap (Figure 17) for the midspan of the bridge span to rest on and to distribute the vertical loads from the bridge into the pier. The cap was affixed to the stone pier by 28 anchor rods that were drilled and grouted into the stone. Six shafts in a 3-by-2 grid were drilled through the concrete cap and on through the grouted stone mass ending 4 feet into the existing riverbed ledge below the pier. 1-inch diameter high-strength threaded steel anchor rods were inserted into the shafts and embedded into the ledge using grout. The rods were bolted and tightened to a specified tension.

Figure 17 Completed pier showing the concrete cap and abutment (VTrans 2013)

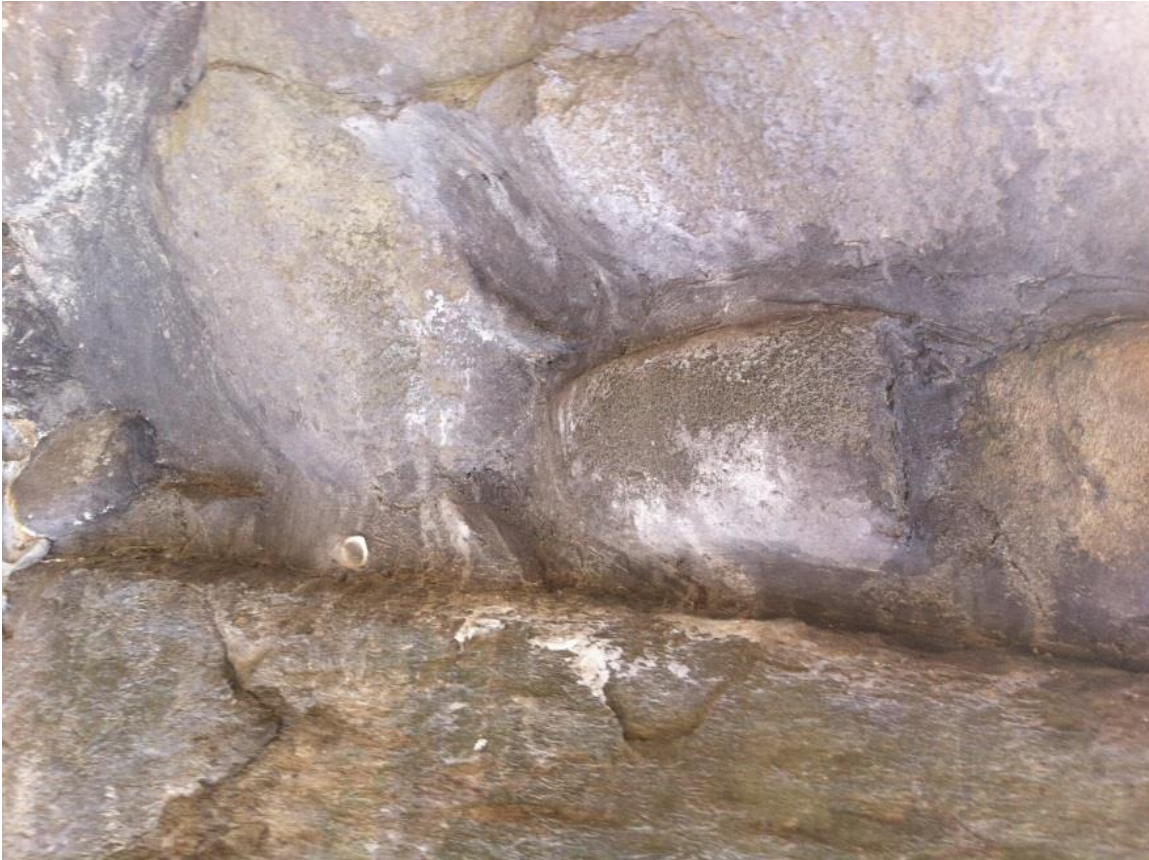
Research and Development has visited the project site once a year since the project has been completed. In a discussion with the CEO of Cathedral Stone Products, Denis Rude, he said that as the salts leach out of the interior of the pier and abutment, a white powder like substance would appear on the surface of the grout. This powder would eventually blow off the surface with wind or be washed off by rain. There were concerns that the repairs to the pier and abutment would cause an efflorescence to form in places. The use of the Jahn products was intended to prevent such efflorescence from forming. In the last two years, the white powdery substance has

been observed forming; however, it is not accumulating (Figure 18). There seems to be a consistent light dusting in places. Overall, the grout appears to be functioning as expected.

Figure 18 Up-close view of white powdery residue on mortar (VTrans 2013)

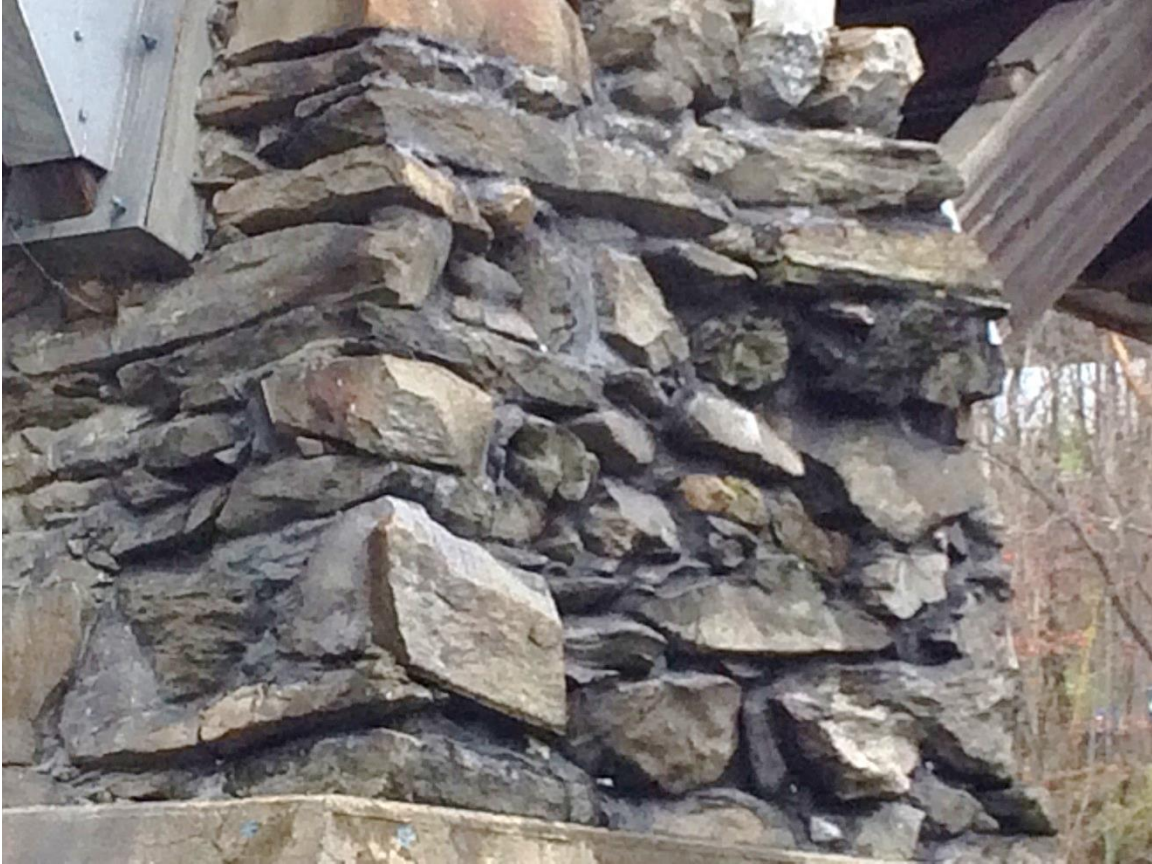
Another purpose of using the Jahn products was to strengthen the dry-laid stone pier and abutment to preserve the overall historic appearance of the bridge. Concerns were that the mortar would be obvious from a distance. Observations at various distances from the substructure units gave an appearance of dark joints between stone (Figure 19 and Figure 20). The mortar and pointed stones were virtually invisible to the eye from afar. Even up close, the dark grey color of the mortar has aged in a way that it is not obvious in most places on each substructure unit. Places where the mortar is visible are where there were large gaps in the dry-laid stone (Figure 21).

Figure 21 Downstream face of pier showing final construction (VTrans 2014)
