## MATERIALS & RESEARCH DIVISION

## RESEARCH UPDATE

NUMBER U88-19

### PERFORMANCE OF EXPERIMENTAL METAL CULVERTS

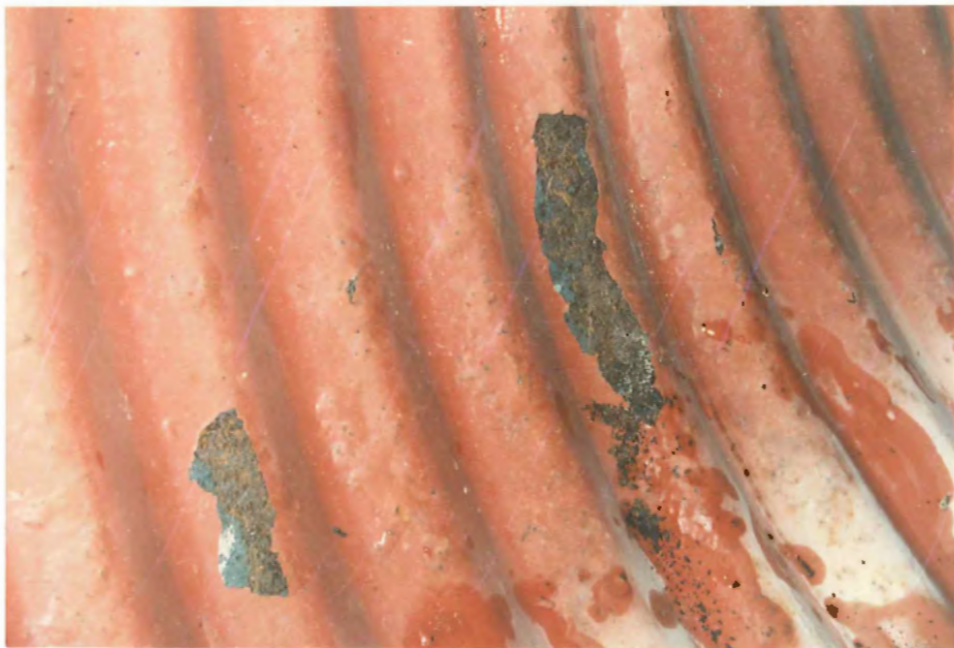
Epoxy Bonded - Segment No. 1 (at outlet)

1983 (2 years exposure). Some pitting or abrasion of coating near outlet on upstream side of corrugations and a similar condition has occurred at annular rolled ends.

1984 (3 years exposure). Coating has cracked and flaked off at a location where pipe was dented during placement.

1985 (4 years exposure). Corrosion undercutting and blistering the coating at a few locations.

1987 (6 years exposure). Slight increase in coating failure. Loose coating is brittle.

1988 (7 years exposure). The outlet half of the 20' section has blistering over 50% of the area on the upstream side of the corrugations from the bottom to the midpoint of the pipe. Very little blistering on the downstream side of the corrugations. Removal of the coating from two 1½" x 3" and 5" areas revealed active corrosion was occurring on the underlying steel. Neither this inspection or earlier ones gave any indication that the blistering was preceded by cracks or other breaks in the coating. The upper 10' of pipe had very few blisters visible but the coatings' surface gloss has disappeared.

Note blisters in coating and complete corrosion where the epoxy was removed for inspection

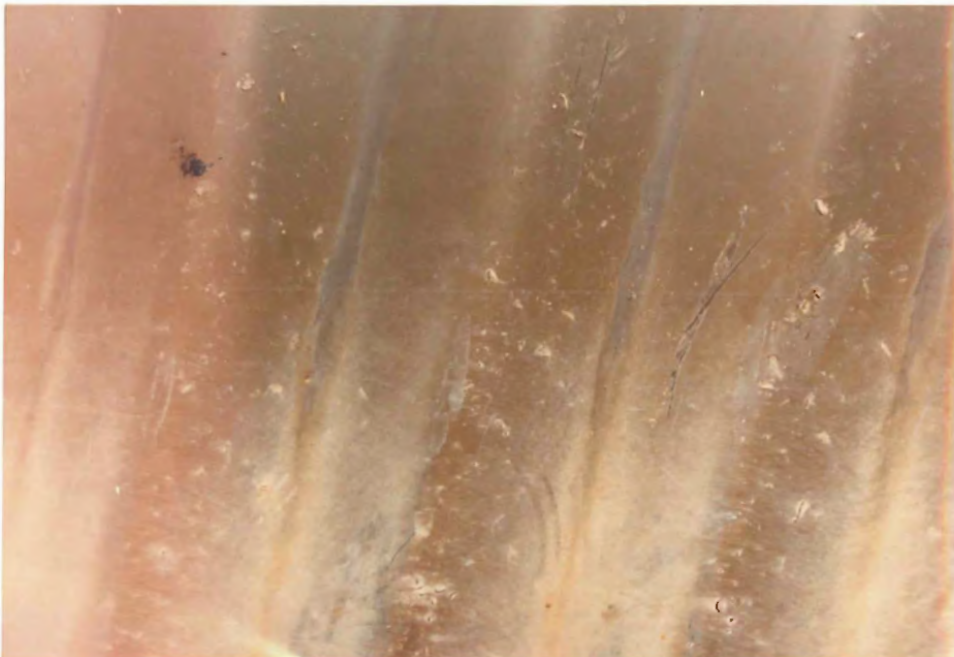
Beth-Cu-Loy - Segment No. 3

1984 (3 years exposure). Minor pitting noted in the coating on the upstream side of the corrugations in the area of water flow.

1988 (7 years exposure). Numerous (3 to 6 sq.in.) small chips, nicks, or gouges in the coating with all located on the upstream side of the corrugations up to the midpoint height of the pipe. In some cases the nicks appear to be deep but there is no visible sign of any corrosion present. The coating is still as flexible to fingernail pressure as it was at the time of installation.

Note nicks in coating on up stream side of corrugations

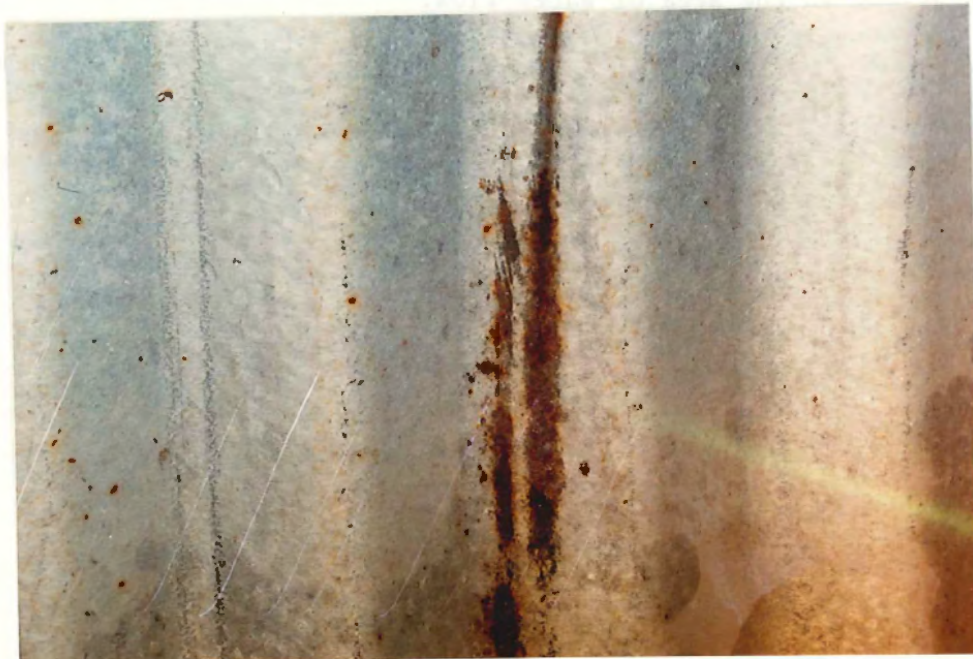
Aluminized Type II - Segment No. 4

1984 (3 years exposure). Some rust at welded helical seams.

1985 (4 years exposure). Rusting on increase at welds and occasional corrosive pits visible at widely scattered locations.

1987 (6 years exposure). All welded seams 100% surface rust plus additional spot locations.

1988 (7 years exposure). Spot corrosion visible at random locations averaging a pit per 4 sq.in. Corrosion also present on a  $\frac{1}{2}$ " wide x 6" to 8" high area in the third corrugation from each seam in the 6 o'clock to 9 o'clock quadrant.

Note band of corrosion plus random spot corrosion
