## MATERIALS & RESEARCH DIVISION

### RESEARCH UPDATE

NUMBER U90-1

#### 3M 350 TAPE ON OPEN GRADED PAVEMENT - I 91 LYNDON-BARTON

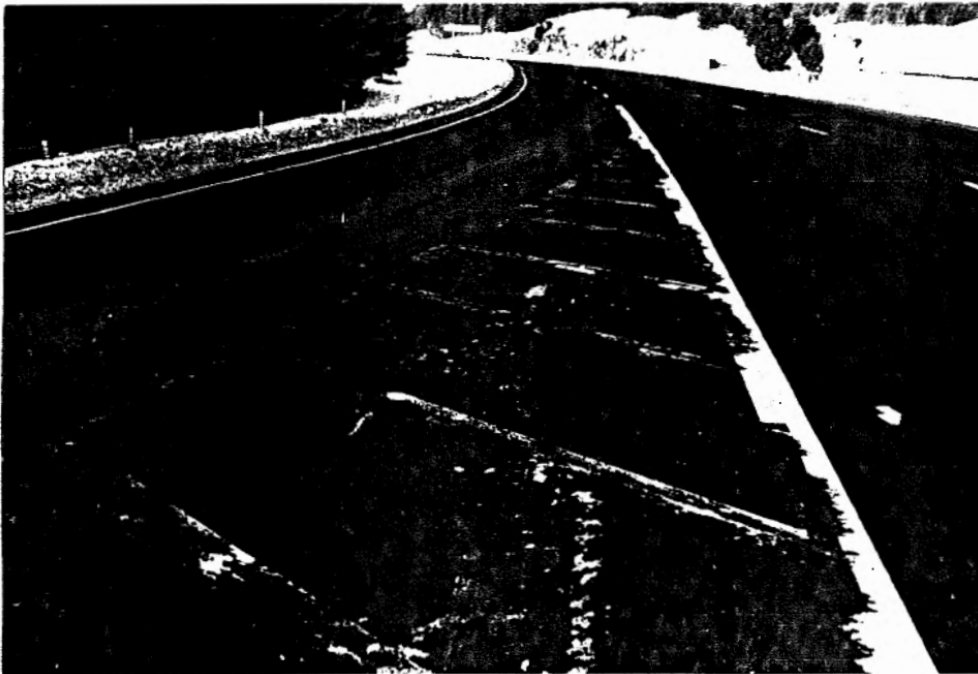
Typical Gore Area as of January 1990

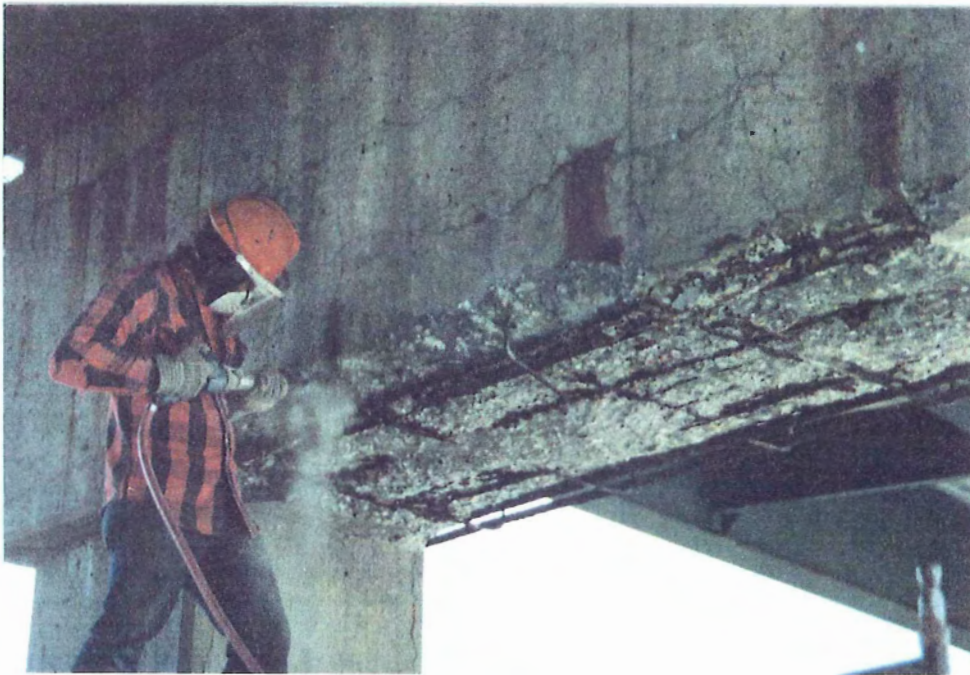
FIGURE 1

Preparation of Existing Concrete Substructure

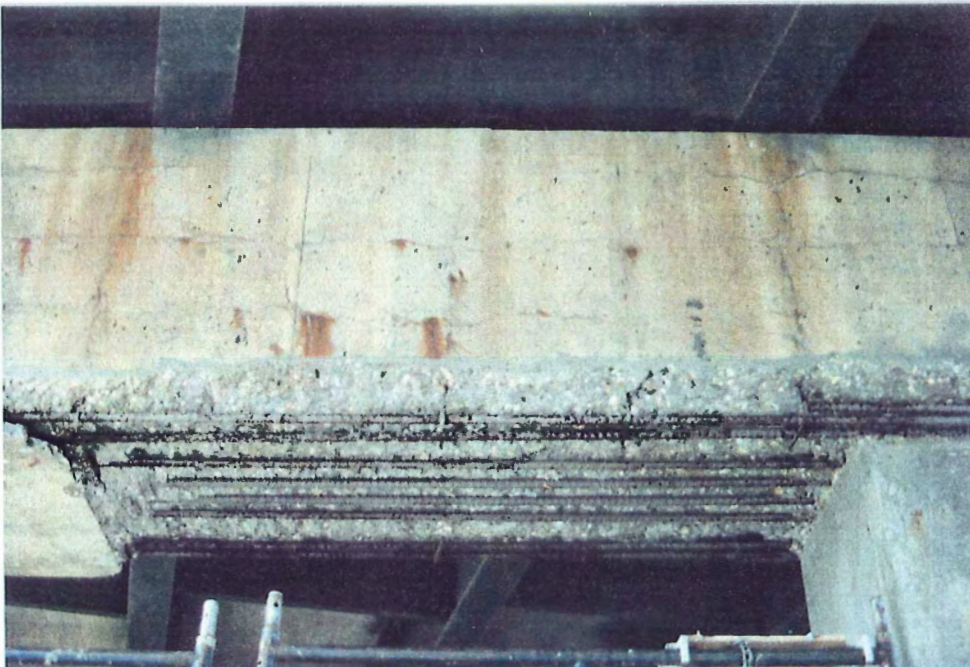
FIGURE 2

Prepared Surface

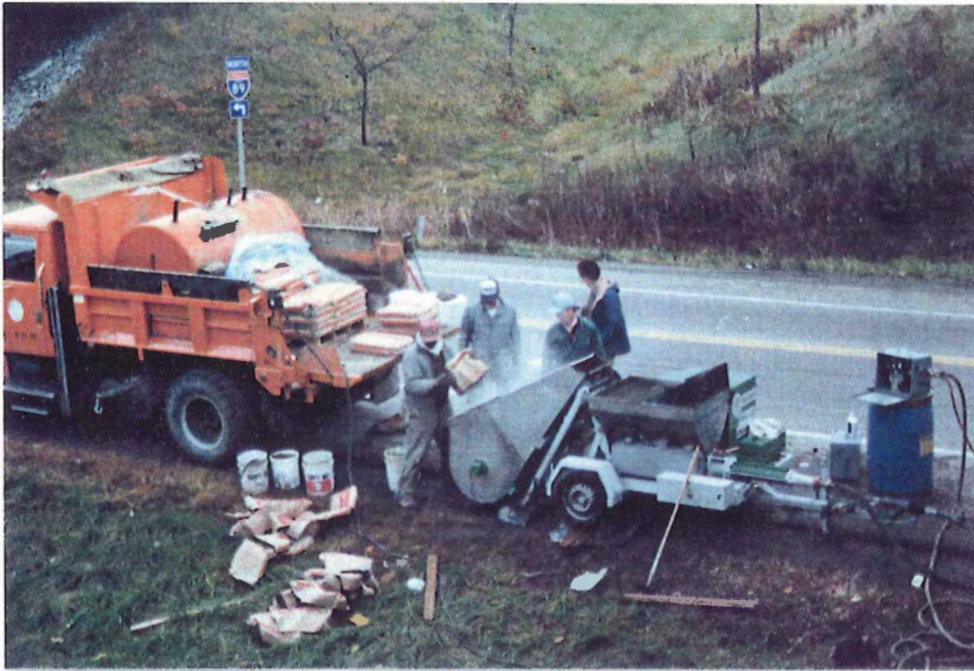
FIGURE 3

Mixing/Pumping Operation

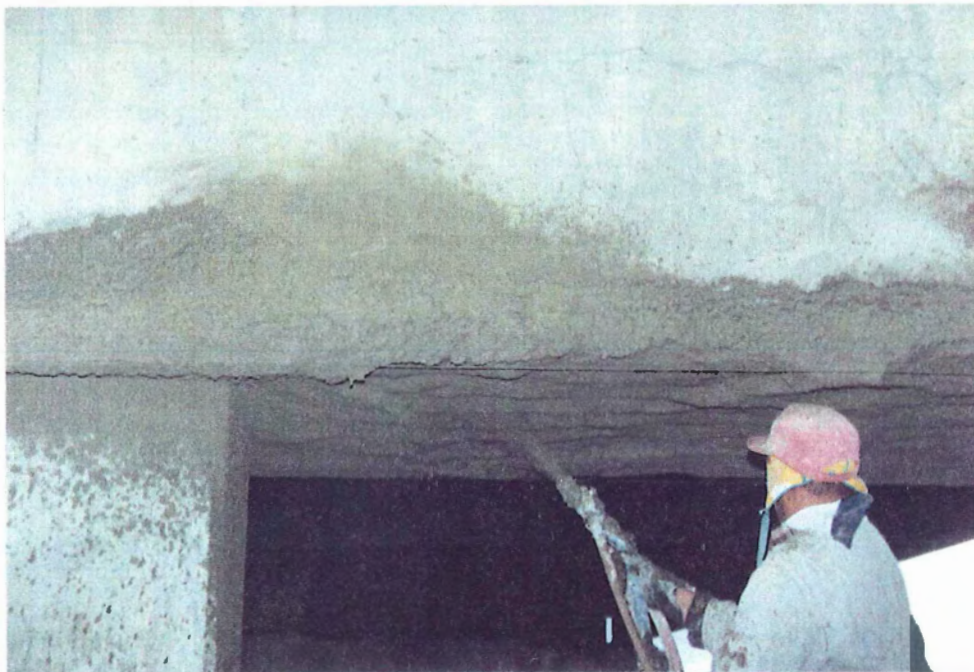
FIGURE 4

Shotcrete Application

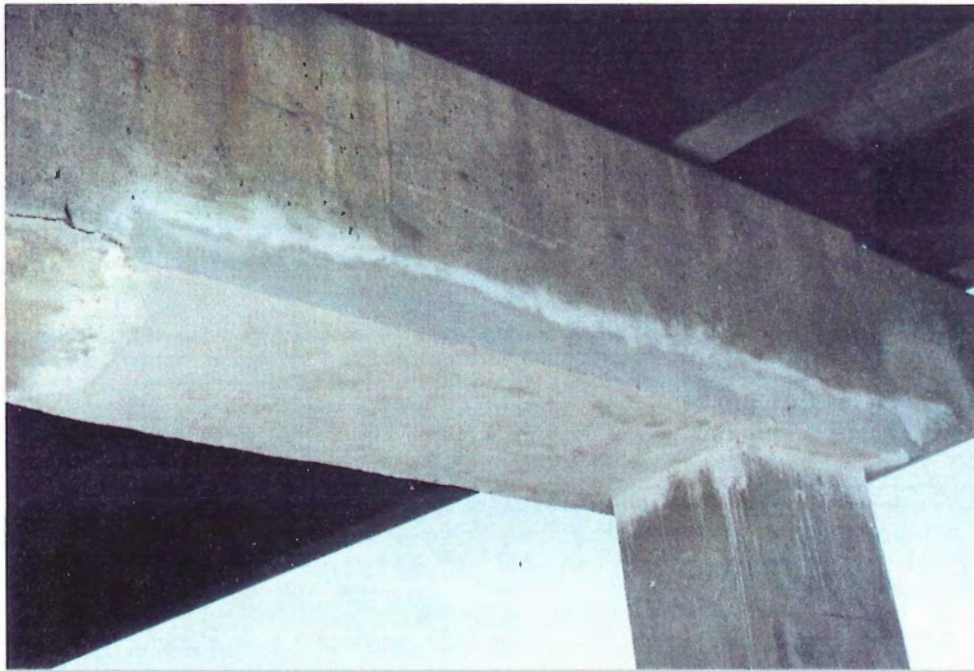
FIGURE 5

A field inspection of the project conducted on April 23, 1990 revealed a series of hairline cracks spaced at 10 to 15 inches along the vertical faces of the pier cap. Cracking extended down one face of the patched area across the bottom of the cap and up the other face. The cracks were interconnected in a random pattern on the bottom. The exact cause and depth of the cracks is unknown. In general, the finer the aggregate in the mixture, the more likely shrinkage cracking will occur. As the outer portion of the repair contained no material coarser than the 3/8" sieve size, this is one possible explanation for the cracking.

Soundings taken on the entire repair area indicated one delaminated section measuring 20" by 23" located 40" from the east face of the westerly column. The remainder of the shotcrete appeared very solid and quite well bonded despite the extremely poor condition of the adjacent concrete and the undesirable weather during application.

Completed Repair

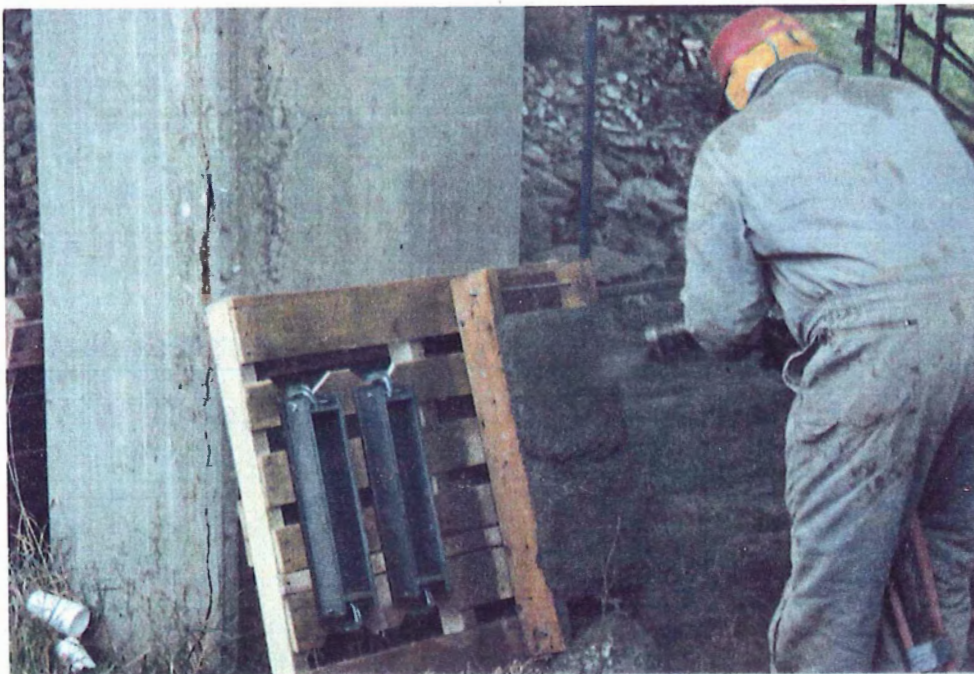
FIGURE 6

All specimens were cast in a vertical position using Gilbertson Shotcrete Specialty's GS-Shotpatch 10. Fabrication was completed with the same equipment and procedures used on the substructure repair, see Figure 6.

Test Specimen Fabrication
