RESEARCH UPDATE

Number U91-9

THORMA-JOINT BRIDGE JOINT SYSTEM
(Status Report)

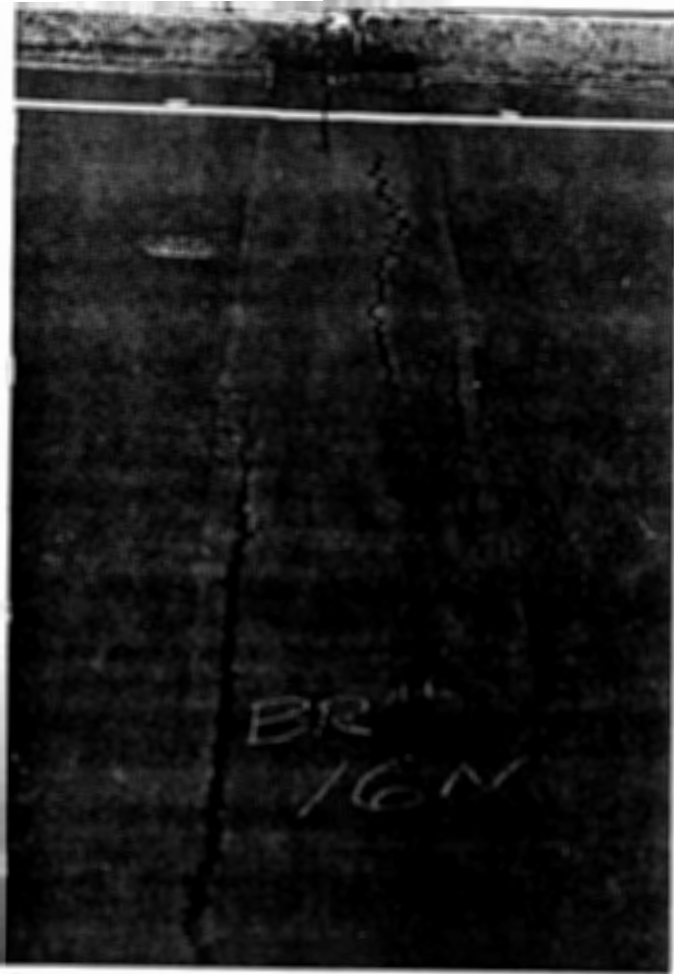
When the joints were re-inspected on December 6, 1990, the distress in the north joint was markedly worse. There were 15.5 linear feet of cracking between the joint material and the adjacent pavement noted, and the distortion in the joint material had given way to 17.3 linear feet of cracking. The joint gap showed a relative movement of 3/4" since the October inspection. The south joint again had no visible signs of distress, probably due to the small (1/16") relative movement in the joint.

The installation of the Thorma-Joint systems as described in Update Report U90-8 and field notes from the joint installation varies somewhat from the procedures outlined by the contractor's proposal. The procedures call for each layer to be allowed to cool before application of the next layer. During the installation, three lifts were placed in less than one hour, which may not have allowed sufficient cooling time. The procedures call for immediate compaction

of the final lift using a roller. Instead, the lift was water cooled, then compacted with a plate vibrator.

It has recently been observed that despite the fact that the north joint gap is only 1/4" from its position during installation, there are still cracks up to 3/4" wide in the joint material. Thermal shrinkage of the mix after installation could be a factor in explaining this phenomenon.

Thorma-Joint System Failure in North Joint

The contractor has been notified of the situation, and has verbally agreed to repair the joint as warranted.
