MATERIALS & RESEARCH DIVISION

RESEARCH UPDATE

Number U93-7

PERFORMED THERMOPLASTIC DEMONSTRATION

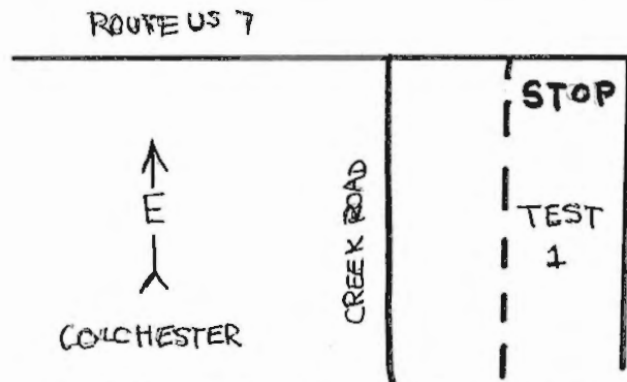
Test 1:

The existing one year old thermoplastic symbol was in poor condition. The one year old pavement was in good condition. The existing thermo letters (STOP) were ground off with a Tennent Rotary Drum Grinder with special grinding teeth made for thermoplastic removal. The area was swept with a push broom. The removal took approximately 25 minutes.

The new thermoplastic letters were heated with the heat gun, using a sweeping motion 4"-6" from the surface. The thermo turned gray/black. Bubbles of oil rose to the surface and the material actually caught on fire occasionally but the flames went out immediately. A fairly heavy application of glass beads were sprinkled on the letters as they were being heated. The joints did not melt together very smoothly. The hot plastic at the bottom of the letters was drawn down with a putty knife to provide a tapered edge. Hopefully this will prevent chipping from the snow plow blade.

The procedure was repeated for each letter. Someone stepped on the "P" and left a dirty spot of asphalt from his shoe. The spot was patched with a small piece of extra thermo melted over the area. During this process, some dirt and dust were blowing onto the site and it is probable that there is a layer of dust between the dried surface and the new thermo. Each letter took about 8 minutes to heat and apply beads.

The area with the poor bond was reheated to improve the bond.

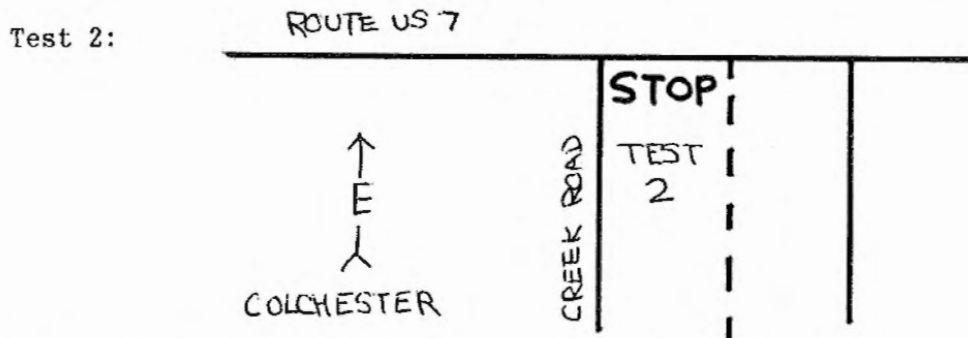
The pre-existing conditions were the same as Test site 1.

On Test 2 the heated letters were sprinkled with a mixture of 1/2 glass beads and 1/2 crushed glass. A small wooden wheel was used to taper bottom edges of the letters. This resulted in a very neat taper.

The joints did not melt together smoothly and the letter "P" was not heated as much as the other three letters.

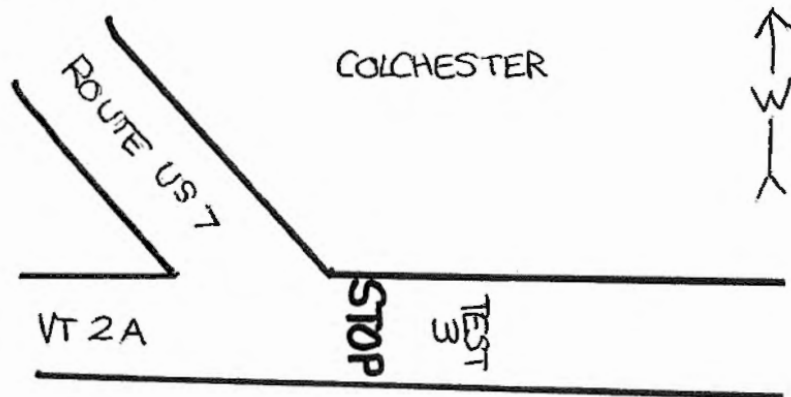
Test 3:

Glass beads were sprinkled on the letters S T & O. On the "P" a mixture of 1/2 Colchester Quartzite (Whitcomb Quarry, Colchester) and 1/2 glass beads were applied on the upper 2/3 of the letter and glass beads only on the lower 1/3.

The quartzite mixture made the thermo appear very dirty.

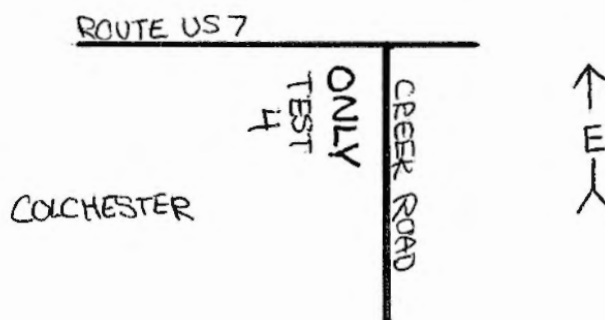
Test 4:

The existing one year old thermo letters were in fair condition, the one year old pavement was in good condition.

The area was cleaned with compressed air and the old letters were heated with the shrink gun. The old thermo bubbled up and turned light brown.

New letters were placed directly over the clean, heated, old letters, one letter at a time. The heated surfaces were sprinkled with glass beads and the letters were tapered with a putty knife.

Bonding test indicated good bond.

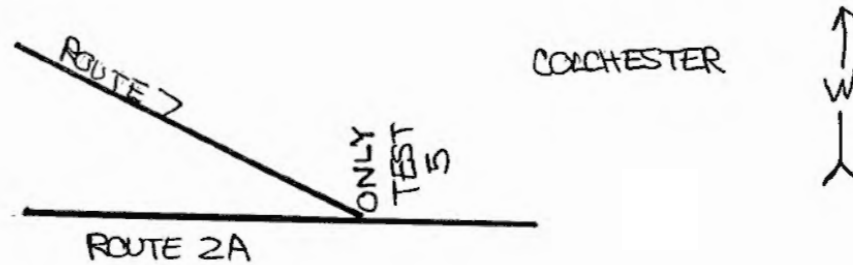
Test 5:

The same procedure was used as in Test 2 except that only glass beads were used.
