RESEARCH UPDATE

Number U94-7

TYFO S FIBERWRAP COLUMN STRENGTHENING & REHABILITATION SYSTEM

The Richmond-Williston IM Deck(29) project includes rehabilitation of seven I-89 structures, among them bridge (BR) #60 in Williston. The three columns of pier #1 of BR #60 were selected for treatment with the TYFO S System. Although the damaging effects of salt splash to this structure were greatly reduced during the late 60's by the addition of drainage troughs at the bridge joints, residual chlorides had taken their toll, and the columns of pier #1 were in need of preventive maintenance.

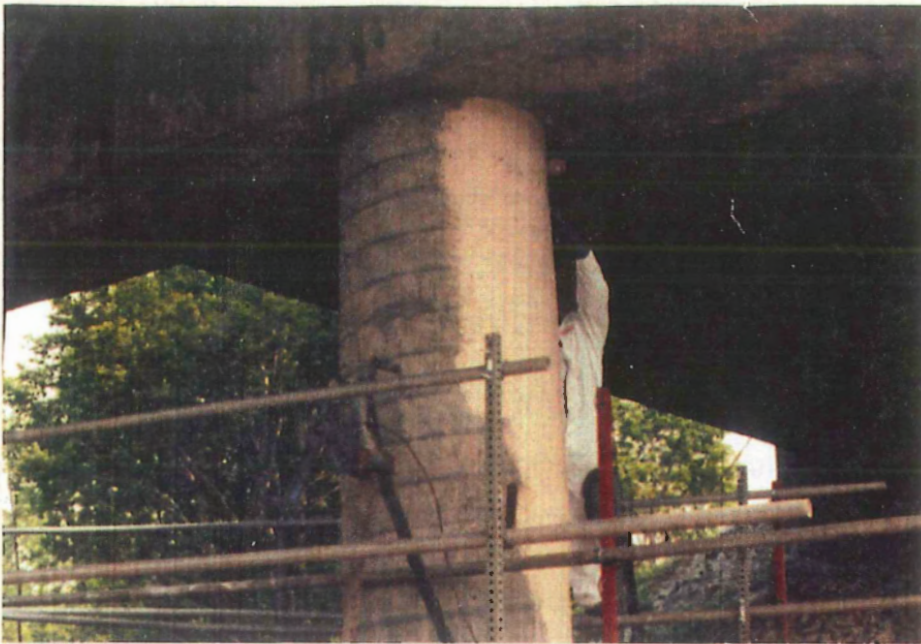
Epoxy-paint mixture was applied to repaired areas.

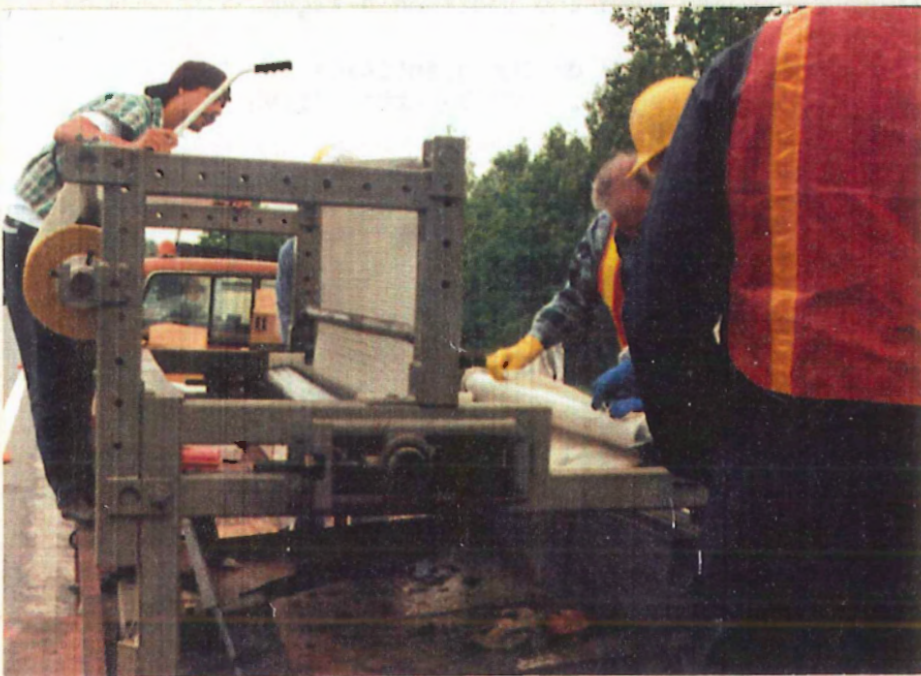
Glass Fabric was drawn through rollers and saturated with epoxy resin.

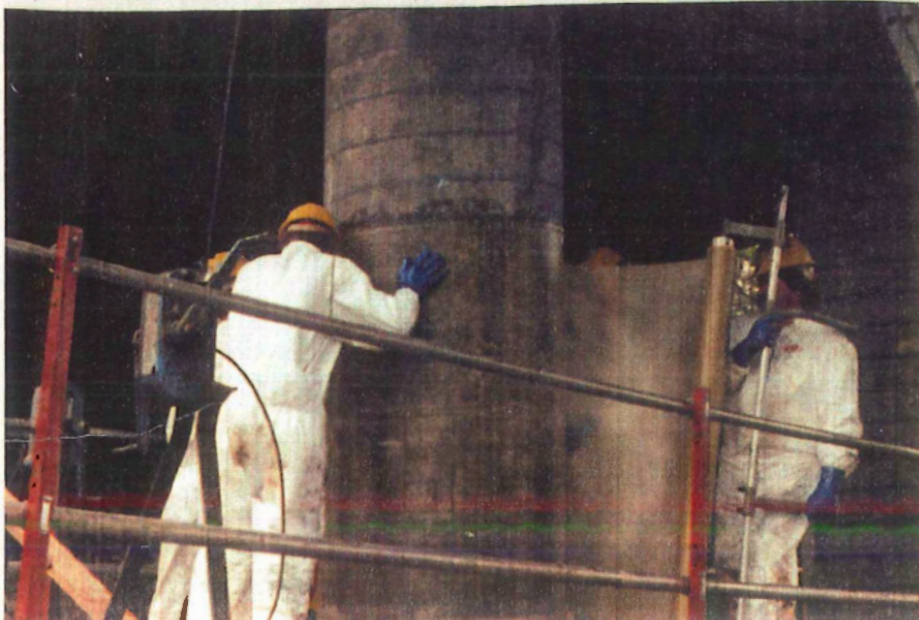
Resin saturated fabric wrapped under tension from adjustable spindle.

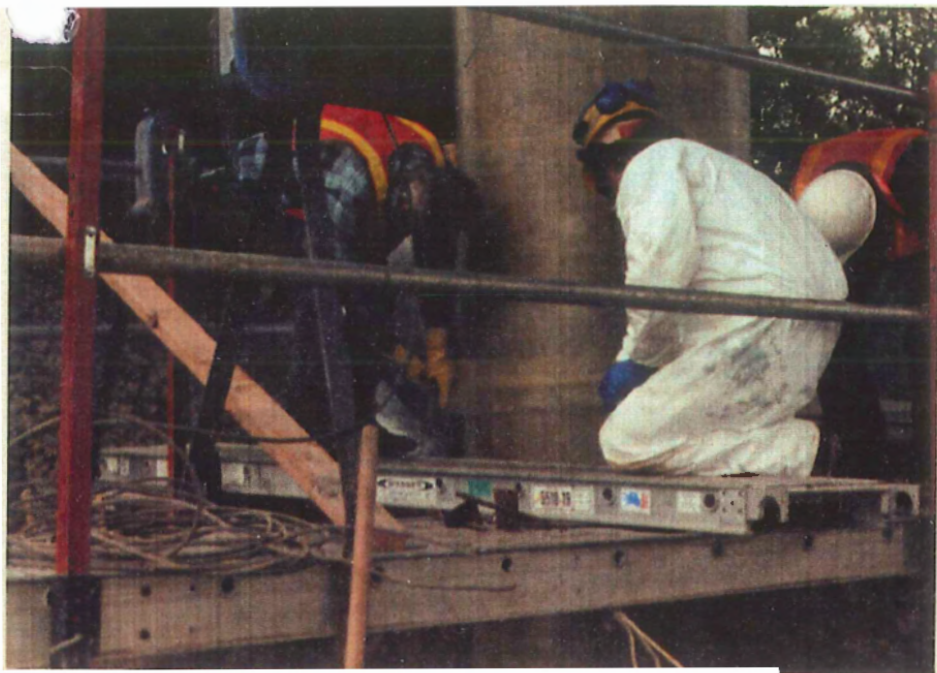
Joints of wrapped columns are covered with six inch strips of resin saturated fabric.

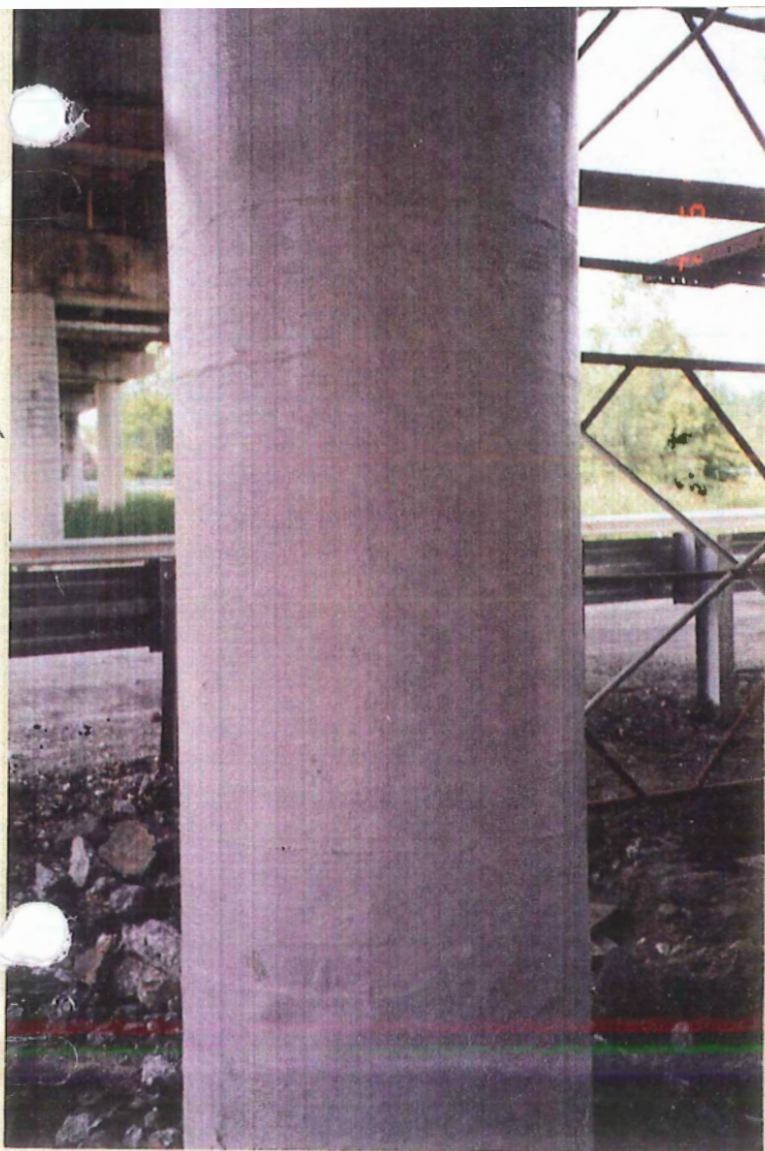
Finished column, wrapped and painted.
