MATERIALS & RESEARCH DIVISION

RESEARCH UPDATE

U95-4

REHABILITATION OF U.S. ROUTE 2 IN CONCORD, VT.

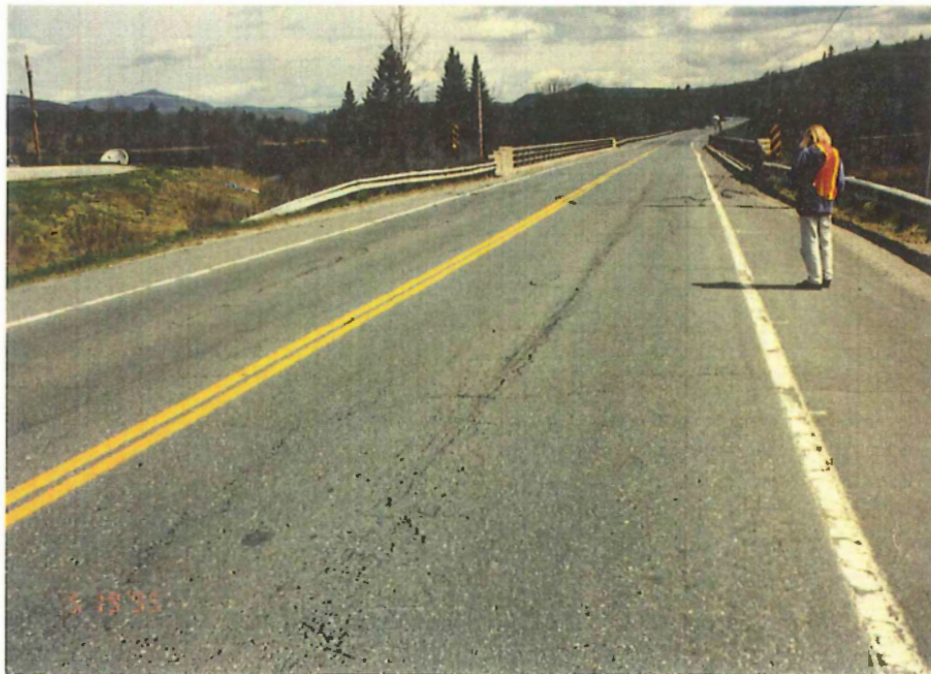
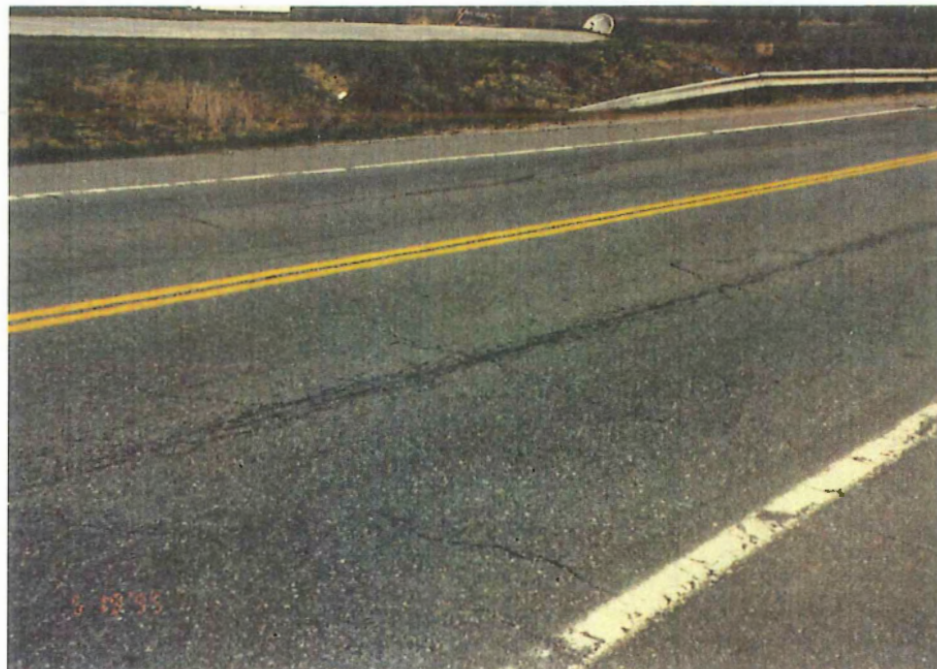
Severe longitudinal cracking in E.B. lane at the westerly end of the project. (both photos)
