RESEARCH UPDATE

Update U96-17

**LDI THORMA JOINT BRIDGE JOINT SYSTEM**

Thorma Joint  
Bridge 16N I91

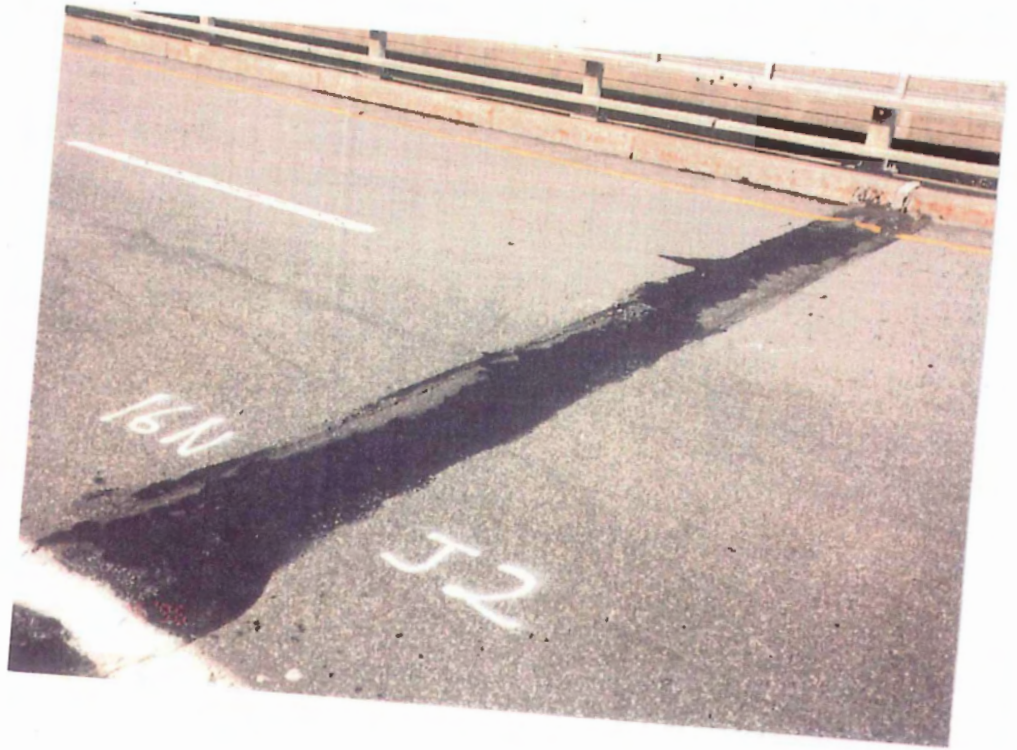
Northern end of Bridge

Both of these joints were inspected by personnel from the Materials and Research Division on July 16, 1996. During this survey it was observed that thirteen feet of material on Joint 1 had separated from the adjacent pavement with twenty-two feet of the same type of distress evident on Joint 2. Excess material, most likely from the replacement of the joint in 1991, was evident in the breakdown lane on Joint 2. This "extra" layer appears to have been scraped slightly by snowplows but no other damage is evident. No scraping is evident on Joint 1, but wheel path wear is noticeable. No joint material cracks, as were noted in U91-9, were evident in either of the joints. Comparing pictures of the joint distress from 1992 to 1996 indicates that very little further damage had occurred. Overall this joint system is performing well in this particular application.
