RESEARCH UPDATE

Update U96-24

**RECLAIMED BASE COURSE STABILIZED
WITH CALCIUM CHLORIDE
(INTERIM REPORT)**

The project began on VT 73 in the town of Brandon at MM 5.887, and extended westerly 13.37 km to MM 3.610 in the town of Goshen.

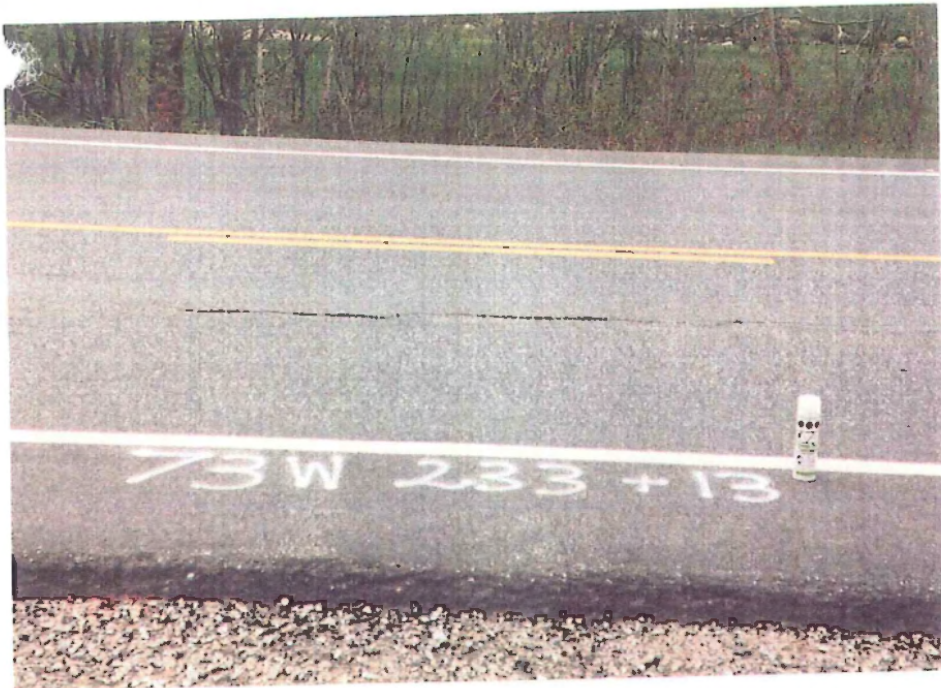
Longitudinal cracking in untreated test site at MM 2.33

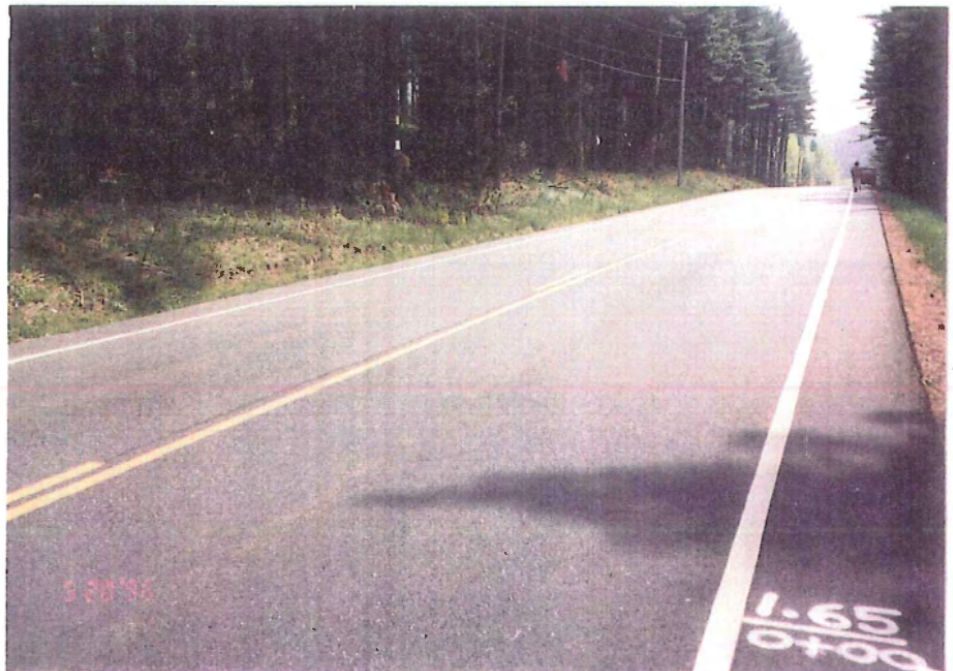
No distress noted in treated lane (east-bound) or untreated lane (west-bound) at MM 1.65
