MATERIALS & RESEARCH DIVISION

RESEARCH UPDATE

Update U97-1

GLASPHALT PAVEMENT PERFORMANCE ON VT 12

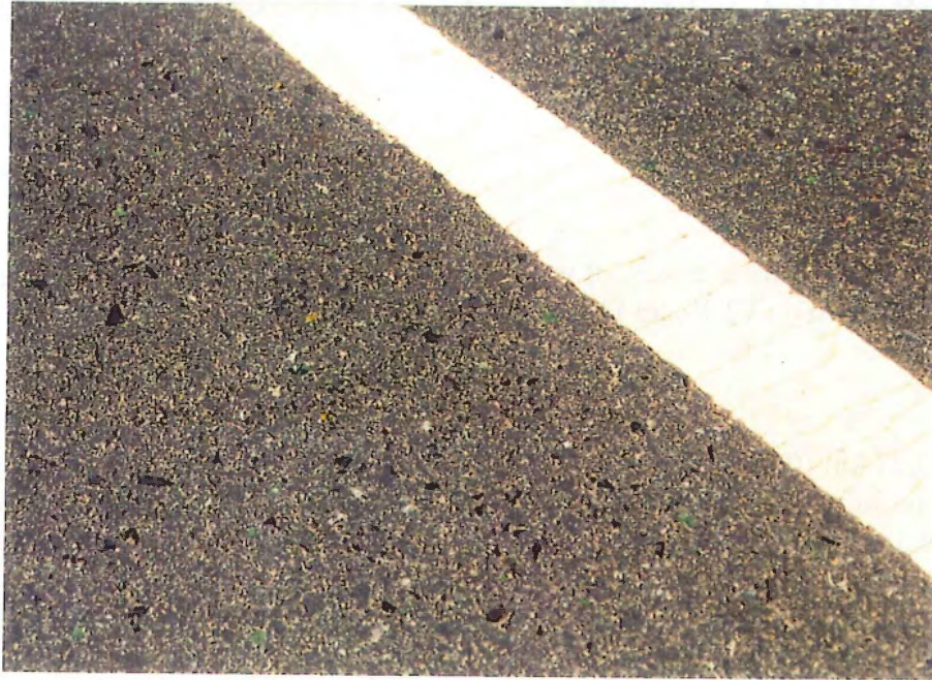
Glasphalt surface, August 9, 1995 (Note the colored glass)
