RESEARCH UPDATE

Update U97-2

XJS BRIDGE JOINT SYSTEM

WP 93-R-21

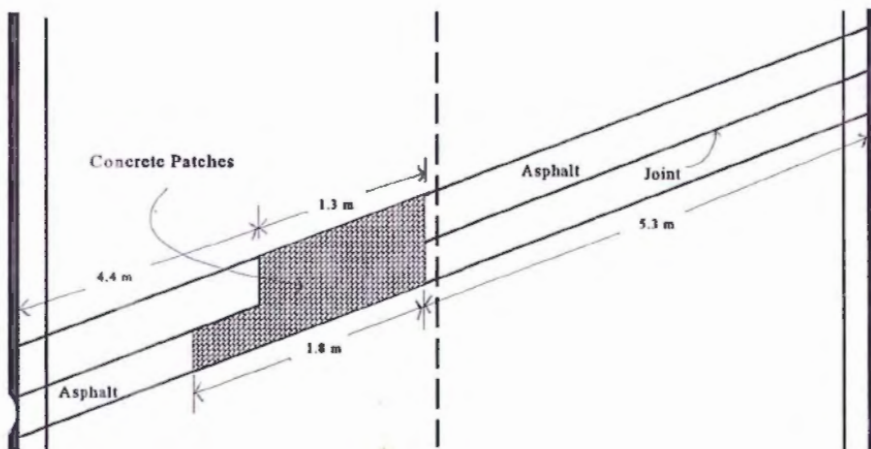
XJS Joint, Bridge 20S I-91, Westminster, VT

The joint exhibited 45 centimeters (cm) of transverse cracking which prompted District maintenance personnel to replace part of the joint in September of 1993 with two concrete patches (see diagram). During an inspection in 1994 it was noted that 0.3 m of asphaltic material either side of this repair job was not bonded to the deck, while another 0.3 m section, adjacent to the joint, was cracked and depressed. In 1995 this joint was again inspected. The sealant used for the system was still quite flexible. No additional problems were observed at that time.

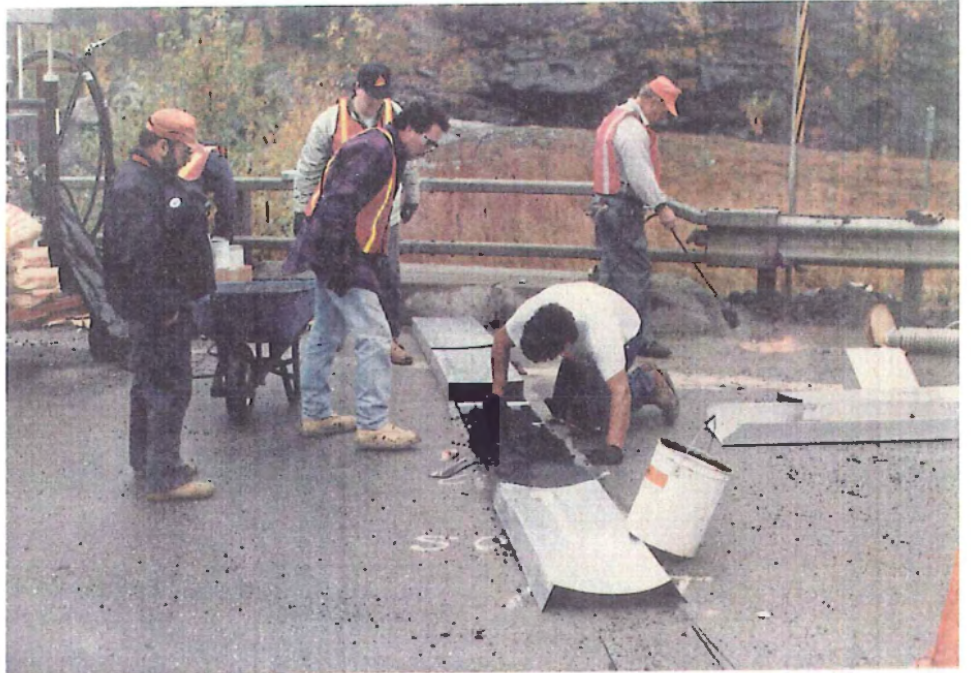
XJS
Bridge 20S I91

Installation
1992

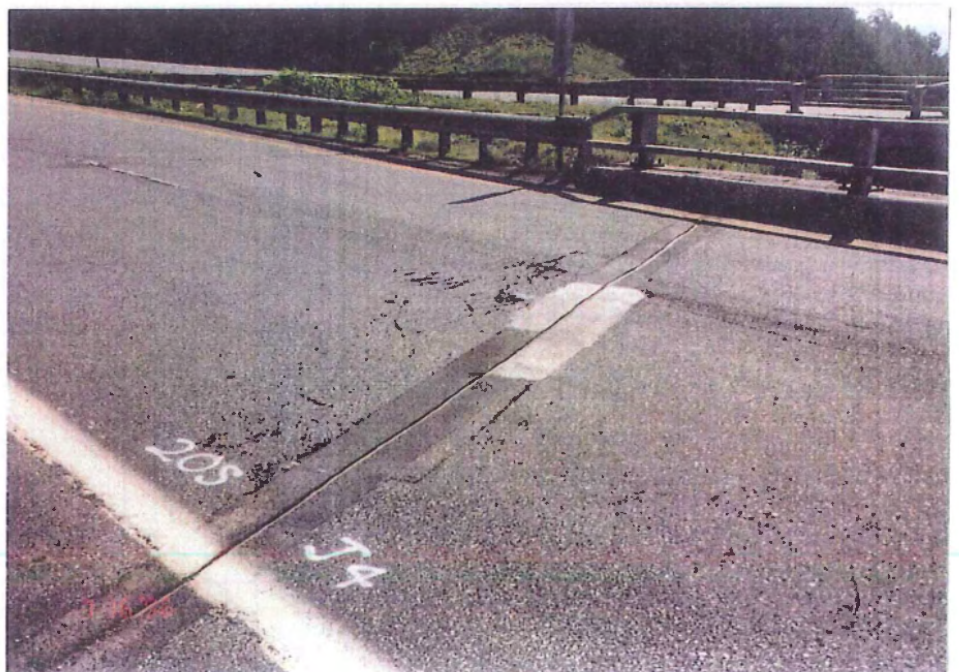
XJS
Bridge 20S I91

This joint, along with others, was inspected by personnel from Materials and Research on July 16, 1996. During this survey only 75 millimeters (mm) of distress, other than the concrete patches were observed. The debonding problem noted in 1994 was not evident. The joint width itself varied from 32 mm near the curb to 40 mm at the left side of the passing lane. Numerous small cracks were noticed in the bituminous concrete pavement on the approach slab.

4 year inspection
6
