RESEARCH UPDATE U97-3

SILICOFLEX STRIP SEAL JOINT SYSTEM

Silicoflex Strip Seal Joint
Bridge # 1
Berlin State Highway
View towards downspout

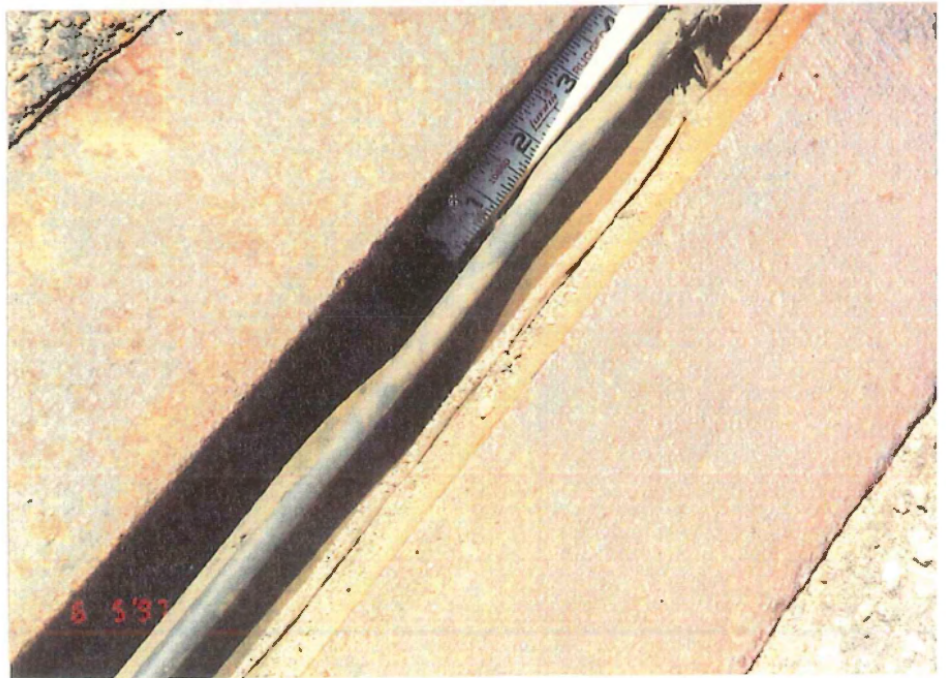
The Silicoflex System was inspected on May 22, 1997, after 1 year and 9 months of service. The joint was completely packed with sand from winter maintenance. The lower end of the joint at the downspout was blocked with debris which prevented drainage. Three sections were uncovered for inspection, one at each end and one near the center. At each location debonding was found. The worst area was near the upper end of the joint where the strip seal was found to be completely pulled away from the steel, leaving an opening approximately 3 inches long. (see photo). At two other locations the V-shaped seal was in contact with the steel but was not bonded. The seal itself appeared to be in good condition, but adhesion has not been retained.

The debonding could be the result of several factors. Most noticeable during the inspection was poor drainage and retention of sand and debris. The bond was further aggravated by considerable rust from the steel angle plates. It is possible that the steel was not thoroughly cleaned before the joint was installed, or that the normally occurring rust has spread underneath the adhesive and weakened the bond.

Bond failure
at upper end of joint

There are no immediate plans to replace the Silicoflex joint; therefore, it will be re-examined after another year to evaluate the rate of deterioration of the bond.

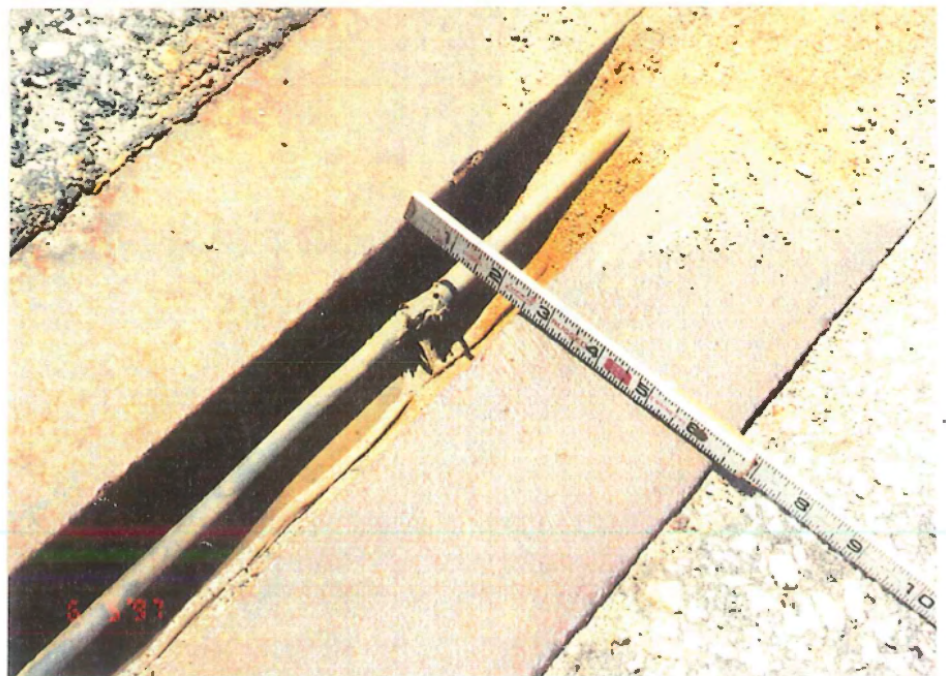
Clogged joint at
downspout end
