**RESEARCH UPDATE U97- 4**

**METROMARK COPOLYMER TRAFFIC PAINT  
VERMONT ROUTE 14****Reference:** WP 96-R-7**Background:**

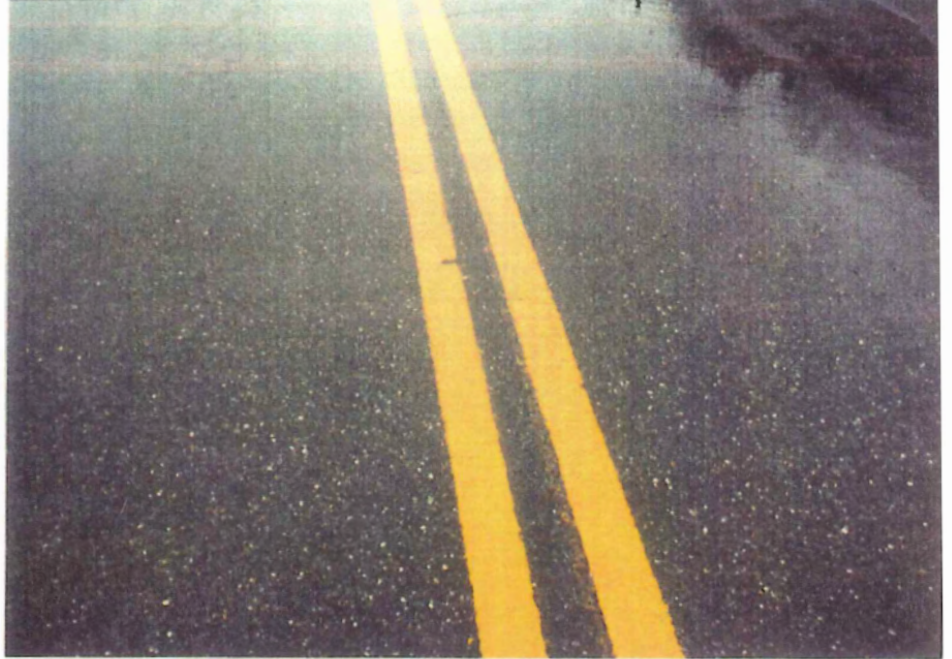
The yellow double centerline is in good condition for most of the project, showing crisp edges and bright color. Over the last two miles of the project, in the Town of Woodbury, the centerline is fading. The centerline appears to have escaped any significant plow damage.

MetroMark  
yellow centerline

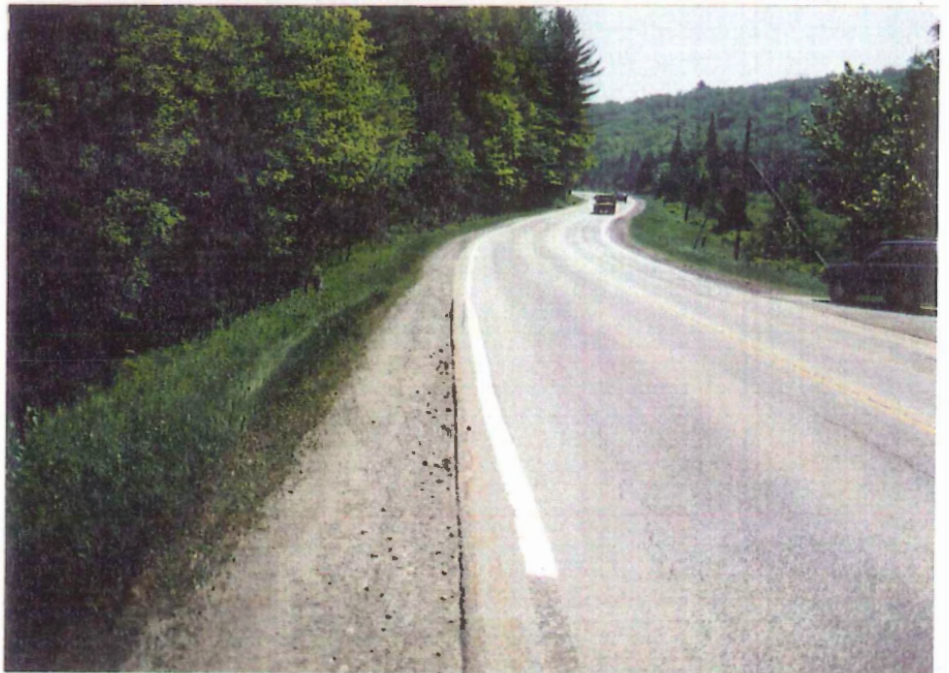
By comparison, the waterborne traffic paint applied adjacent to MetroMark material has faded badly and could use restriping this year, while most of the MetroMark material is intact. (See photo addendum)

MetroMark white (intact)  
contrast to abutting waterborne

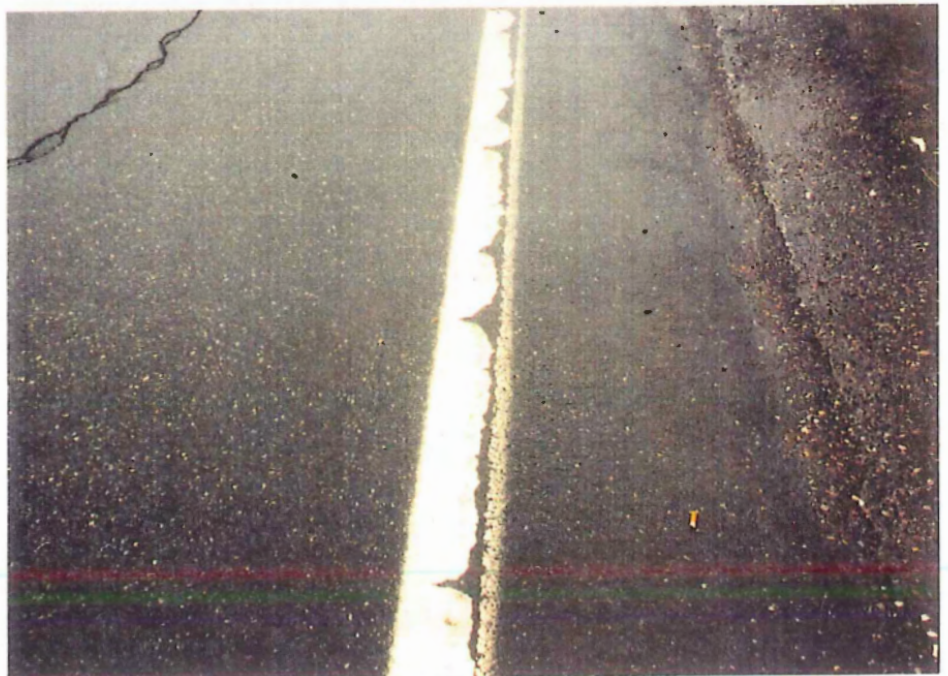
The white edge lines were subjected to more plow contact and have lost roughly 15 to 30% of their material to chipping. The existing pavement had considerable fatigue cracking along the edge of the driving lanes when the striping was performed; consequently, these edge lines have faded. Areas with a stable pavement surface are comparable in condition to the yellow centerline.

Typical plow damage
