RESEARCH UPDATE

U97-12

TYFO S FIBERWRAP

TYFO S Fiberwrap
Bridge 60, Pier #1
I-89 Williston, VT

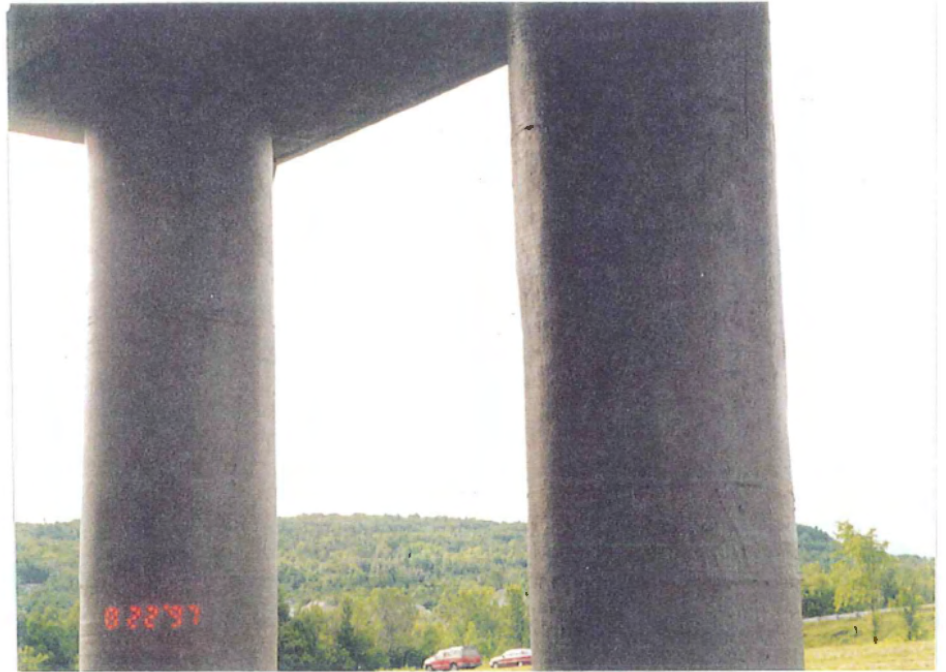
The TYFO material on Bridge #60 was inspected by Research and Development personnel on August 22, 1997. After 3 years and 2 months of service all three columns of Pier #1 were examined and found to be in excellent condition. The fiberwrap material shows no signs of cracking or discoloration.

During the August 1997 inspection several air pockets were discovered, showing up as bulges in the material ranging from approximately 20 to 60 mm in diameter. The paint covering the TYFO was intact. Since the paint is non-ductile, it would have cracked if the air pockets had developed after the paint had dried. Therefore, it is most likely that the air pockets have been there since the material was applied and were overlooked on previous inspections. Therefore, the bulges in the material are not considered an indication of material failure.

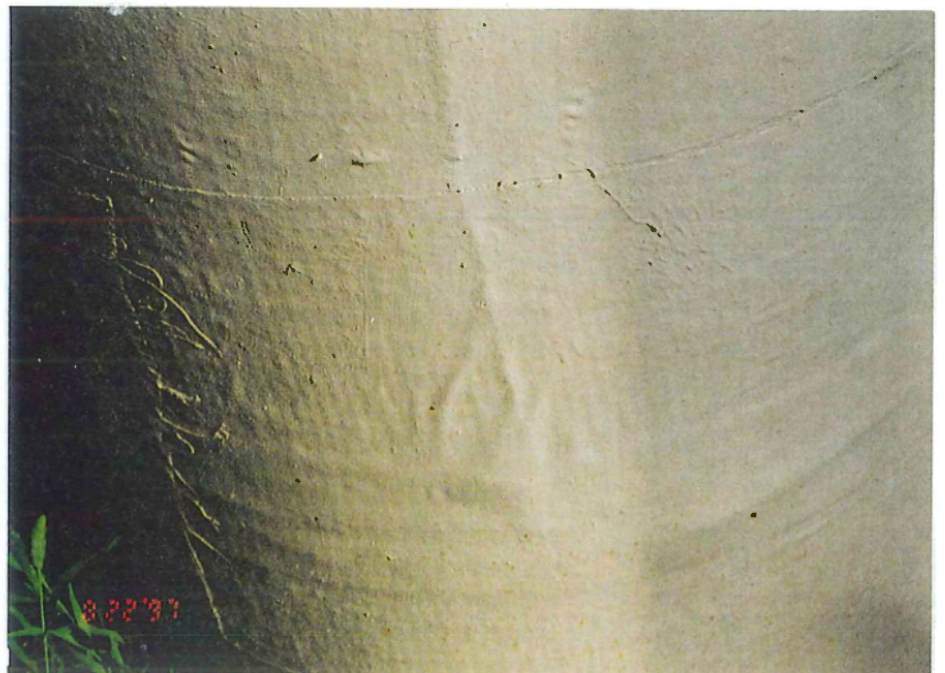
Travel lane side of column,
typical condition
