RESEARCH UPDATE

U 1998- 4

COMPARISON OF PAVEMENT MARKING SYSTEMS WATERFORD-LYNDON, I-91

References Initial Report 1998-2, Category II Work Plan 96-R-4,
Waterford-Lyndon IM091-3(7) Project

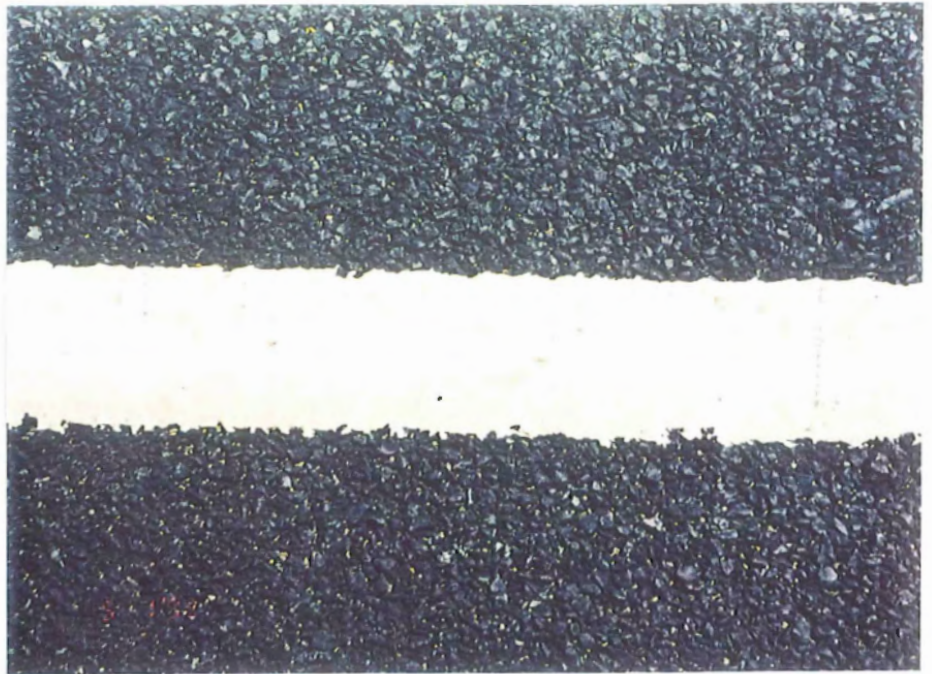
Thermoplastic edge line
MM 134.75

The yellow and white thermoplastic lines were in good condition at both test sites, with very little loss of material over the past winter. Plow damage was minimal, but as expected, the drop-on glass beads were gone from the surface. Since it is anticipated that snow plowing will obliterate the drop-on beads, additional beads are intermixed in the material so that they become exposed as the thermoplastic material wears away, insuring that the markings will continue to be retroreflective. During the field inspection it was noted that the imbedded beads were not readily visible on the surface of the thermoplastic material. The absence of exposed glass beads was corroborated by retroreflectivity readings. The white lines had an average loss of retroreflectivity of 64% over one winter. The yellow lines held up better, with a loss of 26%. (see Table 1).

The thermoplastic lines are exhibiting the best durability, although retroreflectivity is inexplicably low. The markings held up well to plowing over the past winter. The only damage was some minimal chipping at the edges and an occasional dislodged piece of aggregate.

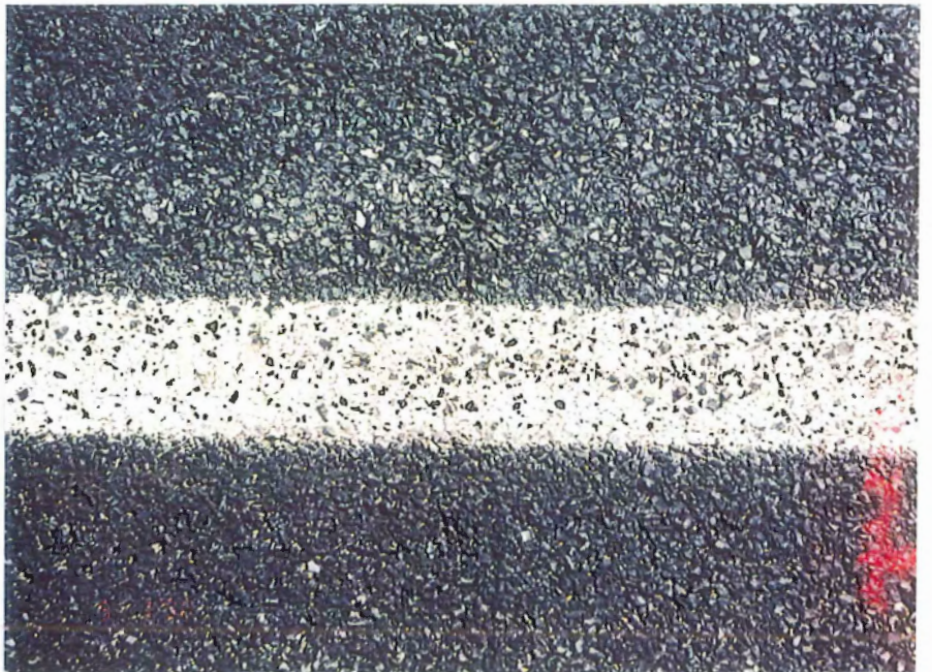
Epoxy edge line
MM 134.50

As shown in Table 1, the initial readings taken on the epoxy lines showed them to have superior retroreflectivity to thermoplastic, especially the yellow lines. But over the past winter the surface of the epoxy markings were badly chipped (see Photo addendum). Approximately 30% of the epoxy on the surface was gone, but material lying in the recesses of the aggregate was intact. Since the lost surface material was chipped off rather than worn or faded, the loss was attributed to plow strikes. The epoxy markings have also dropped considerably in retroreflectivity, averaging a 54% loss on the white lines and 62% on the yellow. Surprisingly, the epoxy markings are exhibiting retroreflectivity comparable to the thermoplastic markings in spite of the loss of material.

The epoxy markings did not show bleed-through and formed a good bond with OGFC. The color of the material was bright and initial retroreflectivity readings were excellent. Over the past winter the material was badly chipped by plowing, with a loss of material of approximately 30%. The epoxy markings are currently providing adequate retroreflectivity; but given the extent of plow damage, it is anticipated that the markings will be exhausted after another winter. Based on these observations it is the opinion of the researchers that the recommended application thickness of 15 mils (380 μ m) is too thin for use on OGFC, for the same reasons described for use of waterborne paint.

The epoxy markings are badly chipped, even though retroreflectivity readings indicate that the lines are adequately visible for continued service. As of the date of this report it is not certain if the epoxy lines will be replaced this summer. Should the lines remain in service they will be inspected again next spring.

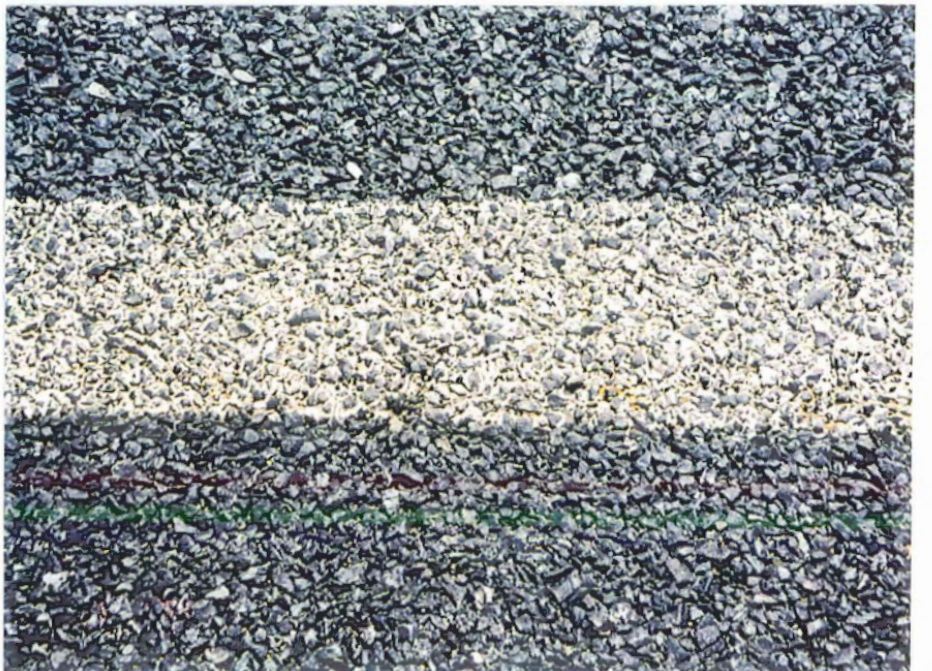
Waterborne edge line
MM 134.00

The waterborne lines had particularly low initial values for retroreflectivity, especially on the white lines, where bleed-through was suspected. The material has worn badly over the past winter (see photo addendum). Given the low initial readings and the loss of material over the past winter, this application is considered to be at the end of its service life.

Of the three materials under study, waterborne traffic paint proved to be the least effective. Initial readings were particularly low on the white lines, probably a result of bleed-through from the newly placed OGFC pavement. The markings were poorly visible after less than one half year of service. It appears that the coarse OGFC pavement, with its high concentration of voids, does not accept a thin 15 mil (380 μ m) application of waterborne paint as well as a smoother surfaced dense graded mix. Waterborne paint tends to pool in the recesses of the OGFC pavement when applied, causing the surface area of the markings to be thin and susceptible to weathering and wear.

The waterborne paint test section is at the end of service life and will be replaced this year by thermoplastic markings. Therefore, there will no more data collected from this application.
