RESEARCH UPDATE

U 1999-5

PAVEPREP CRACK REDUCTION INTERLAYER

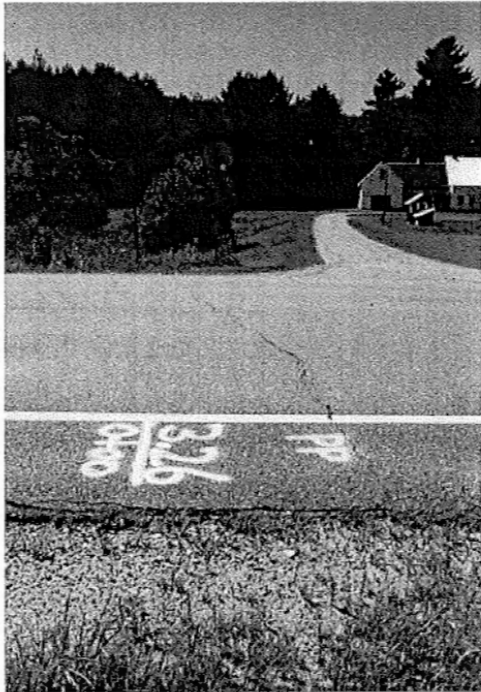
Lowell-Westfield VT Route 100
@ MM 3.26

In 1996 it was initially reported that the test site in Lowell at MM 3.26 had developed three small reflective cracks totaling ten feet in length. In 1997 it was reported as having increased to a total of 14 feet. During a 1999 inspection it was concluded that this crack was not entirely along the alignment of the PavePrep interlayer. A portion of it, nine feet in length beginning at the eastbound shoulder going toward the centerline was along the line of the interlayer, and, from that point on, the crack diverges toward the south, away from the interlayer. Several other cracks are present on both sides of the test site. No cracking was evident at MM 6.13 test site in Lowell.

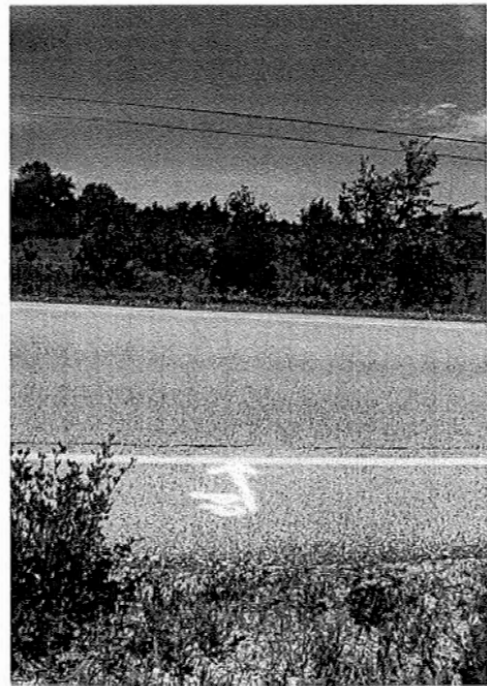
Highgate US Route 7
@ MM 3.60

The Highgate test site shows no signs of reflective cracking along the previous, transverse shoulder-to-shoulder crack, or the centerline.

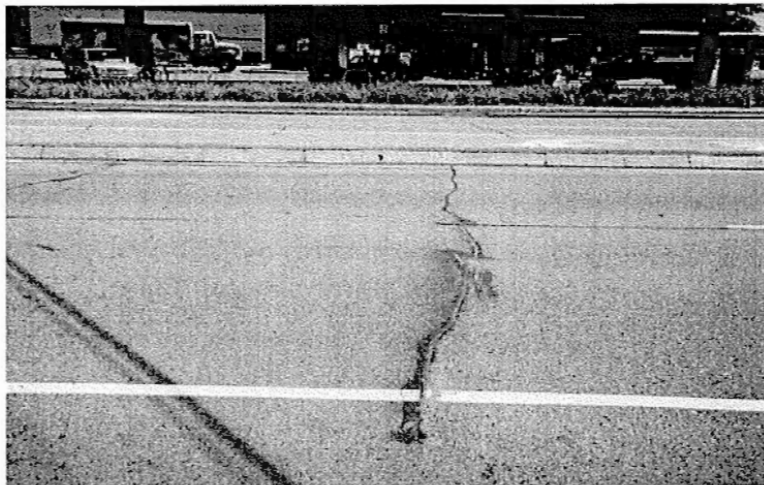
Hartford US Route 5 @ MM 3.13

Since the last inspection in Hartford in 1997, two independent transverse cracks had developed along the alignment in which the PavePrep was installed. One crack measured nine feet in length, beginning at the shoulder edge going toward centerline, while the other was 23 feet in length, beginning at the median and going toward centerline. Overall the crack is across the entire lane with the two cracks overlapping slightly at the center. The crack has recently been filled with a crack sealant.

After five years of service, two of the five test sites developed reflective cracks, and at one of these sites, it failed along its entire length. Although the results are inconclusive at this time, the Hartford failure may be attributed to a high traffic volume and the milled surface on which the material was placed. In Lowell, one site continues to perform as it was designed to, while the other is beginning to show signs of failure. Although both these sites were part of the same resurfacing project, the site at MM 6.13 has less traffic volume than at MM 3.26, possibly contributing to the performance difference. The Highgate site has a concrete road base and low traffic volume, factors that may be associated with its good performance.
