RESEARCH UPDATE

U 1999-7

X.J.S. EXPANSION JOINT SYSTEM

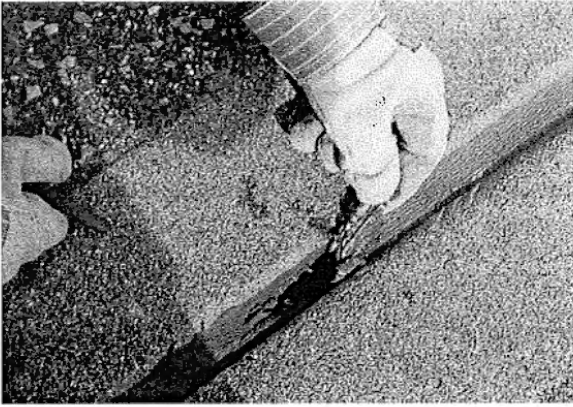
On September 7, 1999, Jim Davis, technical representative from Silicone Specialties Inc. and Materials and Research personnel inspected both joints. The southern joint had no further evidence of damage. In spite of the cracked nosing, the silicone sealant appeared to be intact through the entire length of the joint. The northern joint revealed a small puncture hole in the inner wheel path of the passing lane. The hole was the full depth of the joint sealant and approximately 10-20 mm long. A possible cause for the damage may be associated with a sharp stone or object puncturing the seal and continually pushing down through the material by traffic.

Puncture hole in northern bridge joint (inner wheel path of passing lane)

On October 28, 1999, Jim Davis, with the assistance of District Maintenance, repaired the damage to the northern bridge joint. Repair of the joint involved closing the lane to traffic. The area around the hole was cleaned of debris and then a small area of the existing joint sealant was cut away around the hole forming a V-shape at each end. The idea was to cut away any loose material and create more surface area for the new sealant material to bond to. The joint was then cleaned again with a brush and, in this case, the backer rod was not visible so a new section of backer rod was inserted (slightly longer than the opening) to hold the new sealant material. The repair sealant was applied with a caulking gun. Application began by filling the area between the backer rod and the existing sealant, ensuring a watertight seal. Then the remaining area was filled and tooled for a finished look. The material was left to set for 15 - 20 minutes before traffic was allowed over the joint.

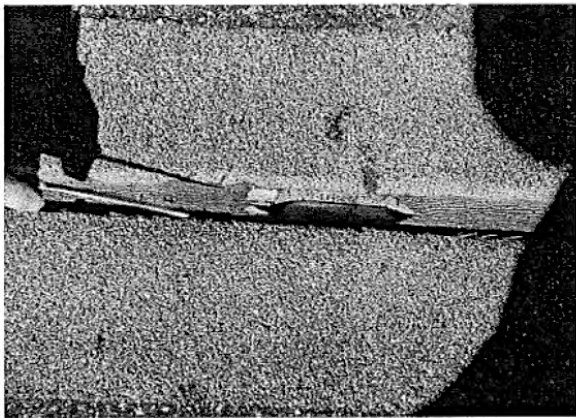
Joint cleaned, V-shape cut out at each end of hole, backer rod installed.

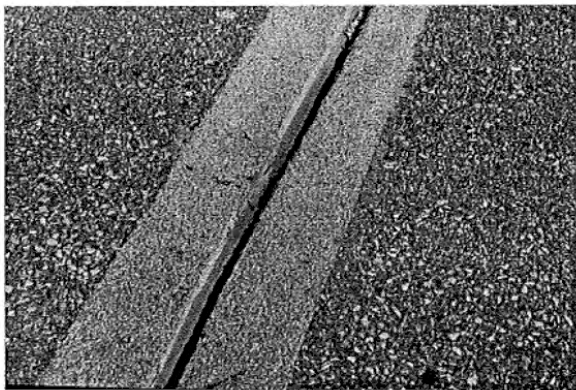
Filled with joint sealant and tooled.
