RESEARCH UPDATE

U 1999-8

**GLASPHALT PAVEMENT PERFORMANCE  
HARTLAND, VT ROUTE 12**

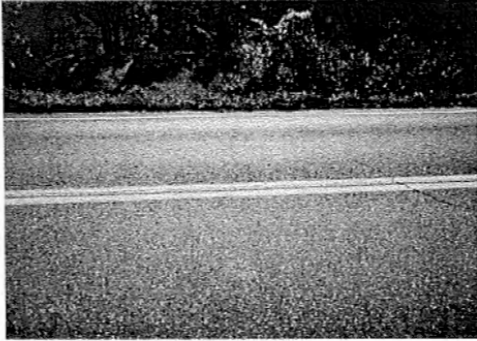
The overall performance of the material appears to be equivalent to the standard bituminous pavement adjacent to it. The addition of glass as an aggregate increases the tendency for asphalt stripping. However, with the addition of an anti-stripping agent, as was the case here, the problem seems to be minimal.

**Glasphalt Pavement (front) /  
Standard Mix (back)**

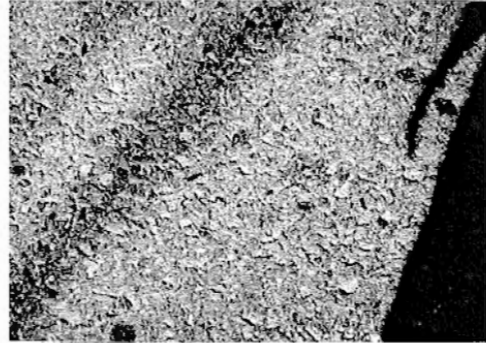
In 1999, an inspection revealed some pitting in the southbound lane where aggregate was lost but the distress was not severe. The presence of glass is still very noticeable, particularly in the shoulder area where less wear has occurred.

**Rough texture in Glasphalt area**
