RESEARCH UPDATE

U 2000-9

**GLASGRID® PAVEMENT REINFORCEMENT
BRIGHTON, VT ROUTE 105
BARNET, US ROUTE 5
(INITIAL REPORT)**

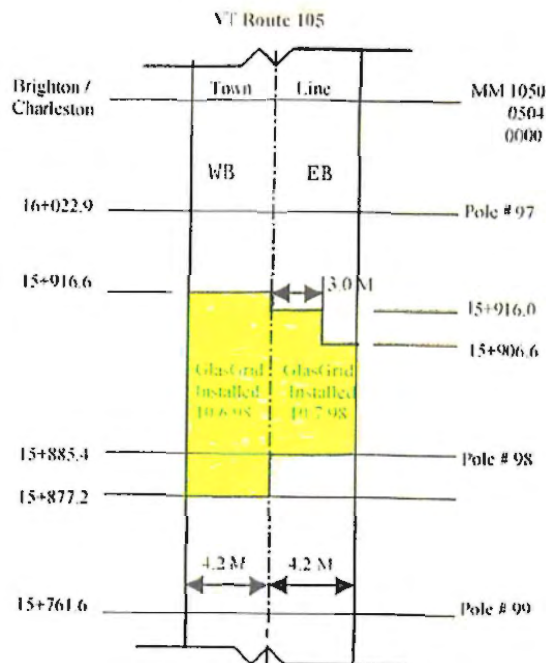
The material selected for the project was GlasGrid® Complete Road System (8501). The test site, located on a flat, tangent section of roadway, included both travel lanes (Figure 1). On October 6, the westbound lane was swept clean and 39.4m of grid was placed the width of the lane on the leveling course. The lane was paved with a 35mm wearing course, with no asphalt emulsion used between courses. A product representative, Alan Ward, of Nead Products, Lewiston, N.Y., was present for the installation.

On October 7, the eastbound lane was constructed with GlasGrid®. The material was placed in an L-shaped configuration with an overall length of 30.6m. Some areas adjacent to the westbound lane were not covered to allow for a side-by-side comparison. An inspection of the site prior to the placement of the 35mm wearing course revealed considerable quantities of small aggregate under the grid, especially along the centerline joint. This was due to the lack of surface cleaning prior to the placement of the grid. The overlap of the GlasGrid® at the centerline was less than the minimum required.

Figure 1. GlasGrid® layout in Brighton.

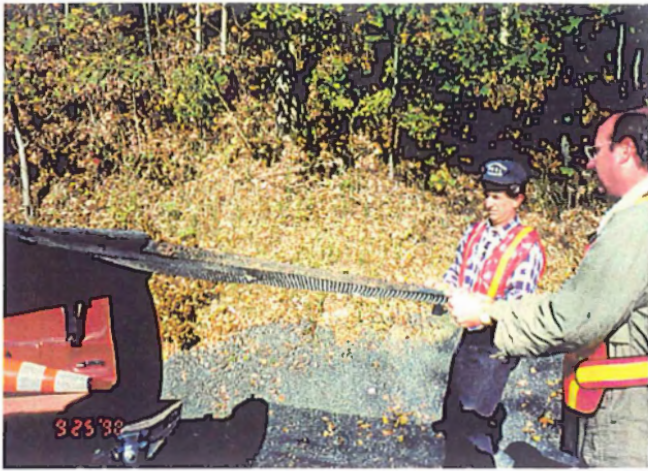
The test area, located on a horizontal curve on a downhill grade, was placed over the outside wheel path of the southbound lane. The test area was comprised of a 30m x 1.5m single layer of GlasGrid® Detail Repair System (8502). The material was installed by hand, being pulled from a roll attached to the back of a pickup truck (Figures 2 & 3). Placed with the tacky side down on the leveling course, the material was then coated with asphalt emulsion and resurfaced with a 40mm wearing course. There was no manufacturer's representative present during the installation.

Figure 2. Installing GlasGrid® in Barnet.

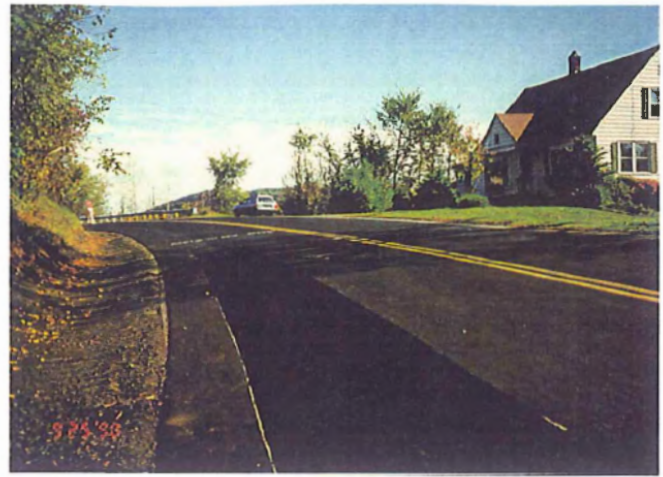
Figure 3. Placement of GlasGrid® in Barnet.

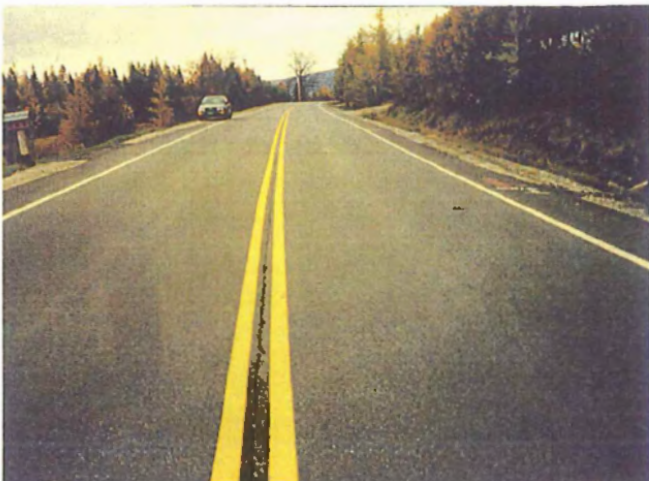
In 1999, after one year of performance, the GlasGrid® test site had shown no evidence of reflective or stress related cracking. A longitudinal crack developed along the centerline both within and outside the test site area (Figure 4). Also worthy to note, the overall performance of the project area on the immediate ends of the test section had not developed any cracks.

Figure 4. Brighton, one year after placement.
(Photo taken October, 1999)

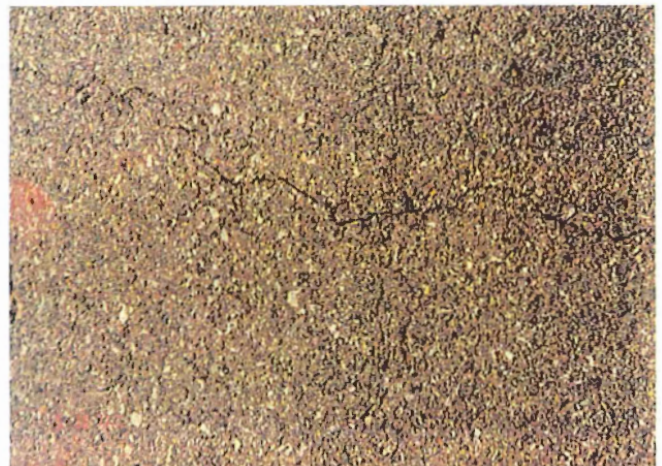
In May 2000, after 1½ years of performance, the test site began to show evidence of very slight cracking in the westbound lane. Two areas were identified, one near Sta. 15+916.6 and another located just westerly of the first. These hairline cracks, about three feet in length, were located in the center of the travel lane (Figure 5). No evidence of this type, or any other type of cracking was present in either the eastbound or westbound lane. The same type of hairline cracking occurred outside the test area, in the same lane, just east of the GlasGrid® location. The longitudinal crack along the centerline appeared unchanged.

Figure 5. Development of hairline cracks.
(Photo taken May, 2000)

The Brighton site utilized the Complete Road System (8501) product. This product, designed with a single strand mesh in each direction, provides equal strength both longitudinally and transversely. GlasGrid® installation at this site included both travel lanes, and in one lane, was under the direction of a manufacturer's representative. The placement of the second lane did not have the same quality control, and the surface preparation was not as recommended. The first of these two lanes has exhibited cracking which is similar to cracking in the same lane outside the test area. The lane adjacent had no signs of cracking. The travel lanes were constructed with a 35mm wearing course, 5mm less than that recommended. It is uncertain if this could be associated with the cracking in the test site area.

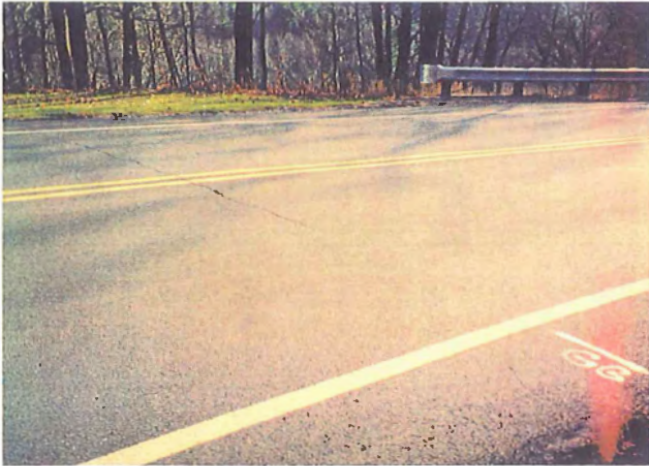
In 1999, after one year of performance, transverse cracking began to develop in the northbound lane, adjacent to the test site. Two of these cracks extended into the southbound lane to the edge of the grid material, but the test area remained free of transverse and longitudinal cracks (Figure 6).

Figure 6. Barnet, one year after placement (24m south of material's north edge). (Photo taken November, 1999)

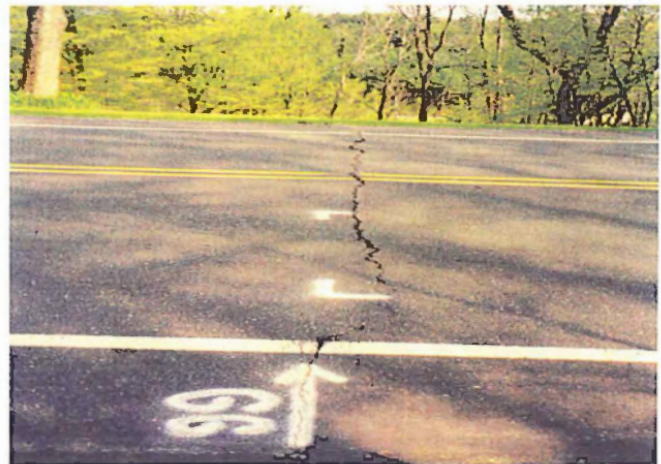
In May 2000, after 1½ years of performance, the GlasGrid® test area had developed transverse cracks. Two full-length transverse cracks were located approximately 9m and 24m south of the north edge of the GlasGrid® placement (Figure 7). Although, no other cracks were evident in the test site area, transverse cracking was typical both north and south of the test site.

Figure 7. Full-length transverse crack, developed after 1½ years performance (9m south of material's north edge). (Photo taken May, 2000)

The Barnet site utilized the Detail Repair System (8502) in the outer wheel path of the southbound lane. This product, designed with a double strand across its width, provides twice the tensile strength in the transverse direction. The test site showed no signs of longitudinal cracking, but transverse cracks appeared within and outside the test area. This failure is probably reflective cracking associated with the movement of the underlying concrete road base. It is uncertain if the use of the asphalt emulsion between pavement layers including the GlasGrid,[®] a practice not recommended by the manufacturer, could have contributed to the early failure of the material.
