RESEARCH UPDATE

U 2002-3

TIRE CHIPS IN THE BASE COURSE OF A LOCAL ROAD (Final Report)

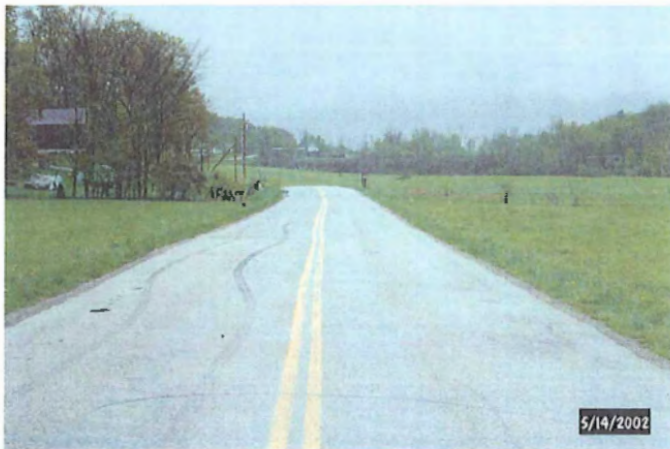
Section 1 constructed in 1990.

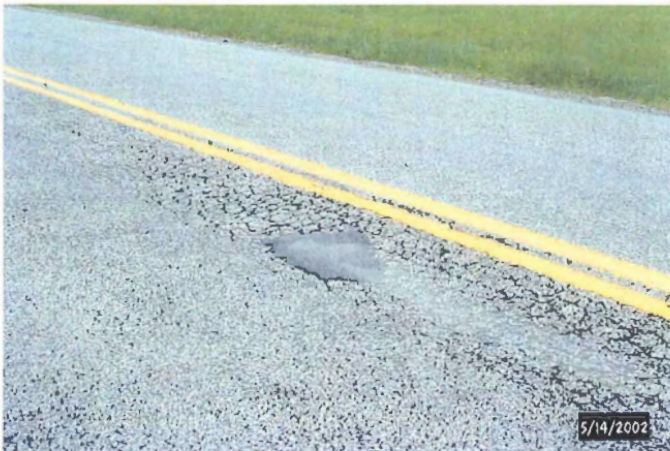
Cracking within Section 1, in the location of the test pit dug in 1993.

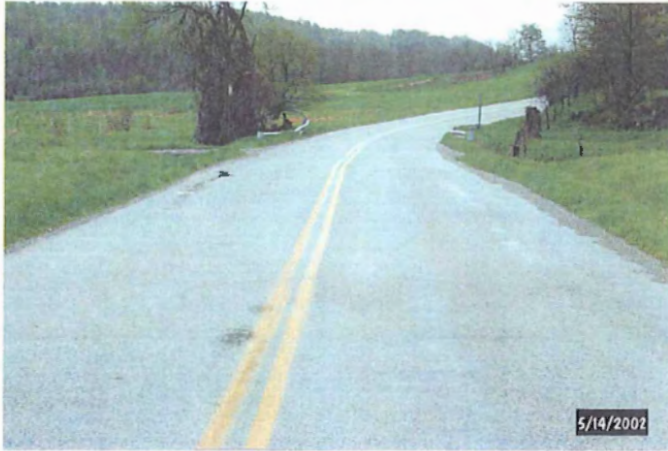
Section 2 was constructed in 1991 and a slightly different approach was used. Only 6-8" of material was removed and stockpiled, this material was then mixed with the tire chips and placed in the road. Using the mixture of material and tire chips did not provide enough drainage and the road was muddy again the following spring. The next summer they covered the section with an additional 6-8" of new gravel. Presently Section 2 exhibits the most rutting as seen in the following photos.

Section 2 constructed in 1991.

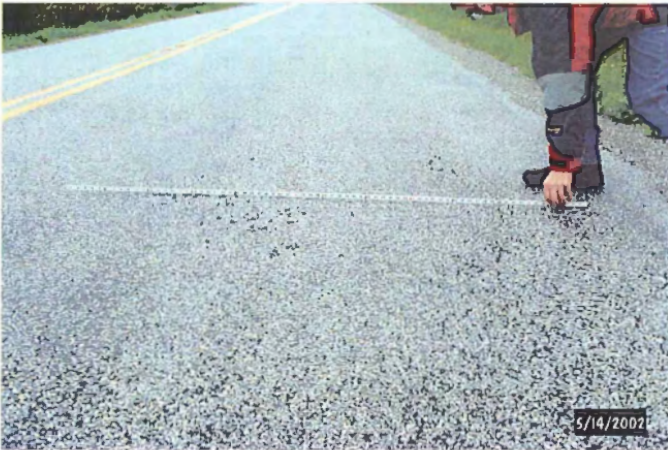
The ruts in Section 2.

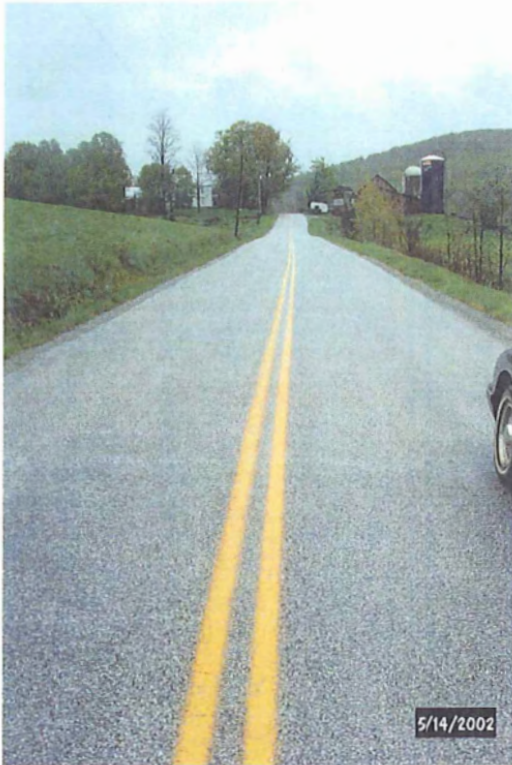
Section 3 was constructed in the same manner as Section 1 and performed the best in terms of rutting and deformation, as shown in the following photo.

Section 3 constructed in 1993.

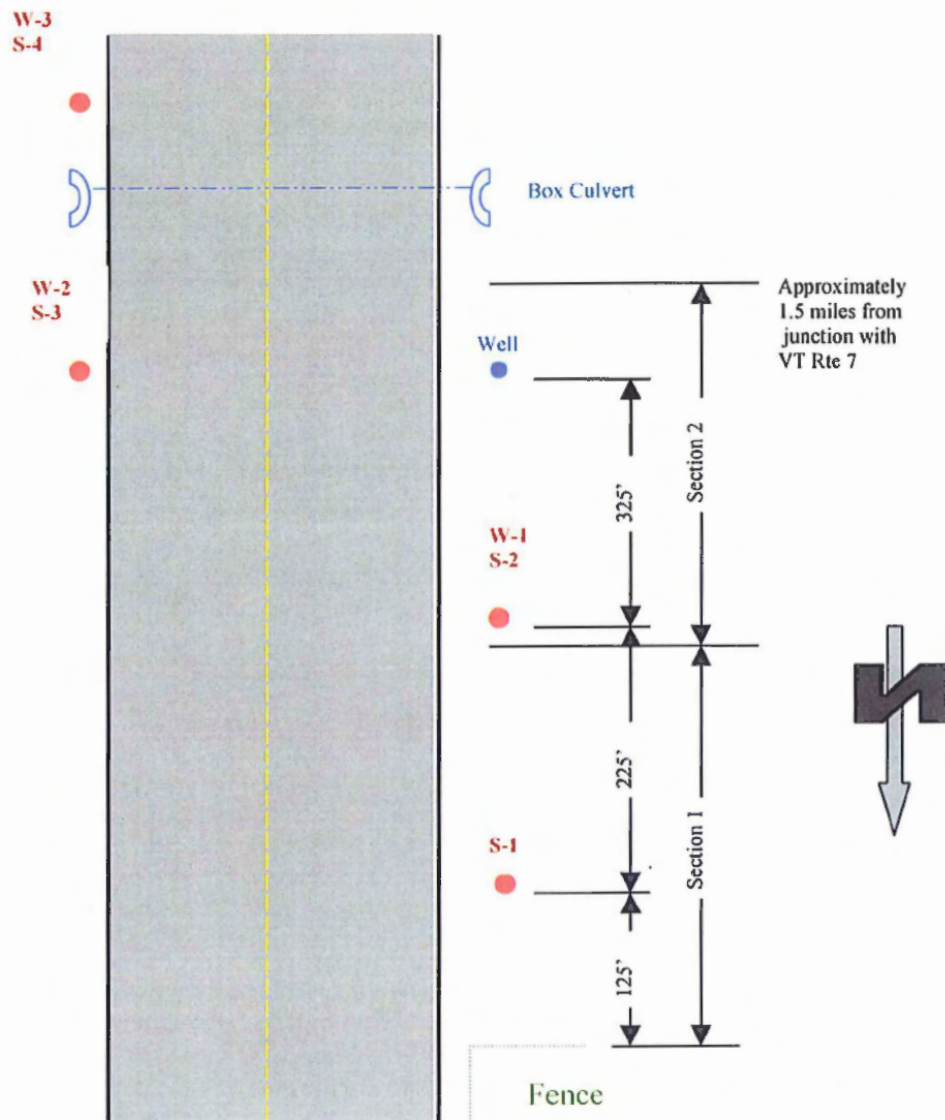
Soil and Water Sample Locations
Oakland State Road
Georgia, VT

- S-1: 6" deep 2' off shoulder
 S-2: 16" deep 2' off shoulder
 S-3: 14" deep 2' off shoulder
 S-4: 16" deep 2' off shoulder
Well: Water level was 3" above ground in pipe and 2" from top of pipe.
 Higher than 6' from bottom of well.
