RESEARCH UPDATE

U 2002-4

THIN POLYMER OVERLAY – GEORGIA, VT

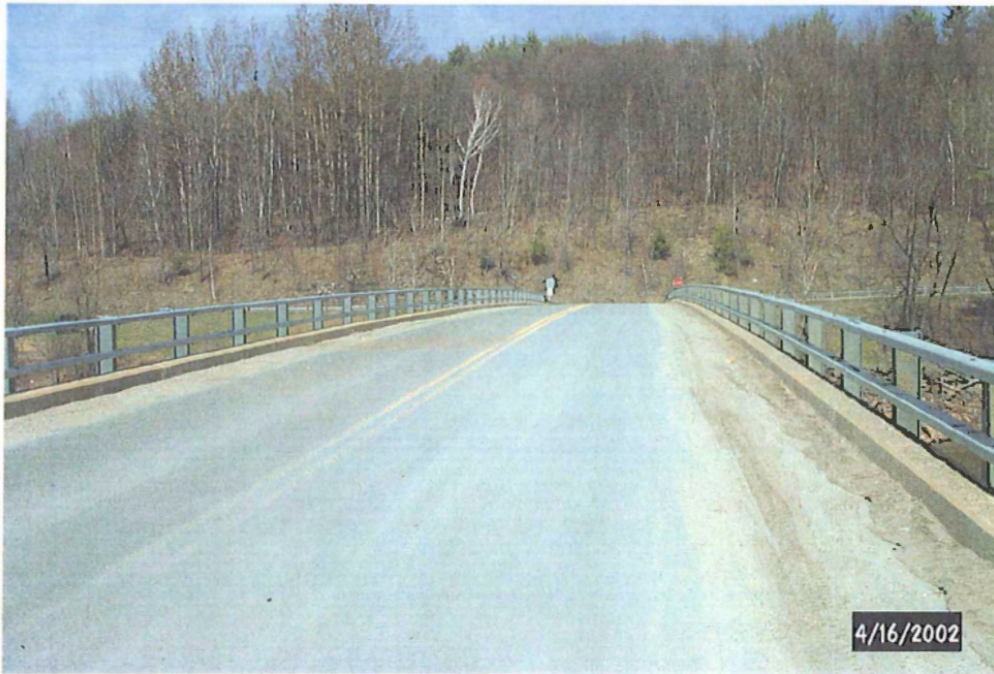
Bridge Number 10 in Georgia was revisited on April 16, 2002 and inspected for cracking and debonding. Chain dragging was performed on the length of the deck and no debonding was apparent. Visual inspection of the deck revealed no cracking. The following photographs illustrate the condition of the deck.

South half of Bridge Number 10

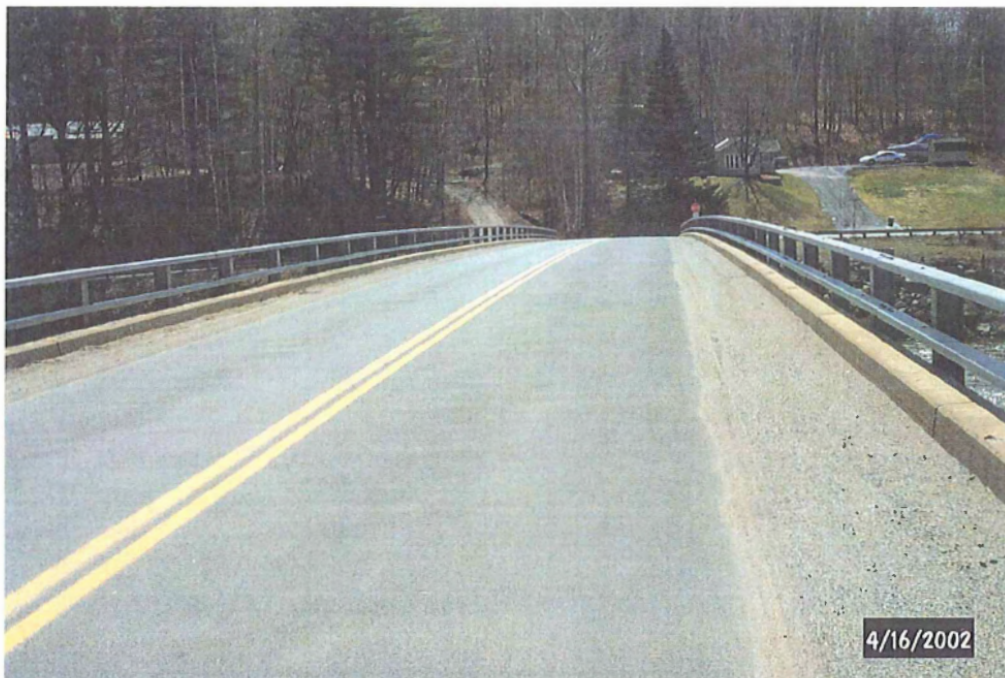
North half of Bridge Number 10

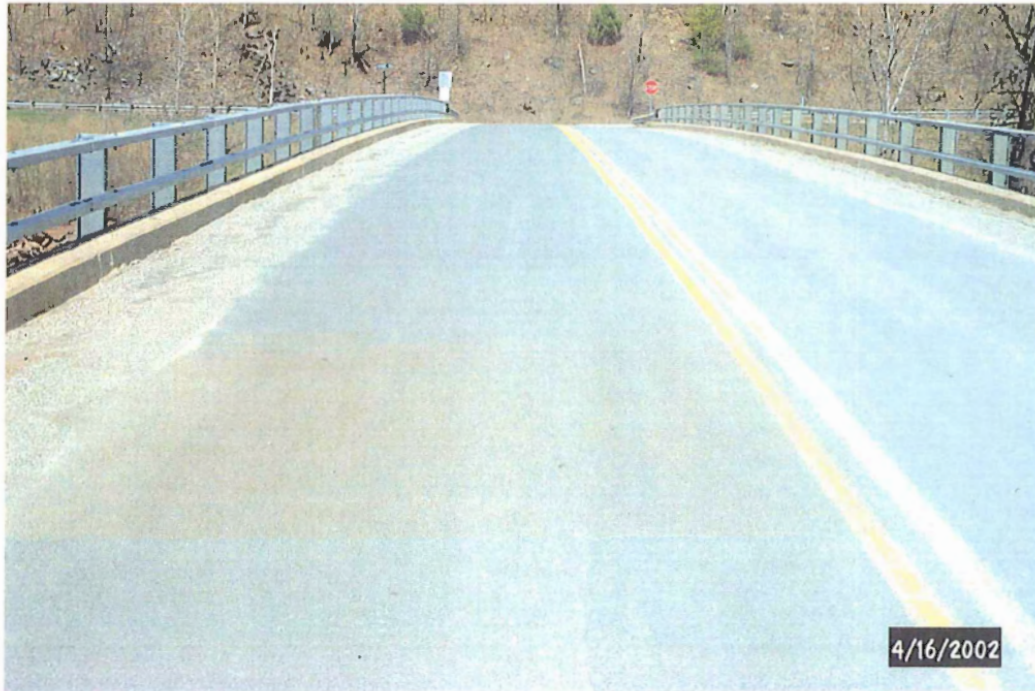
Two observations were made during inspection. The first, illustrated in the photograph below, was of a patch of the deck that appears to be discolored. The Research Staff could not discern a reason for this discoloration, however it does not appear to have harmed the wearing surface.

Discolored Patch

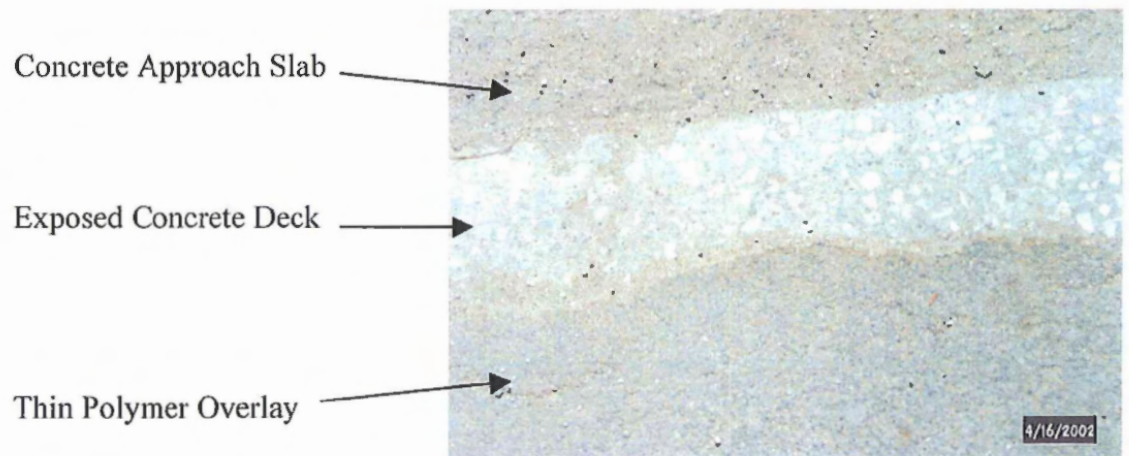
Second, a small portion of the south fixed edge is beginning to peel away from the concrete, which is shown in the next photograph.
